# Journal

## What Went Wrong?

### Diagnosing Building Envelope Distress

John J. Hoffmann, FAIA and Deborah J. Costantini, AIA

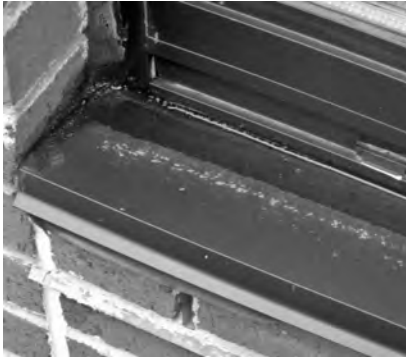
jamb, aluminum sills bent upward at the front edge (Figure 1a), and, most notably, significant gaps between the head of the window frame and the opening (Figure 1b). Concerned that the windows may have fallen in their openings, the project team conducted a follow-up window investigation to find out what had gone wrong.

**▲ Figure 1a:** Masonry expansion led this sill to bend upward at the front edge.

Unfortunately, this building was designed without relieving angles or horizontal expansion joints. Although there are other ways to accommodate movement, these are limited to low-rise buildings, and no such provisions were made here. As a result, the cumulative expansion of all of the brick masonry over the entire four-story building led to substantial differential movement, particularly at the top floor, where the brick had expanded so much that the window sills were now sloped inward, toward the window, allowing water to collect along

the frame (Figure 1a).

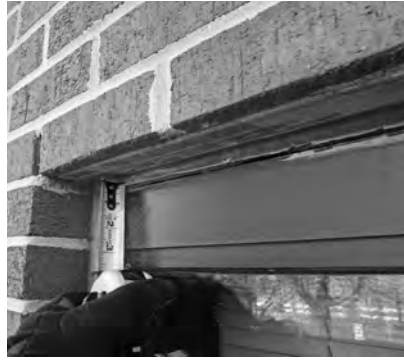
**▲ Figure 1b:** As the brick veneer expanded, it pulled upward away from the window.

With the window units anchored to the concrete back-up, which shrinks over time as it dries out, and no provision for the expansion of the face brick, the window units remained in place while the brick veneer grew, making it appear on first glance that the windows were sinking. Only through a comprehensive masonry and window investigation could the real problem be uncovered.

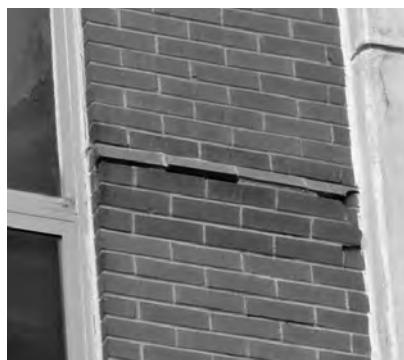
In the example presented in Figure 2, relieving angles are present, unlike in our previous example. However, here we found displaced and spalled brick courses immediately above and below the relieving angle. The question was: why?

**▲ Figure 2a:** Brick displacement due to poor flashing design and freeze/thaw cycling.

A test probe into the distressed brick revealed asphaltic sheet flashing that was lapped but not sealed, which allowed water to travel between the overlapping layers. In addition, the flashing had deteriorated and was no longer providing much protection at all. As water migrated through the porous brick and lingered in the deteriorating flashing, it led to corrosion of the steel relieving angle. As steel corrodes, it expands, placing outward pressure on the surrounding brick and leading to cracks and spalls.

As the outside temperature rose and fell, trapped water underwent successive freeze/thaw cycles, expanding as it froze and contracting as it thawed. These changes in temperature and pressure forced off pieces of the outer surface of the brick, and led to the displacement visible in Figure 2a, in which the face brick is nearly detached from

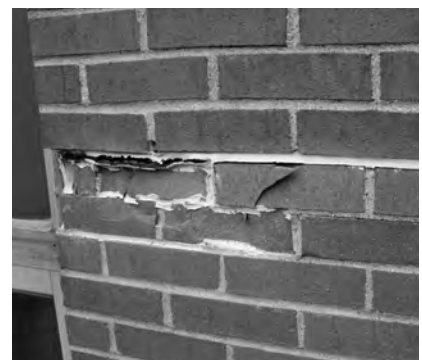
Observing the beginnings of damage at the wall surface, a well-meaning soul with a caulk gun went around and sealed up the open joint at the relieving angle. Unfortunately, this joint was open for a reason: the porous mortar above the relieving angle is meant to allow any moisture inside the wall to discharge. Once this escape route was covered over with impervious sealant, water collected inside the cavity wall.

**▲ Figure 2b:** An attempt to fix spalled brick with sealant made matters worse.

the facade. As deterioration worsened, the same good intentions that led the maintenance staff to apply sealant to the mortar joint brought them back again, caulk gun in hand, to fill in more sealant in and around the spalled brick, inadvertently making the problem worse (Figure 2b).

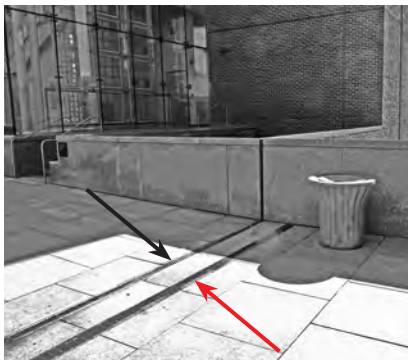
The corroded steel beam in Figure 3b sits directly under an expansion joint in the plaza, where the main entrance ramp meets a level surface; Figure 3a shows this expansion joint from above, with the ramp extending upward to the left of the joint. Notice that the trench drain, at the right (red arrow), is downhill from the expansion joint (black arrow). Every time it rains, water runs down the ramp toward the bottom, where, traveling along the first available path, it meets the

open expansion joint and travels into the occupied space below. With the only drain situated downhill from the expansion joint, much of the water has already found its way into the building before it ever gets there.

**▲ Figure 3a:** The only drain (red arrow) was downhill from an expansion joint (black arrow).

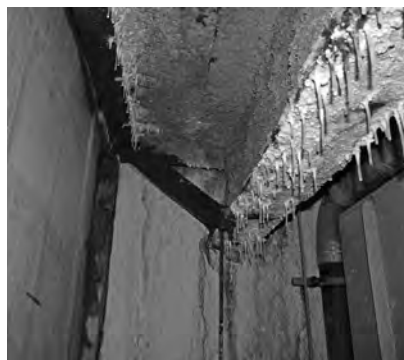
**▲ Figure 3b:** Plaza leaks corroded steel and melted fireproofing beneath the faulty joint.

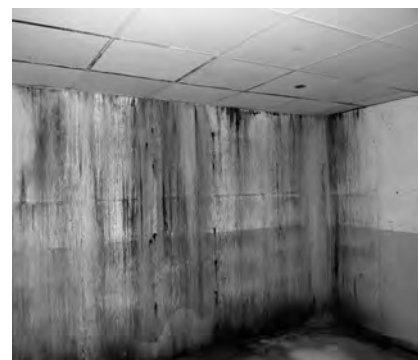
From the outside, the main entrance ramp and plaza shown in Figure 3a looked great: the plaza surface was clean and even, with no heaved pavers or uneven joints. Visitors to the building would have no idea of the horrors within: the spaces one and two levels below the ramp were so riddled with water damage that they became virtually unusable (Figures 3b and 3c). What was going on?

The lesson here is that problems due to faulty waterproofing and drainage design don't always look like problems on the surface. The pristine surface of this plaza belies the extensive deterioration below, where water infiltration has led to corrosion, disintegration of fireproofing materials, efflorescence, staining, and severe water damage to finished spaces. That's why it's so important to properly investigate the source of leaks, and to address the underlying problem.

**▲ Figure 3c:** The plaza looked great, but leaks left rooms below looking anything but.

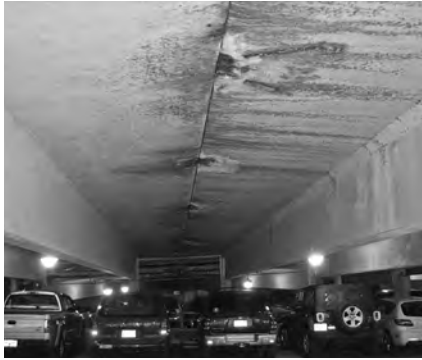
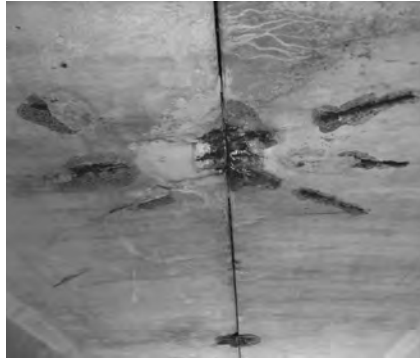
The garage pictured in Figure 4 is a typical four-level freestanding parking structure constructed of precast concrete units in a double-tee (TT) configuration. The distinctive star-shaped pattern of corrosion and spalling in Figure 4b occurred at regular intervals along many of the connections between precast members (Figure 4a). With steel reinforcing present throughout the concrete deck, why was corrosion concentrated at these locations?

An investigation into the garage conditions, including test probes at areas of corrosion and spalling, provided some answers. As moisture penetrated through failed sealant joints at the double-tee connections, it encountered the embedded steel elements that connect one flange to the next. In addition to weld defects that ranged from poor configuration to faulty execution, the garage was constructed with mild carbon steel connections, rather than stainless steel. Despite a coat of anti-rust paint, the connections at this thinnest part of the concrete flange succumbed to corrosion, which extended outward from the welded plate, along the embedded structural steel.

▲ Figures 4a (left) and 4b (right): Corrosion concentrated at flange connections in this precast concrete garage due to inappropriate materials, weld defects, and sealant joint failure.

More concerning, the fractured welds, combined with the missing concrete and loss of embedment area at the beam flanges, mean that the connection capacity at many of the intersections between precast units was significantly compromised. Although the distinctive reddish-brown rust stains and chipped concrete are obvious indicators of, at a minimum, a maintenance issue, what they don't immediately reveal is the serious nature of the damage from a structural standpoint.

Previously, a misguided repair attempt applied patching material to the surface (some of the remaining repair compound is visible in Figure 4b). Not only were these patches performed poorly, with insufficient surface preparation, they failed to address the

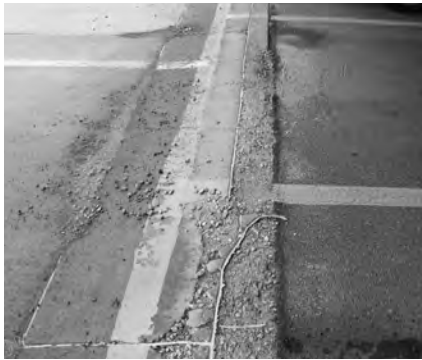
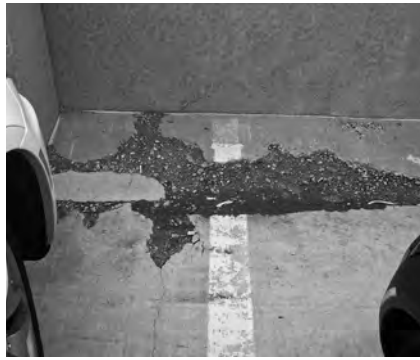
▲ Figures 5a (left) and 5b (right): Insufficient air entrainment of this concrete surface left freezing moisture no room to expand, leading to severe disintegration.

Precast garages often have some cast-in-place elements, and the way in which these different types of concrete interact can impact the longevity of the garage, particularly at parking surfaces. In Figure 5, portions of a tri-level precast garage became quite an eyesore—and presented hazardous conditions for pedestrians—when crumbling concrete led to uneven surfaces. Scaling was so severe in some locations that all that remained of the cast-in-place topping was loose aggregate and sand.

spalls and cracks. During the condition assessment, we found that the concrete was unusually soft and porous, offering little resistance to chipping.

In this case, however, petrographic testing revealed that air entrainment of the cast-in-place concrete at curbs and washes was insufficient. As freezing moisture in the concrete expanded, it had nowhere to go, so it pressed outward, leading to cracks, spalls, and eventually, to near total disintegration of the parking deck surface. Previous repair efforts temporarily improved concrete integrity, but even in these new areas, cracks had been left unaddressed, indicating that these locations, too, would likely deteriorate unless the poorly prepared concrete was completely replaced.

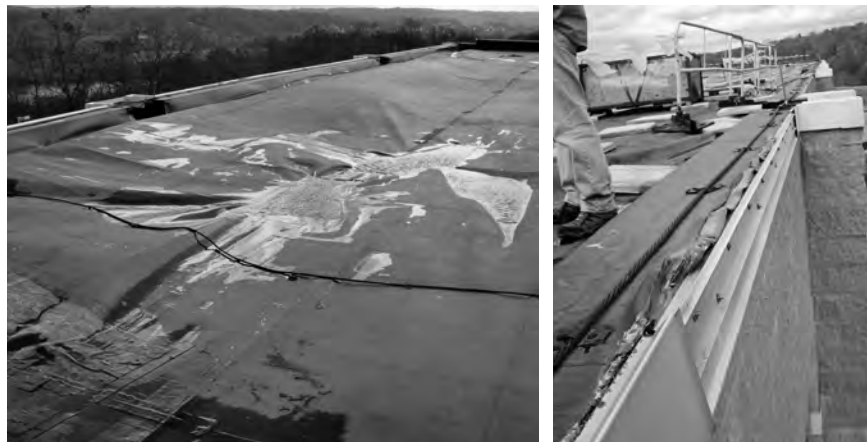
In October 2012, during Hurricane Sandy, a catastrophic roof failure occurred at a suburban data center (Figure 6). Situated on a ridge overlooking a river, the facility's relatively open terrain left it exposed to the full force of the high storm winds. Although the roof structure and membrane assembly were designed

Having ruled out design error as the cause of the failure, the project team then looked to workmanship and detailing of the roof installation. Field investigation revealed several factors at play; one was that insulation boards could be easily lifted from the roof deck, and were not fully adhered. In some cases, asphalt adhesive coverage below the boards was a scant 25

percent. Many of the boards were “cupped,” or warped, which contributed to the poor adhesion. The temperature of the asphalt at the time of installation may also have been a factor.

At the roof edge, the EPDM membrane had been cut off at the top of the parapet, rather than extending over and down the outboard face of the blocking (Figure 6b). In addition, wood blocking in the areas of failure was of insufficient depth to engage the fasteners. Compounding this lack of securement were voids beneath the edge metal where it extended over split-face concrete masonry units. These openings, along with the disengaged fasteners, allowed positive pressures to penetrate the underside of the edge metal.

Other construction defects, including large voids in the concrete roof deck and faulty cricket construction that allowed moist air to accumulate under the membrane, also contributed to the roof blow-off. Although any one of these conditions might in itself have caused the problem, the likely source was some combination of all of them. Despite the sound design of the structural deck and roofing assembly, a host of preventable errors during

▲ Figures 6a (left) and 6b (right): Roof blow-off caused by insufficient insulation adhesion, poor edge detailing, and other construction defects.

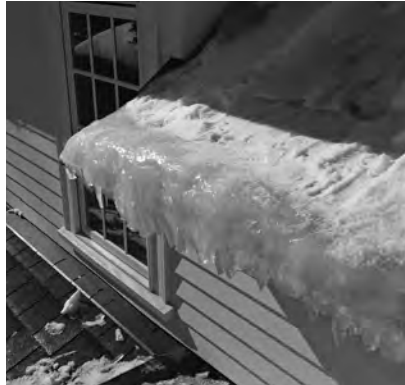
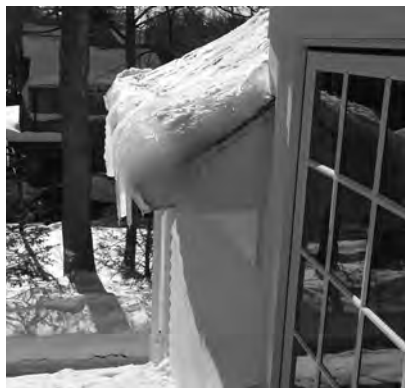
At a residential building on a college campus, severe ice dams at the roof led to leaks at both above-grade levels and the basement ceiling (Figure 7). During a very cold winter, one might expect to see some ice damming on older structures, but this was new construction, just a few years in service. Clearly, more than just bad weather was to blame for the persistent leaks and hazardous ice formation.

Our investigation uncovered several problems in both design and construction. Unbalanced ridge and soffit venting, combined with thermal penetrations in the attic insulation, allowed warm air to collect at the underside of the eaves, warming the roofing materials sufficiently to melt the snow. Once this snow melt reached the gutter and drip edge, it re-froze (Figure 7a). Over time, this repeated thawing and freezing created an accumulation of ice at the gutter, which allowed water to back up under the roofing shingles and penetrate to the building interior (Figure 7b).

and water barrier failed to meet code requirements, and was insufficient to the demands of the climate. Given the complexity of the roof, the majority should have been protected with ice and water barrier beneath the roofing shingles; according to the drawings, only a small portion actually was.

In addition, the original drawings differed substantially from as-built conditions, which can contribute to construction deficiencies. By not accurately reflecting the existing roof framing or attic floor, the drawings did not provide sufficient guidance for the installers for ice and water barrier terminations, particularly where roof and wall areas intersect.

**▲ Figures 7a (top) and 7b (bottom):** Ice dams at eaves led to extensive leaks at the building interior and required replacement of the roof just a few years after it was installed.

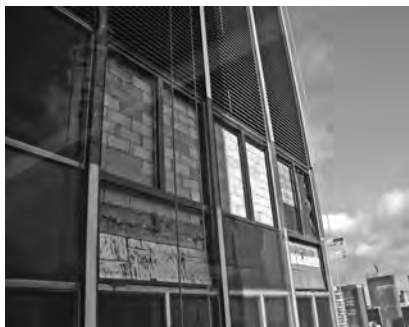
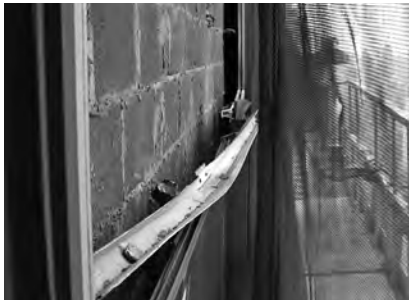
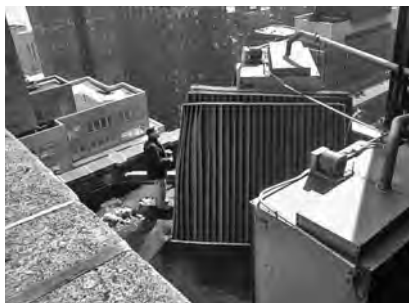
Winter weather was also the catalyst for building envelope failure at a very different type of building in a very different type of setting: a glazed curtain wall in the middle of Manhattan (Figure 8). During a blizzard, a portion of the louver and frame system detached and fell from the building (Figure 8a and 8b), landing on a roof setback (Figure 8c), as well as on the roof of an adjacent building and the street below. Fortunately, no one was injured.

interviewed the curtain wall manufacturer to complete the picture of the probable cause of failure. Constructed in 1962, the curtain wall system employed a series of bolts and clips to secure the framing to the building structure. Newer curtain wall buildings use locking nuts to counteract vibration, but in buildings of this vintage, nuts and bolts working loose was not uncommon, even when some type of lock-washer was used. During the investigation, we found enlarged holes on some outrigger clip connections, which was consistent with fastener loosening.

Other construction defects that likely contributed to the failure were the absence of an anneal slip, used

to prevent galvanic action between dissimilar metals, between steel and aluminum outriggers, as well as failure to weld mullion splice sleeves. The expansion joint in the area of failure was only about ¼ inch wide, yet calculations and manufacturer data predicted an estimated ¾ to 1 inch of expansion over the twenty-foot aluminum mullion.

Although weather conditions at the time of failure were harsh, they were not sufficient to have explained a failure of this magnitude. Instead, a combination of factors, ranging from design errors to construction omissions to limitations in the curtain wall securement system of the time period, coalesced to result in a life-threatening disaster. Something as small as failure to properly account for the material properties of an assembly – in this case, expansion, galvanic action, and seismic forces – can lead to calamity if not considered during design and construction.

❑ **Figures 8a (top), 8b (middle), 8c (bottom):** A portion of this glazed curtain wall detached and fell dozens of stories.
