REVIEW OF FATIGUE FAILURE STUDIES FOR WELDED PRECAST DOUBLE-TEE CONNECTIONS: NEW DATA VALIDATES SAFETY CONCERNS

Lawrence E. Keenan, AIA PE, Hoffmann Architects + Engineers, New Haven,
Connecticut

ABSTRACT

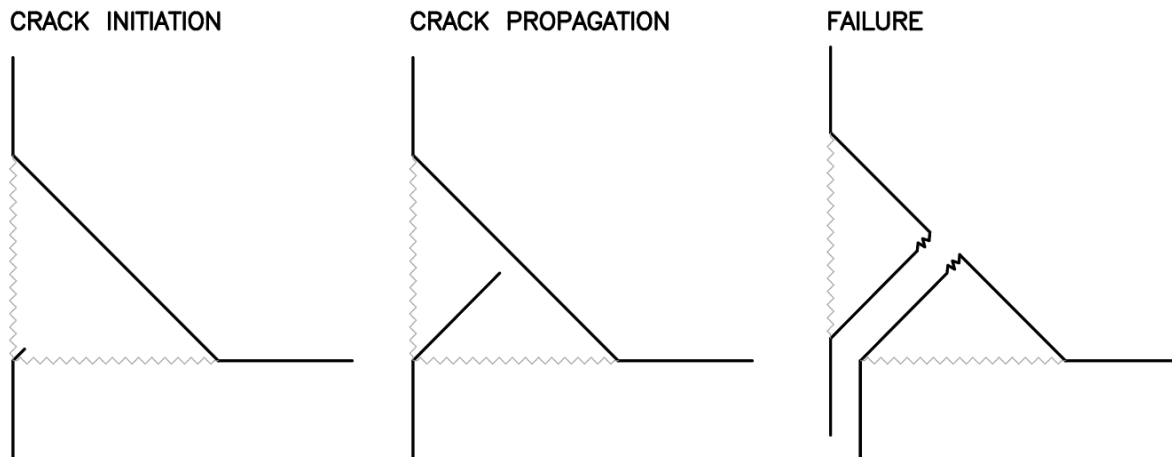
Fatigue fracture occurs in three steps: crack initiation at the root of the weld, crack propagation through the throat, and, finally, abrupt failure at the face as stress in the remaining weld metal increases proportionally to the section lost until the remaining strength is exceeded (Figure 2). This final failure can be delayed as stress is redistributed to adjacent connections, causing the abrupt failure zone to be very thin.

Figure 2 Three stages of fatigue failure of a fillet weld in a double-tee connection.

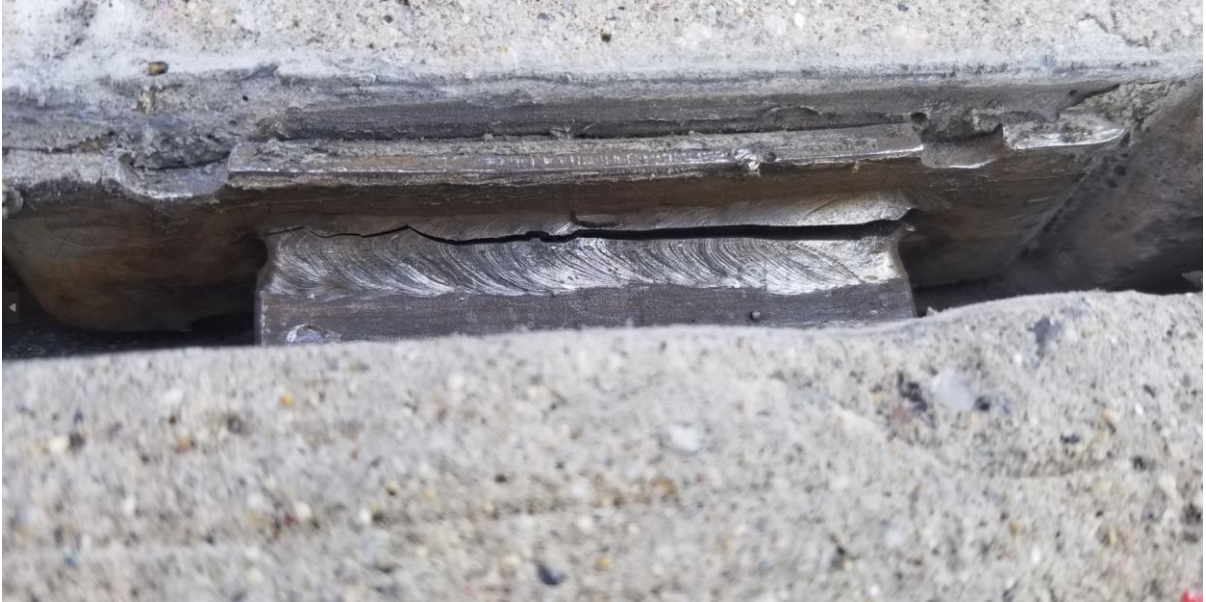
Fatigue fractures are easily distinguished from other types of connections failures by appearance. The fatigue fracture, occurring due to moment about an axis parallel to the weld, is necessarily straight (Photo 1). Further, the failure surface typically has two visibly distinct regions created during the crack propagation and subsequent abrupt failure stages. The crack propagation stage is distinguished by a smooth, flat, burnished appearance, a result of microscopic striations arranged in parallel (Photo 2). These *beach marks* are a visual record of the numerous steps in crack formation caused by individual cycles of loading and are easily discernable on scanning electron micrographs (Photo 3).

Photo 1 Fatigue failure of weld. Straight, flat weld fracture through throat of weld.

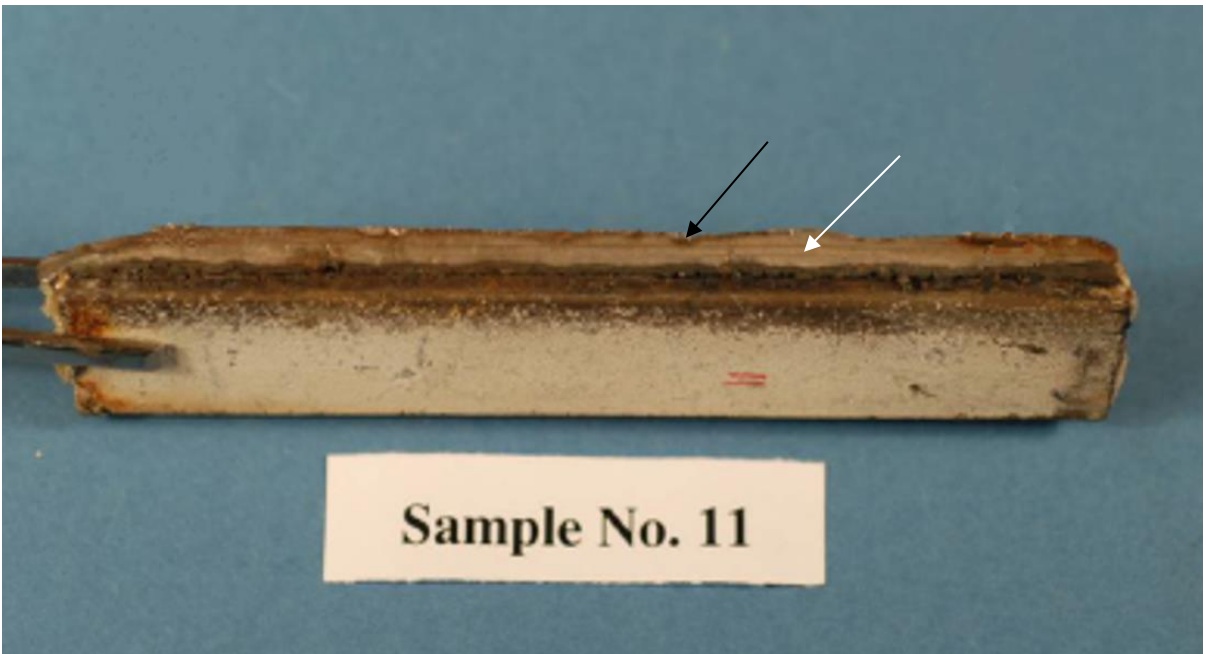
Photo 2 Fatigue fracture through throat of weld. Note straight, flat burnished appearance at surface of fatigue fracture (white arrow) and jagged fracture at abrupt failure (black arrow).

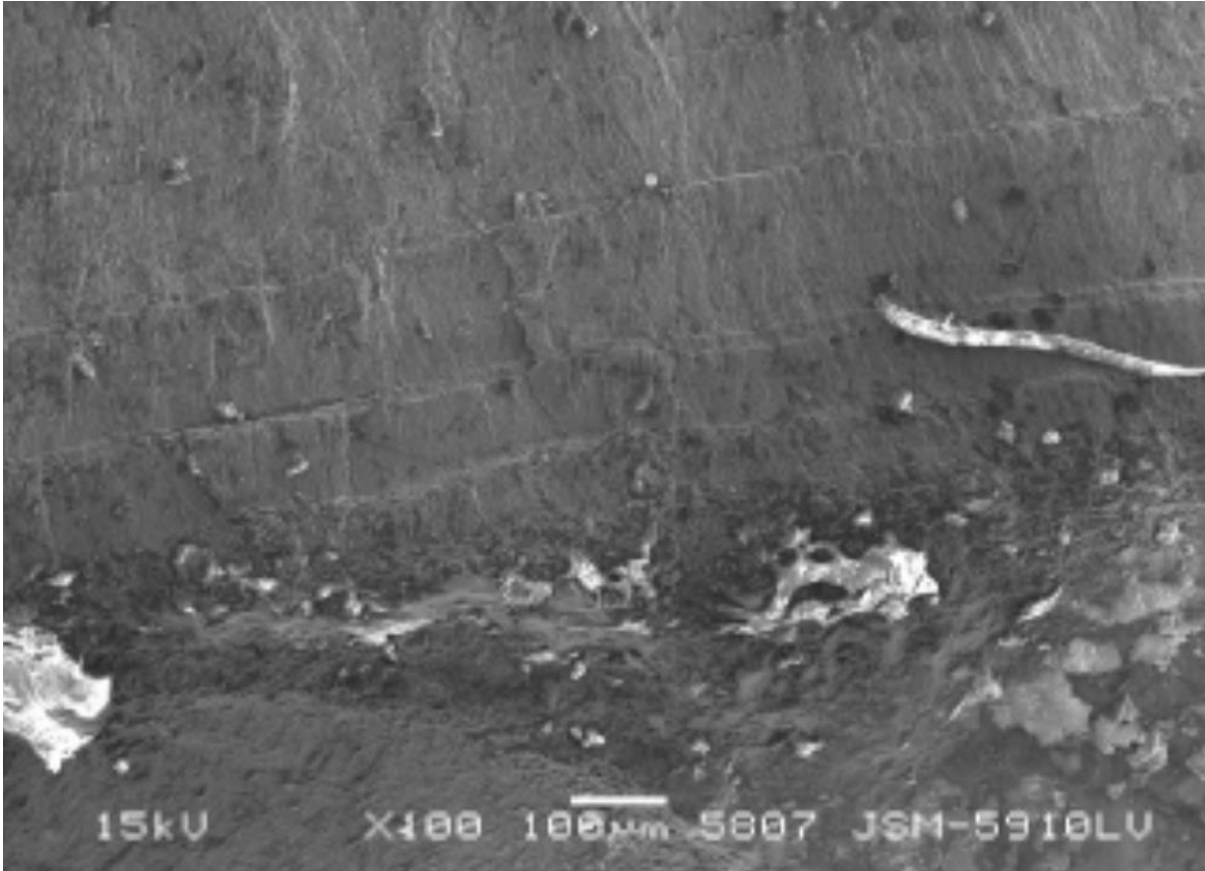
Photo 3 Scanning electron micrograph showing “beach marks” indicative of fatigue cycling.

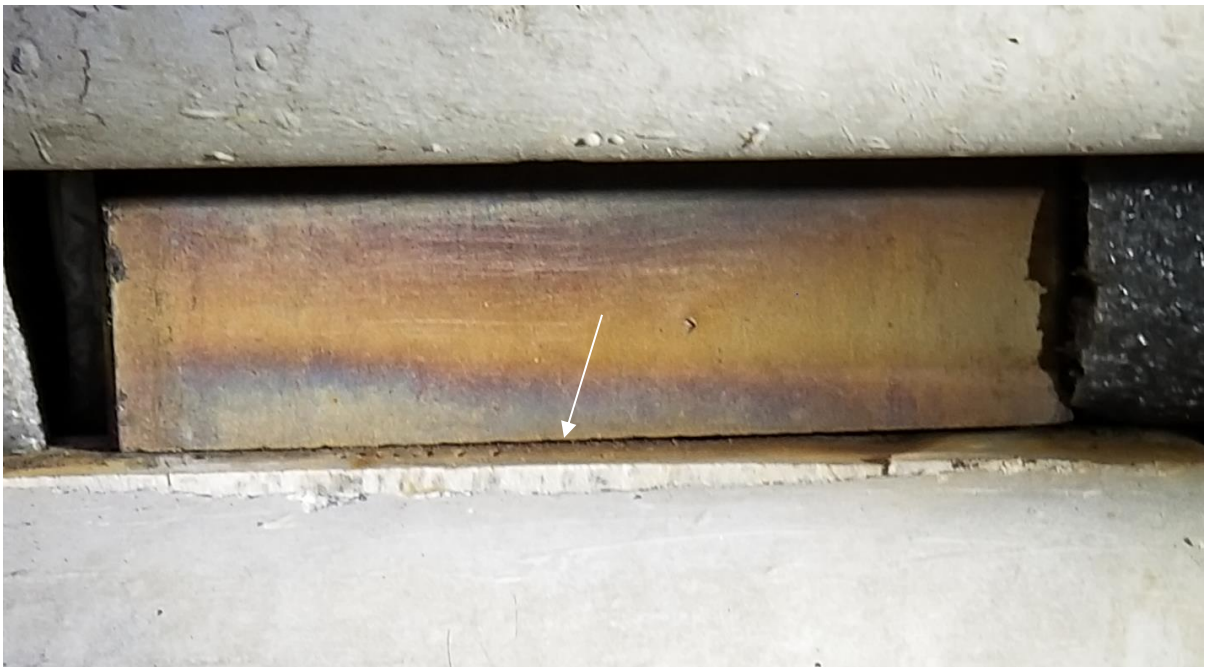
More importantly, the act of welding itself necessarily causes such a gap to occur. As the weld metal cools, transverse shrinkage of the weld pulls the members to the weld. This well-documented phenomenon, termed *angular distortion* (Figure 11),⁶¹ creates a root opening on the side of the erection bar first welded and lifts the other side of the erection bar off the opposing embedment. The distortion effect is greatly exaggerated by the relatively thin ribbon of steel from which the embedments are fabricated. Such deformation is further exacerbated by the 50 percent higher coefficient of thermal expansion of stainless steel over mild steel, making it highly susceptible to warping when welded. This angular distortion commonly creates a visible separation between the erection bar and the embedment into which at least a business card can be inserted (Photo 4).

Photo 4 Typical gap between bottom of erection bar and embedment.

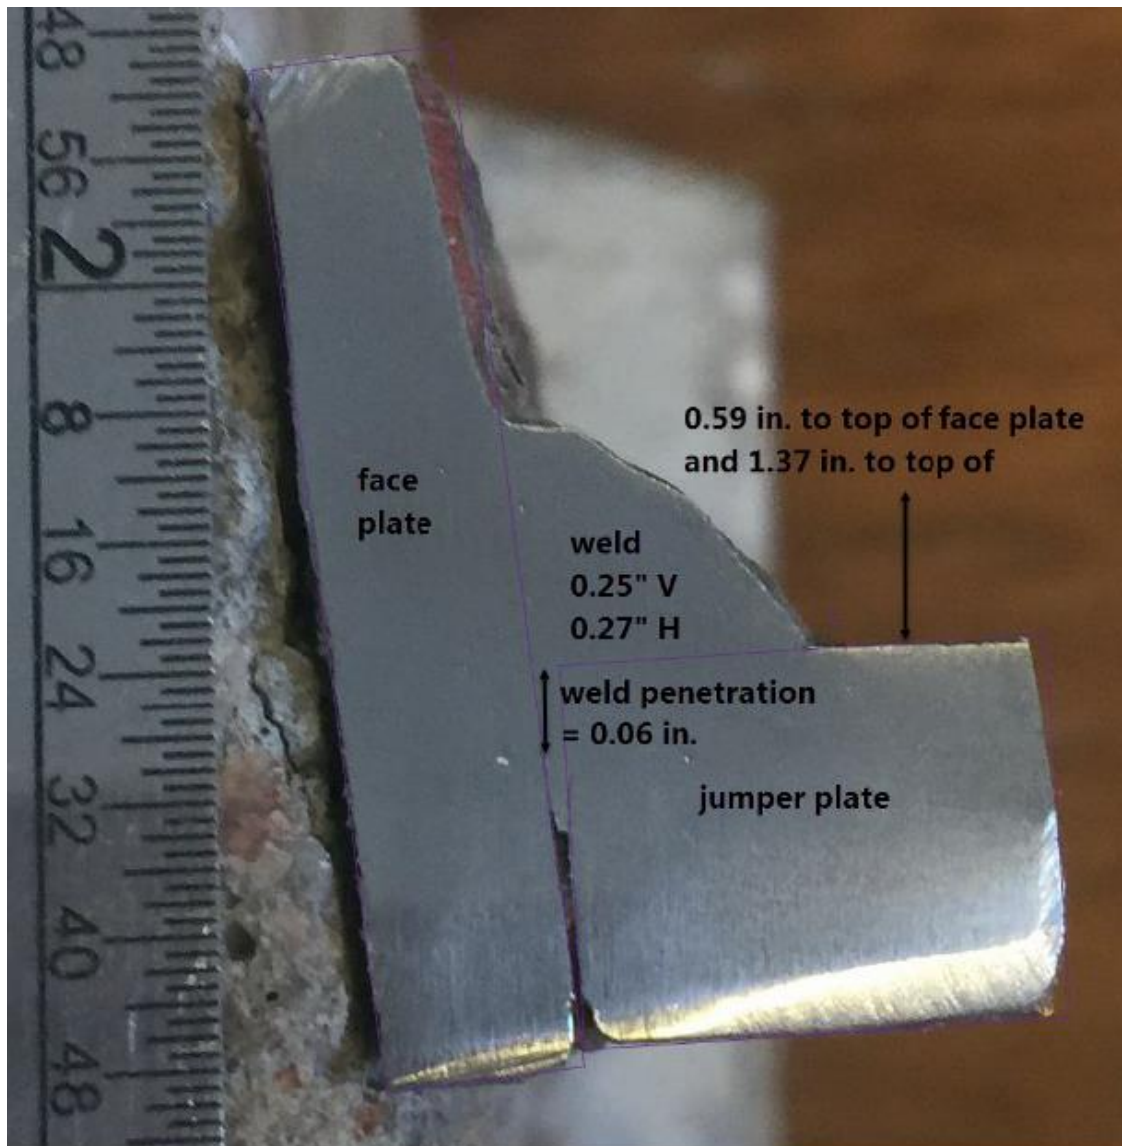
As this is arguably the most important aspect of the design model, it is notable that the PCI Task Group Study does not consider the probability that hard contact may not be a given in the connection assembly. It is notable, then, that included within the Task Group's studies is a photograph of a cross-section cut through a connection that visibly shows a large root opening (Figure 11)⁶⁴, proving that such a gap does, and is likely to, occur.

Figure 12 Excerpt from “Double Tee Flange Connections – Experimental Evaluation” Figure 15.⁶⁵ Note gap between jumper plate and face plate.
