Hoffmann  
Architects

# Journal

## Roof Drainage Systems

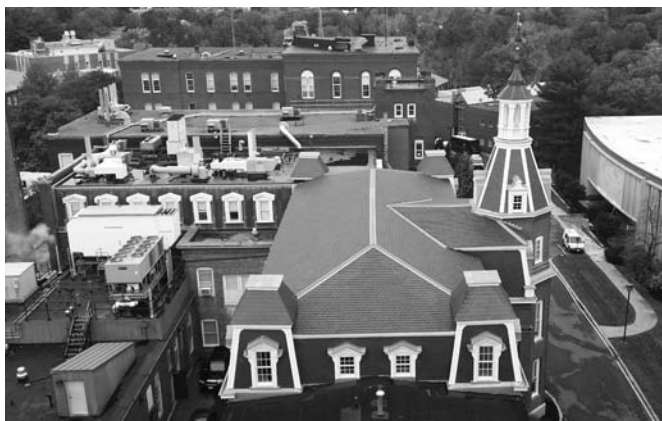
▲ Different roof types demand different drainage strategies.

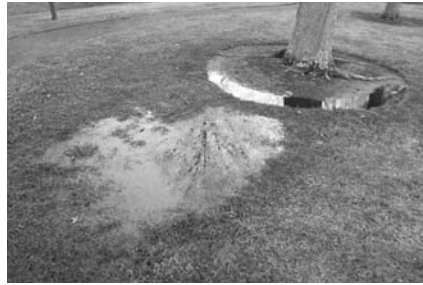
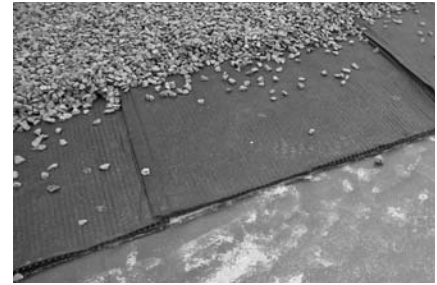
**A** In this vegetative roof above a parking garage, insufficient drainage caused ponded water (left). The new assembly (right) incorporates waterproofing membrane, drainage mat, and gravel.

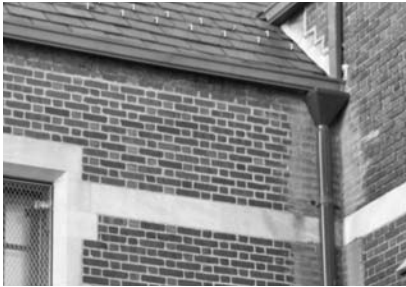
▲ Undersized gutters led to facade deterioration at eaves and downspouts.

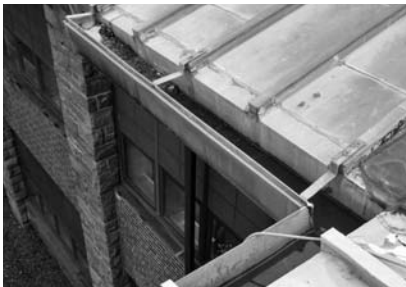
▲ Clogged with debris, these inadequate gutters are filled with standing water.

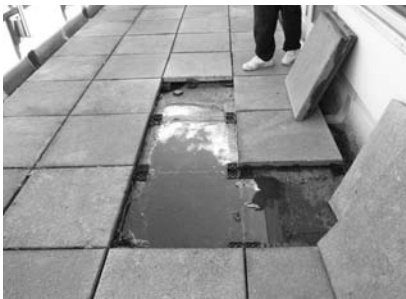
▲ At the surface, these pavers seem fine. But trapped water below may be causing leaks.
