Journal of architectural technology published by Hoffmann Architects, Inc., specialists in the rehabilitation of building exteriors.

## Restoration and Replacement of Glazed Curtain Wall Assemblies

Daniel L. Bishop, AIA

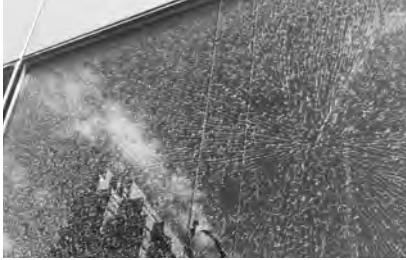
▲ Broken glass.

Damaged glass can be both unsightly and a safety hazard. Cracks in glass may be caused by incidental impact, extreme temperatures, or applied forces caused by thermal movement or displacement of structural elements. Contaminants incorporated into the glass during manufacturing, notably nickel sulfide inclusion, may also lead to what appear to be spontaneous cracks, as the contaminant expands differently than the surrounding glass.

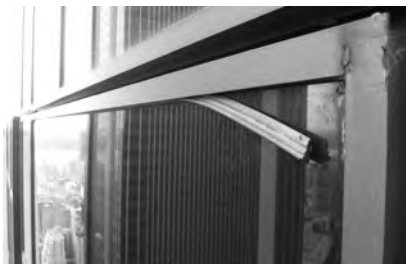
▲ Failed gaskets and seals.

Curtain wall systems are typically designed with integral weep systems to collect and channel incidental water infiltration to the exterior. However, as gaskets are exposed over time to UV radiation and weather, they become brittle and shrink. Deterioration of the gasket creates voids that admit more water than the system was designed

Gaskets installed between the curtain wall frame and glass can be replaced. Gasket replacement can require intensive effort, however, as glazing, framing members, and adjacent elements may require temporary removal to allow access to gaskets. To ensure compatibility with the existing curtain wall frame, identification of gasket size and profile is required.

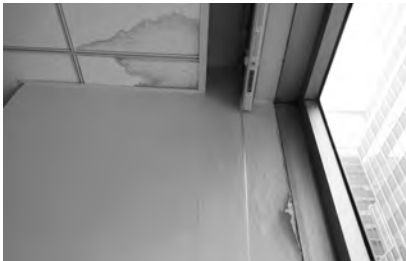
▲ Leaks and drafts.

At the perimeter of the curtain wall, missing, poorly installed, or deteriorated flashings may allow water to penetrate the assembly and leak into the building. Water may be observed directly in line with the site of flashing failure, or moisture may be initially concealed as it travels undetected through interior cavities, only to reveal itself at seemingly unrelated locations.

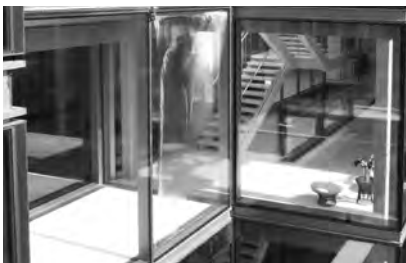
▲ Condensation.

Condensation is especially worrisome for cool climates. When indoor air is heated and outdoor temperatures are cold, insufficiently insulated exterior walls develop an interior surface that is cool enough to condense ambient moisture. Condensation may be directly observed as 'sweat' on visible surfaces, or it may be hidden from occupant view within concealed spaces, such as spandrel locations.

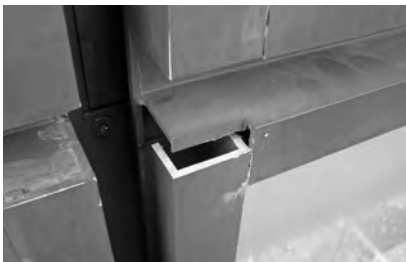
▲ Frame displacement.

Curtain walls consist of framing members that are supported by anchors secured to the building structure. Should these anchors be insufficient, or deteriorate, the curtain wall can become displaced. The resulting misalignment of materials will open seams and apply stress that may deform or break curtain wall components.

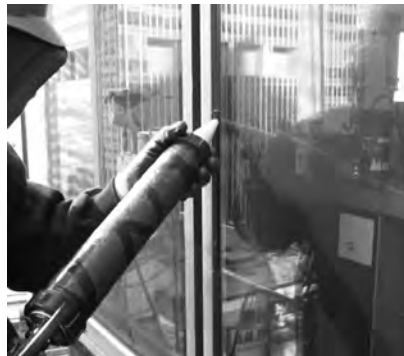
▲ Wet glazing an existing glazed curtain wall.

In lieu of gasket replacement, existing gaskets may be cut back and sealant applied at the glass-to-frame joint. While wet glazing spares the time and expense of removing glazing and framing elements to replace gaskets, the use of sealant requires attentive installation and ongoing maintenance. Understanding of adhesion

and durability properties during the sealant selection process is critical, as incorrectly specified sealants can fail to bond properly or become weathered and brittle. Provision for expansion and movement is also essential.

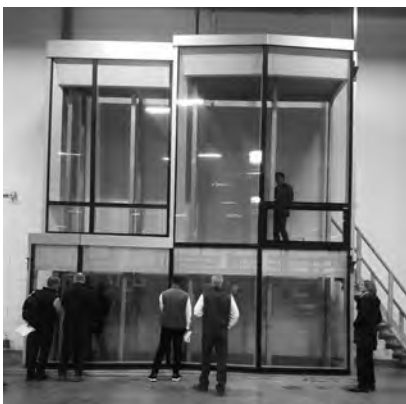
▲ Mockups verify aesthetics and performance.

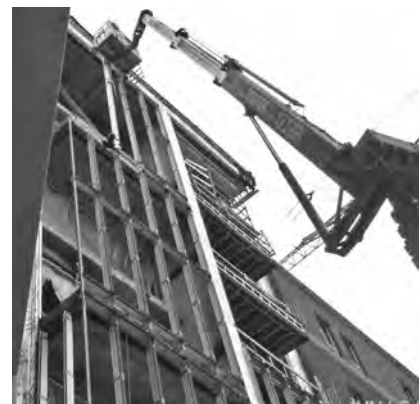
▲ Installation of a new stick-built curtain wall.

In a **stick system**, individual curtain wall components are shipped to the job site for field assembly. Components

can be supplied in stock lengths for field cutting, or in knock-down fashion, where components are custom machined and sized by the manufacturer. With a stick assembly, all connections and seals are installed in the field.

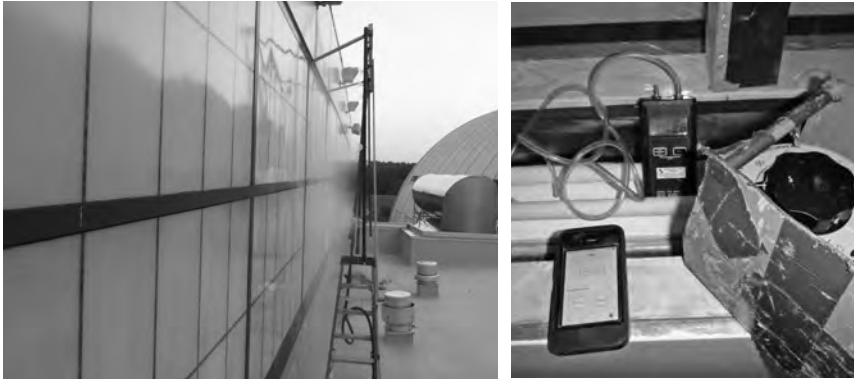
▲ Field water penetration test to investigate leaks at an existing glazed curtain wall assembly.

Whether rehabilitation or replacement is ultimately selected, quality assurance measures, including field testing for air and water infiltration, are an opportunity to evaluate expected performance. ASTM International and the American Architectural Manufacturers Association (AAMA) develop voluntary standards for the testing of materials and products. Field testing of installed assemblies may be mandated by code, required to meet voluntary accreditation standards, or used to confirm installation quality and performance.

- ASTM E783: Standard Test Method for Field Measurement of Air Leakage Through Installed Exterior Windows and Doors
- ASTM E1105: Standard Test Method for Field Determination of Water Penetration of Installed Exterior Windows, Skylights, Doors, and Curtain Walls, by Uniform or Cyclic Static Air Pressure Difference
- AAMA 501.1-17 Standard Test Method for Water Penetration of Windows, Curtain Walls and Doors Using Dynamic Pressure (references test chamber and water spray system per ASTM E1105)
- AAMA 501.2-15 Quality Assurance and Diagnostic Water Leakage Field Check of Installed Storefronts, Curtain Walls and Sloped Glazing Systems (not used for operable components)
- AAMA 503 Field Testing of Newly Installed Storefronts, Curtain Walls, and Sloped Glazing Systems (references ASTM E1105 for water infiltration and ASTM E783 for air infiltration)
