A Primer on Deterioration in Building Envelopes

John J. Hoffmann, FAIA

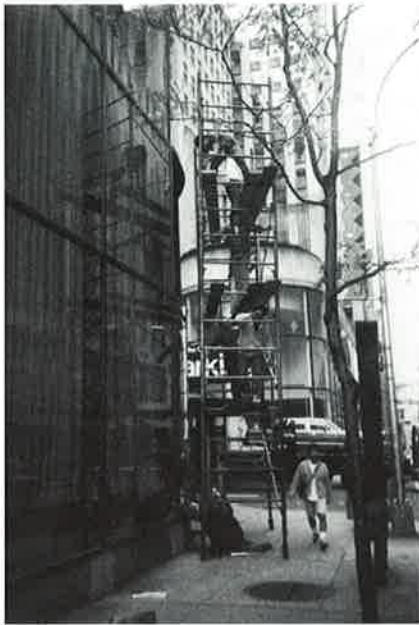
Investigation of leaks in a bronze-and-glass curtain wall on a New York City building.

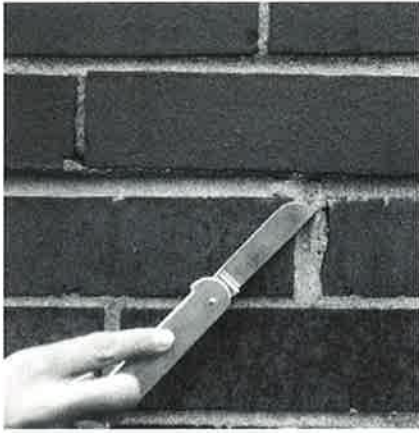
A rather poorly constructed masonry wall. Note the many openings in the mortar, which allow water entry.

1. Masonry curtain walls: A major problem in masonry curtain walls is the *deterioration of mortar joints* (the horizontal and vertical bands of mortar between bricks in a brick facade), which leads to water entry. This deterioration

Deteriorated mortar joints can be repaired by *repointing, tuck pointing, and pointing*. These are methods of removing and replacing old mortar with new mortar. This complex, labor-intensive, and costly process is, nevertheless, essential to preventing water entry and further building deterioration.

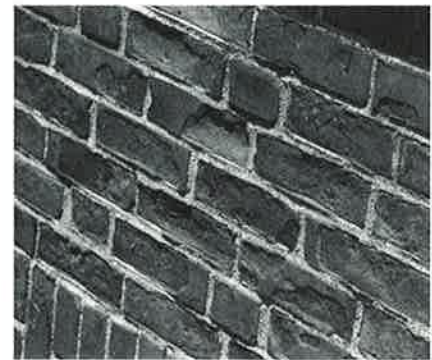
The brick has lost its face from water entering the wall through the back of the parapet.

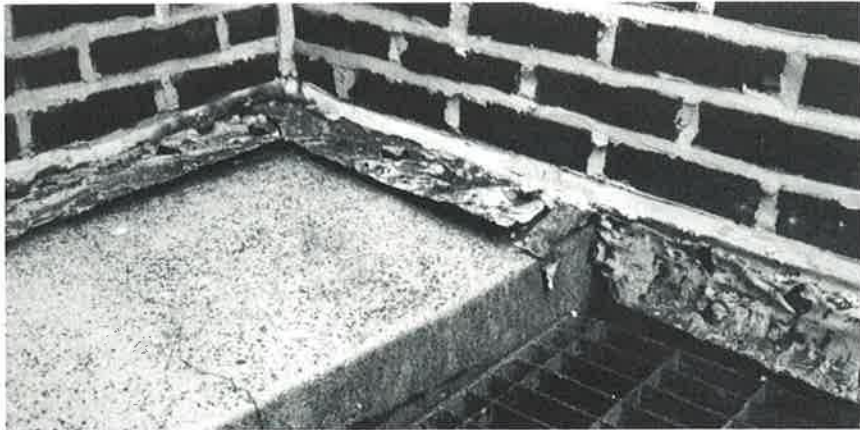
This completely deteriorated copper counterflashing was not replaced when the wall was re-pointed, a poor effort in itself.

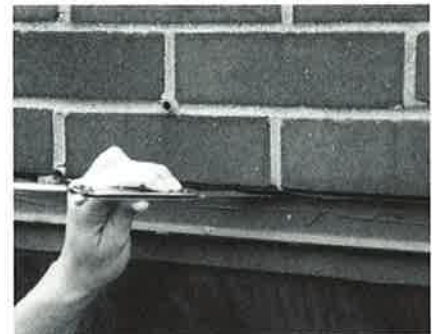
Adhesive failure of the sealant at the joint connecting the brick masonry, wall flashing, and aluminum window.

Adhesive failure occurs when the sealant does not bond to the substrate. Lack of adhesion is usually due to improper preparation of the substrate surface. Failure is virtually guaranteed if the substrate is dirty, damp, improperly primed, or contaminated by other construction materials. The exact cause of failure must be determined first, however, to make sure the problem is

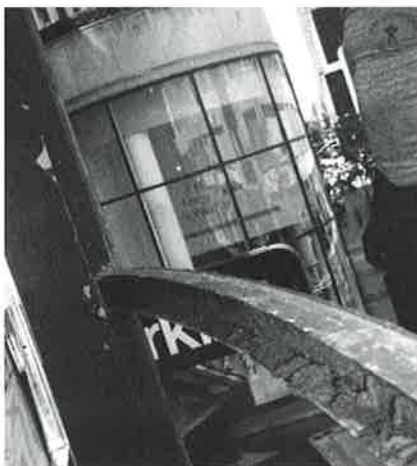
Rust has formed on the steel supportive structure behind this leaking bronze-and-glass curtain wall.

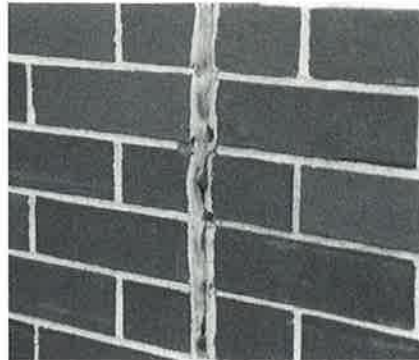
Cohesive failure of the sealant in a brick masonry expansion joint.

Cohesive failure is the failure of the sealant to bond to itself, as evidenced by cracks and splits in the center of the applied sealant. This type of problem is clear evidence that the joint's movement was more than the sealant could handle.
