Journal

Balcony and Roof Railings and the Code: Maintain, Repair, or Replace?

John P. Graz, AIA and Rachel C. Palisin, PE, LEED AP BD+C

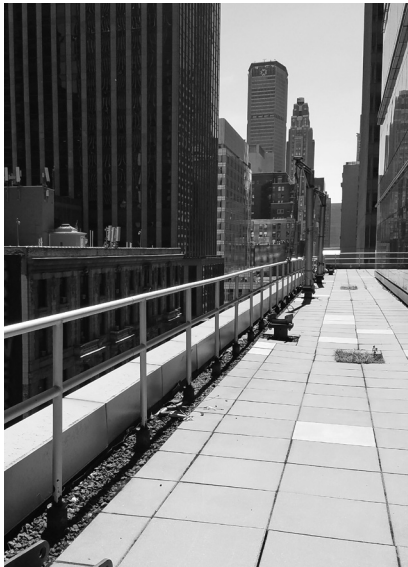
▲ As codes change, owners may find that existing railings must be updated or replaced.

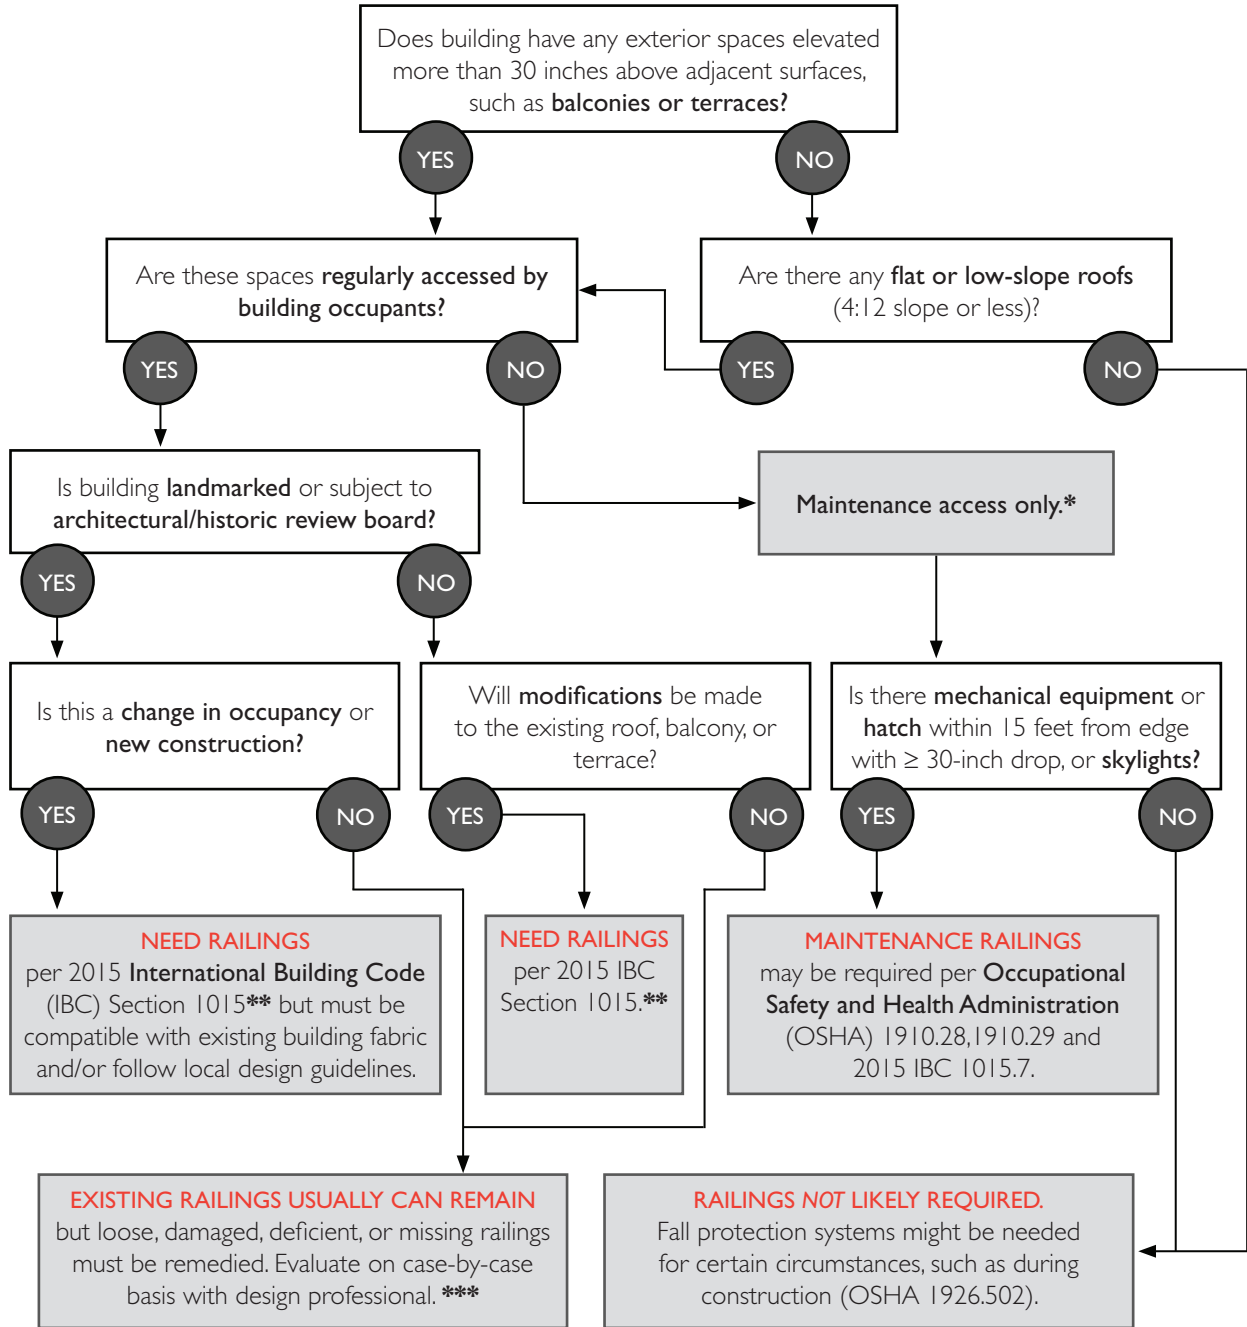
Do My Roofs, Balconies, or Terraces Need New or Updated Railings?

* In New York City, roofs, balconies, or terraces with slope of 2.4:12 or less and height of 22 feet or greater require railings per 2014 NYC Building Code, Section 1509.8. Often, older buildings may comply with the code under which they were constructed.

** In NYC, railings must comply with 2014 NYC Building Code, Section 1013 and 1607. Often, older buildings may comply with earlier codes.

*** The International Existing Building Code (IEBC) may also be applicable, depending upon building location.

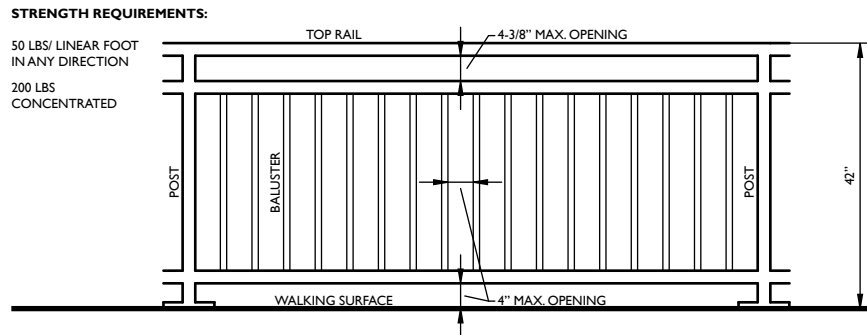
2015 International Building Code (IBC)

Typical Examples of Compliant Railing Configurations

The predominant model code that dictates railing assembly height, configuration, and anchorage is the International Code Council *International Building Code (IBC)*, which is in use or adopted in all 50 states and the District of Columbia. The latest version was published in 2015, but many states have yet to adopt the newer code, with some still using versions from as early as 2003. This variation in adoption can mean that regulations for railings can differ between states, with some holding buildings to more rigorous standards than others.

The diagram at the top of this page illustrates the dimensional and structural requirements of the 2015 IBC, which demands higher performance than previous iterations. The 2015 IBC mandates that glass used in railing systems generally be laminated tempered glass, whereas the 2012 IBC accepted single tempered glass. Beyond the most recent revision, additional changes pile up when looking back just a few code cycles. For example, the 2015 IBC limits openings near the top of the railings to a maximum diameter of 4-3/8"; as recently as the 2006 edition, the IBC allowed top rail openings up to 8" diameter. As codes become more demanding, it is easy to see how a building constructed several years – or several decades – earlier could have railings which fall well short of meeting current regulations.
