Hoffmann  
Architects

# Journal

## Forecasting Building Envelope Reliability: And Preparing for Inevitable Deterioration

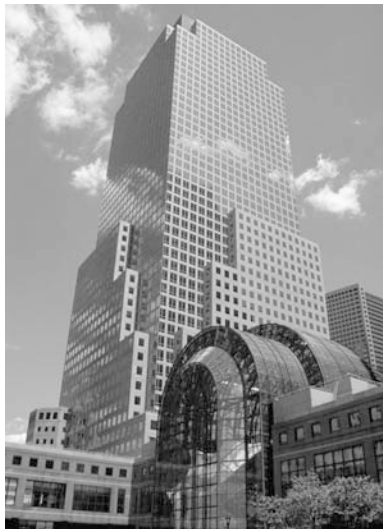
▲ Forecasting building envelope reliability—and managing maintenance and repairs to best provide for the inevitable deterioration of systems and materials—is critical to maximizing the useful life of a structure.

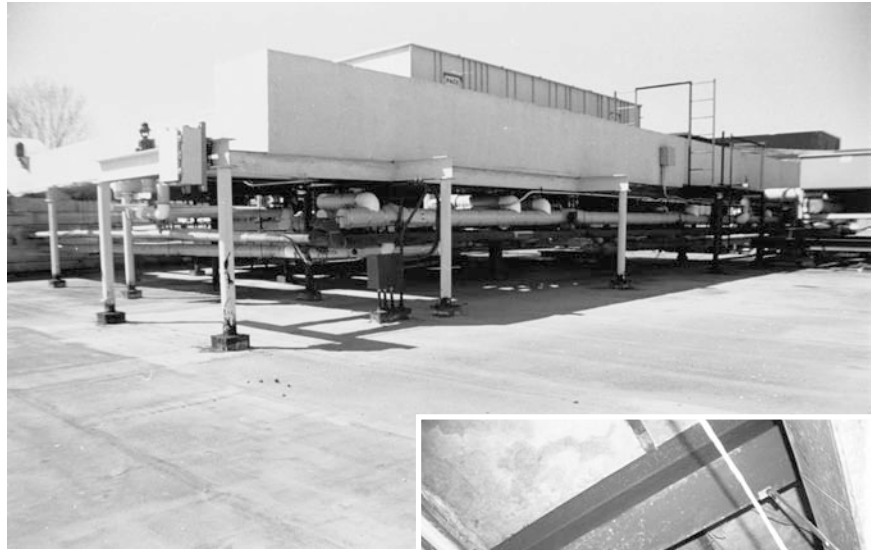
▲ What may seem like minor deterioration at the surface of this EPDM roof (above) has resulted in significant deterioration to the underside of the roof deck (shown at right) viewed from the interior:

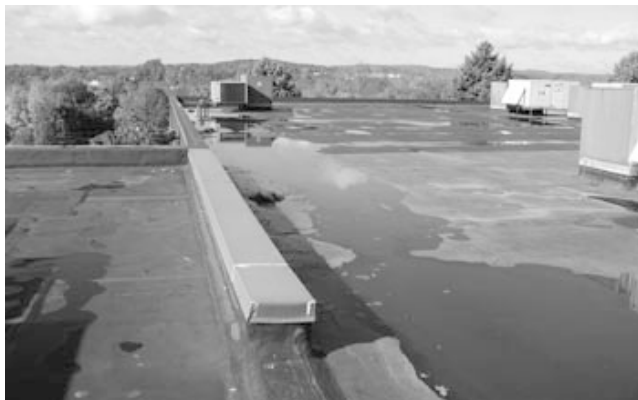
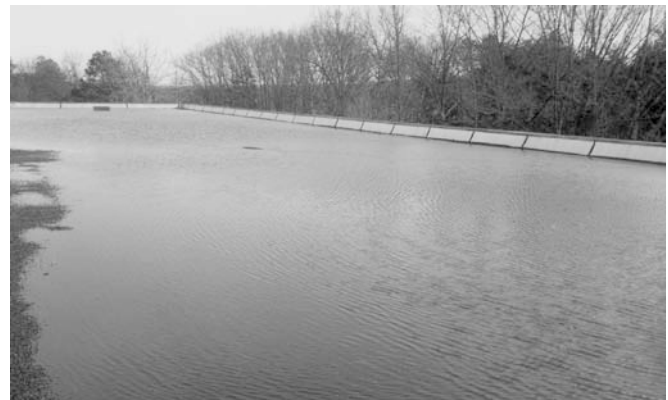
▼ Warning signs: Below left, water begins to pond on a low slope roof, indicative of inadequate pitch and/or drainage. Below right, a more extreme example of the same.

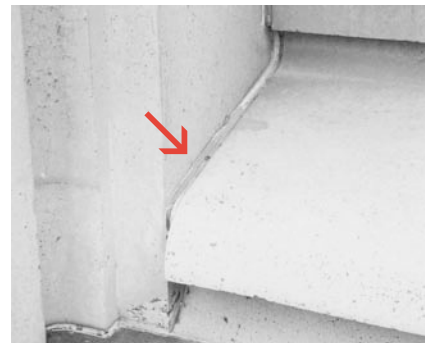
- ▼ Sealant joint failures permit water entry and, when not properly repaired, result in stains/efflorescence, cracks, spalls and crazing in stone/masonry exteriors.

The useful life of sealant, for example, is contingent upon the appropriateness of the material for the joint condition (does it adequately provide for differential movement?); the adequacy of joint preparation prior to material application; and the ambient temperature at the time of application, among other things. Failure to provide for any of these requirements may lead to premature sealant failure.

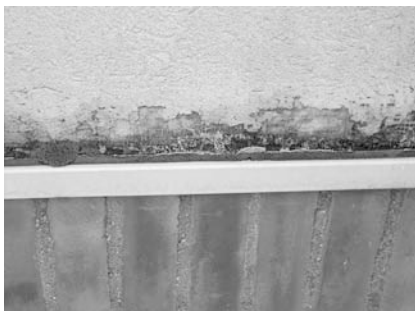
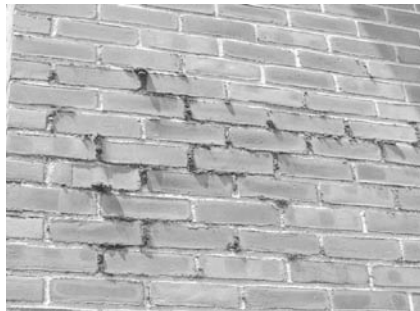
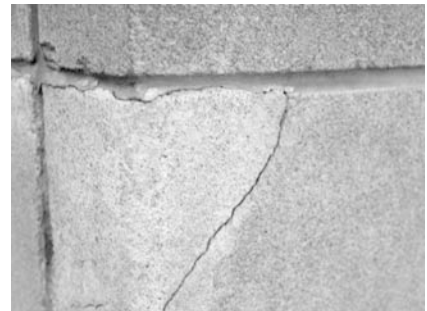
▼ Signs of trouble: Below left, mildew and deterioration at joint between EIFS and metal base. Below center, moss growth in mortar joints of brick wall indicates water retention. Below right, crack in stone facade.

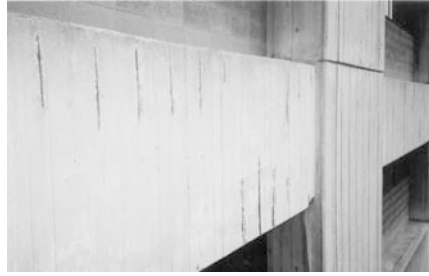
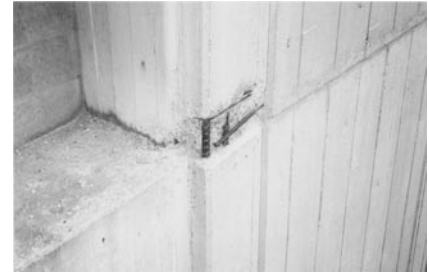
**A** Above left: Cracking and spalling of concrete panels on an exterior wall. Above right: Corrosion of embedded steel reinforcement has caused severe spalling at this corner.

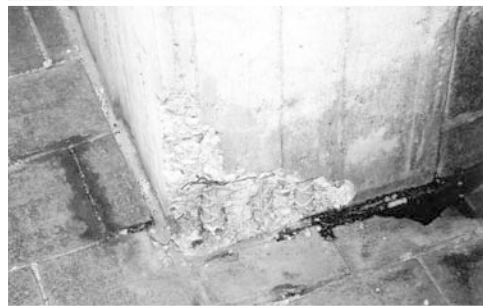
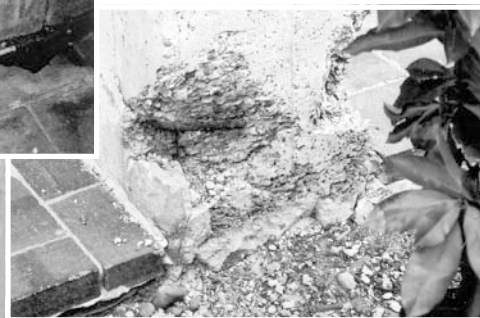
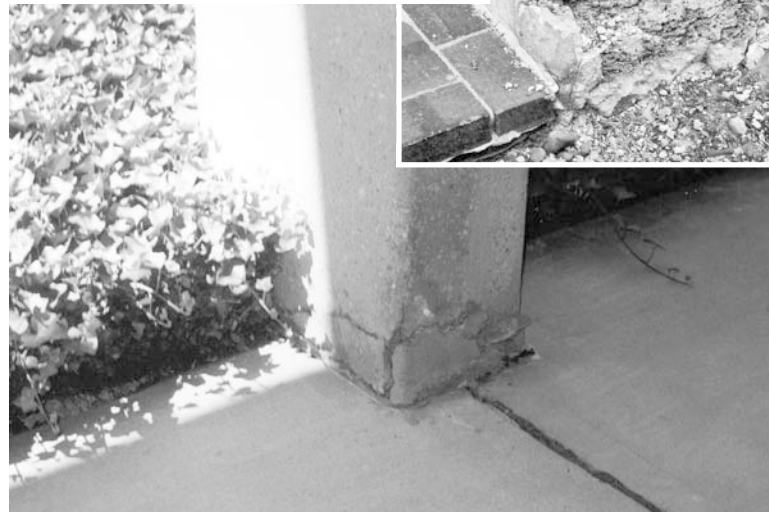
**V** Clockwise from bottom: Cracks at base of concrete column; spalled concrete and exposed steel reinforcement; severe deterioration at column base.

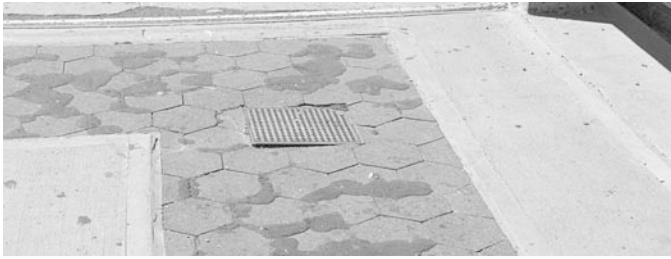
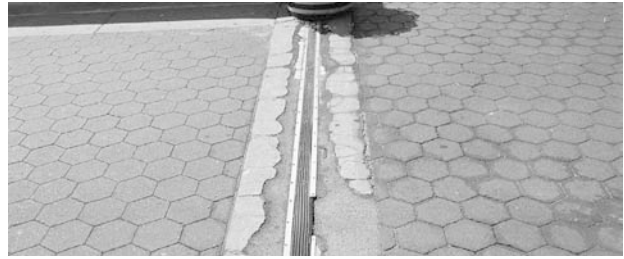
**A** Clockwise from above: Misaligned drain and oozing asphalt setting bed material make for a hazardous and unsightly wearing surface; deterioration at expansion joint; and, at joint between paved and poured wearing surfaces.

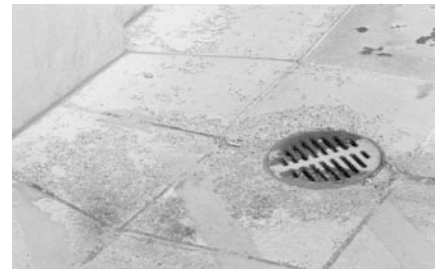
▲ Scaled concrete at drain may be indicative of standing water or inadequate drainage.

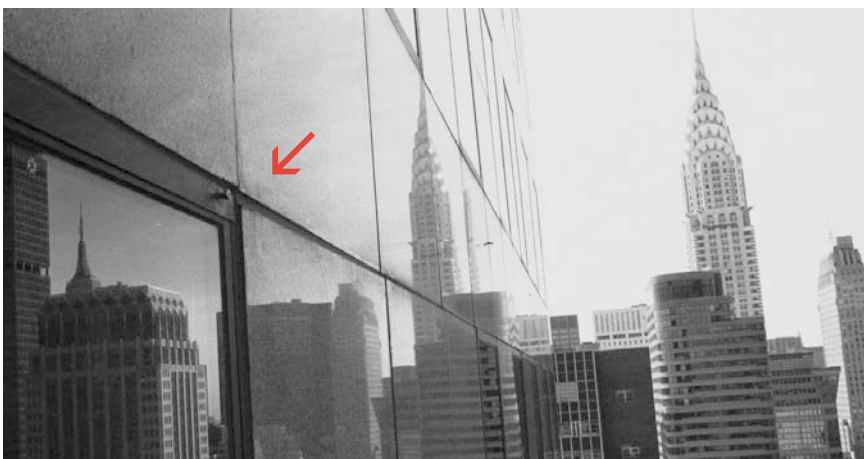
▲ Clockwise from top: A cracked stone panel; displaced panels result from failed anchor system.

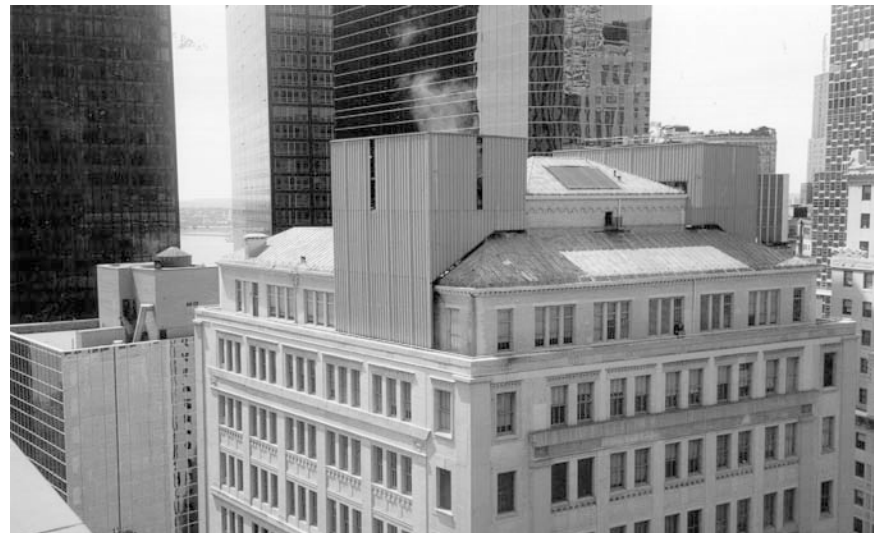
■ **104 Broad Street** New York, New York. When the original copper roof proved beyond its useful life, Verizon Communications retained Hoffmann Architects to design and direct a minimally disruptive copper roof replacement effort for this telecommunications' hub.

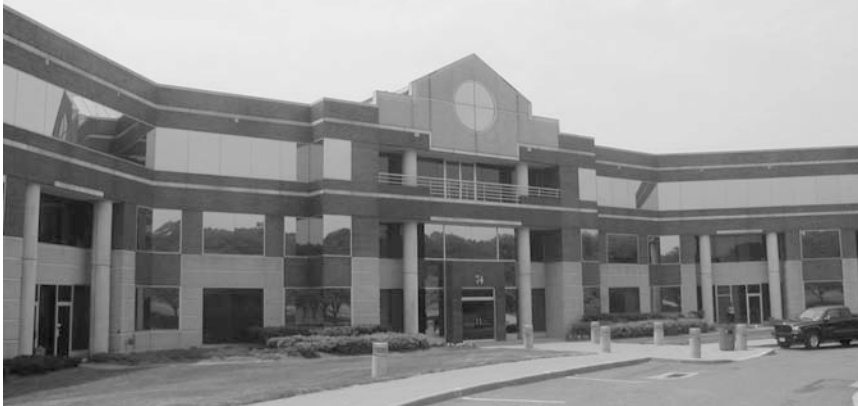
**▲ Pond View Corporate Center** Farmington, Connecticut. Hoffmann Architects conducted a water infiltration investigation of the facade and developed a program to rehabilitate this corporate facility.
