Journal

Guide to Campus-Wide Building Envelope Assessment

Benjamin J. Robinson, AIA

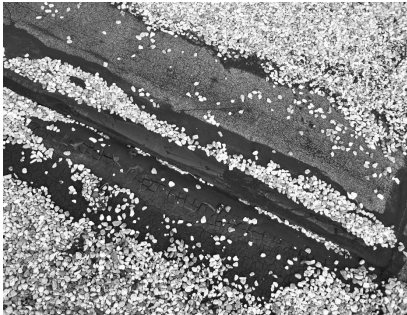
▲ Deteriorated roof membrane.

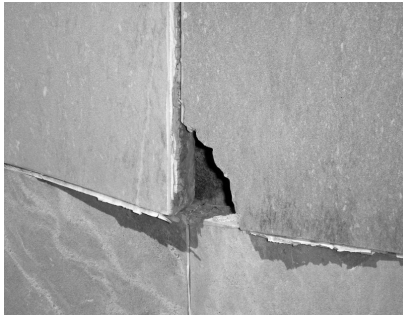
▲ Displacement and fracture at stone facade.

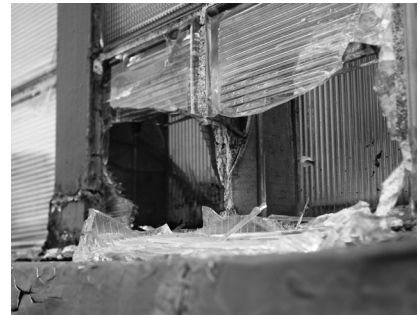
▲ Shattered glass block windows.

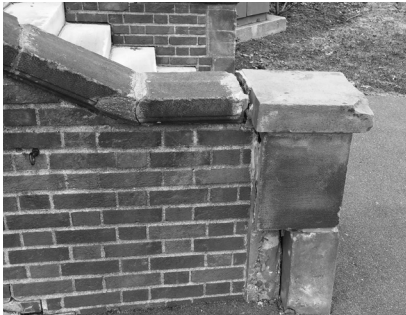
▲ Site wall and exterior stair damage.

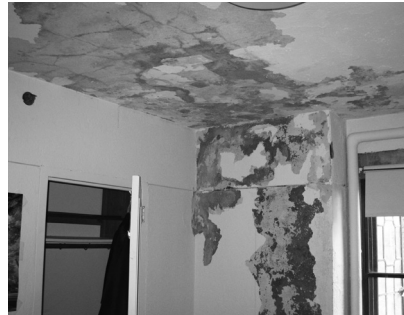
▲ Interior finish damage from roof leaks.

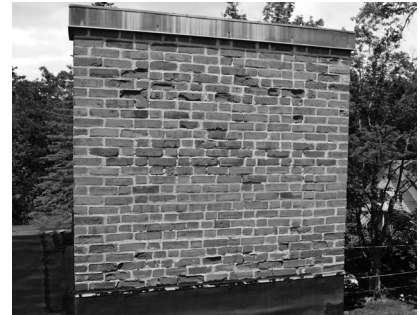
▲ Spalled brick masonry at chimney.

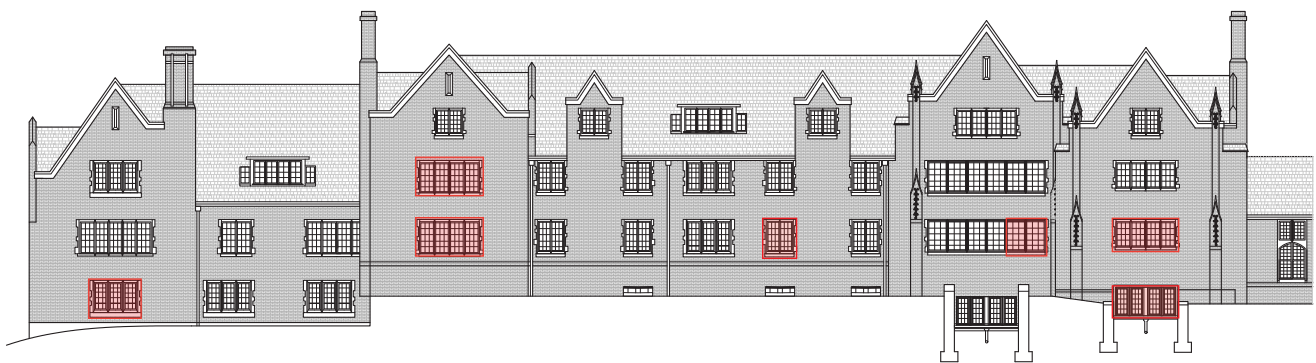
▲ Elevations can be keyed to the defect survey to identify levels of deterioration.

By providing an orderly way to categorize observed conditions, such taxonomies allow for the prioritized scheduling of repairs and maintenance across multiple buildings or even an entire campus. The building assessment report should define the properties of each category of deterioration, ideally with photographs documenting conditions typically observed for each, to facilitate future assessments. Should the scope of the survey permit, field observations may then be transposed onto building plans, using a numbered or color-coded system to identify levels of distress and failure for a given building element, such as windows or roof areas, for easy reference when it comes time to schedule repairs. Similar keyed drawings can expedite investigative testing and identify sites for in-depth analysis.

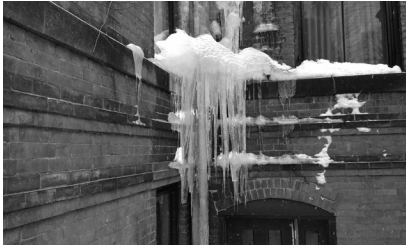
▲ Assessment in different seasons permits observation of weather-related conditions.

To evaluate the performance of building envelope elements under different climate conditions, it is beneficial to conduct observational site visits at different times of the year. An

investigation in the spring might pick up on cracked foundation walls that would be concealed by snow later in the year; but would miss ice damming or condensation that is only present during the winter.

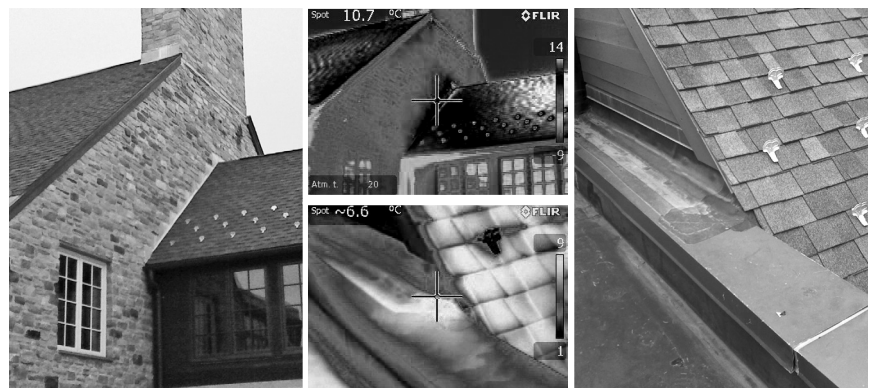
▲ Infrared photographs (at center; converted to black and white) highlight areas of heat loss with color hues that represent thermal gradients.

To aid in diagnosing pesky – and sometimes mysterious – leaks, infrared or thermal photography is beneficial. While this type of photographic documentation “sees” heat or temperature differentials and not moisture, the presence of water can be confirmed with a moisture meter or an invasive probe. Thermal photographs also

reveal missing or insufficient insulation, discern air leakage at dissimilar component interfaces such as window to wall intersections, and can even detect embedded pipes and electrical wires.

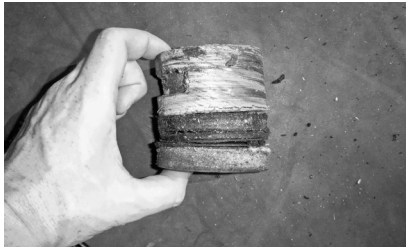
▲ Test cores may be used to evaluate conditions within a roof assembly.

Roof cuts. While it may seem counter-intuitive to cut holes in an existing roof as part of an assessment, roof cuts provide vital information that not only determines the remaining roof lifespan, but also influences the design for eventual replacement. Besides providing samples for hazardous materials

testing, invasive probes through a roofing system at select locations allow the design professional to understand the depth of the system, as well as the condition and configuration of the roof deck. Probes can provide critical information otherwise unknown by the building owner and architect/engineer. For example, a roof deck assumed to be concrete may actually be gypsum, wood, or metal. Each of these materials may require different anchorage methods for a new roof.

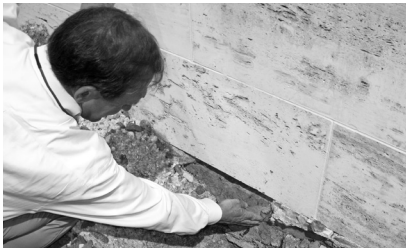
▲ Visual assessment permits close observation of defects at exterior walls.

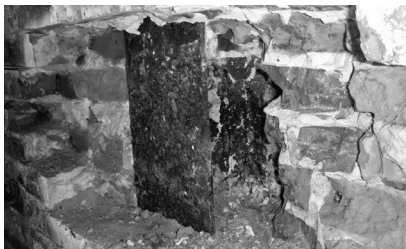
▲ Invasive probes can reveal concealed problems, such as corroded structural steel.

To examine concealed conditions, it may be advisable to create a probe into the building facade. A brick wall surface, for example, may be but one of a number of wythes of solid masonry, or it might be a single layer of brick anchored across a drainage cavity or a veneer of very thin brick adhered to

a metal panel, or perhaps some other construction type altogether. While straightforward visual observation offers some clues, certain types of wall construction are indistinguishable until the inside of the wall can be examined. Knowing the wall type also aids

in diagnosing deteriorated conditions. Even in cases where original documents and drawings illustrate the composition of the exterior wall assembly, as-built construction can differ markedly from the design. Invasive probes can also reveal construction

defects or design deficiencies that can lead to problems, from leaks to displacement to structural failure. For the purposes of a complete and comprehensive condition survey, removal of a section of the wall area may seem unnecessarily destructive. However, the small patch needed to restore the facade might be worth it if the investigation uncovers problems that might have been catastrophic had they been missed.

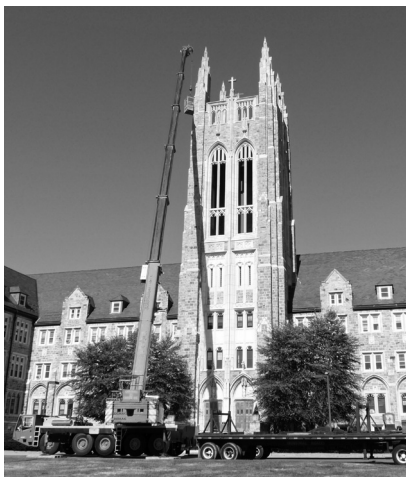
▲ Close-up investigation may be aided by lifts, drops, or other observation platforms.
