Journal of architectural
technology published by
Hoffmann Architects, Inc.,
specialists in the rehabilitation
of building exteriors.

Historic Stone Masonry Restoration

Elizabeth A. Campbell, AIA, LEED AP BD+C and Christopher M. DeRosa

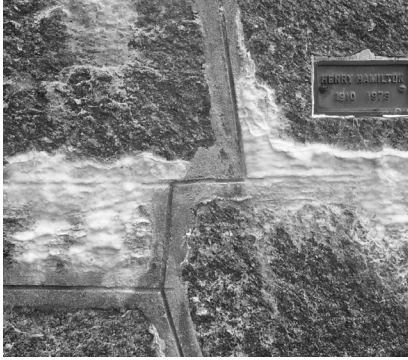
▲ Efflorescence.

As moisture within the wall evaporates from the exterior face, it leaves behind waterborne salts, which remain on the stone surface. This characteristic white stain, or **efflorescence**, is often a result of rising damp, which occurs when groundwater is drawn up into the base of the wall. Efflorescence may also be caused by moisture introduced into the wall assembly through improperly installed or missing flashings at the top of a parapet.

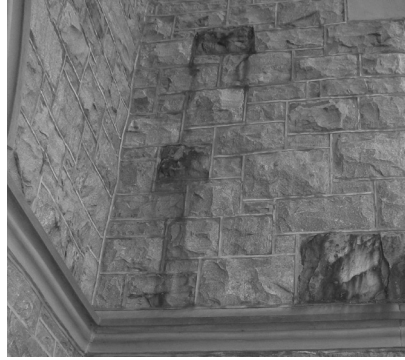
▲ Iron subflorescence.

Where efflorescence is observed, **subflorescence** also may be present. As trapped moisture migrates through stone, it may leave behind a potentially harmful accumulation of crystallized salts along veins or internal cracks, which can damage the stone's internal structure. In some cases, these salts may accelerate corrosion of naturally occurring ferrous compounds in the

stone, leading to characteristic rust-colored stains.

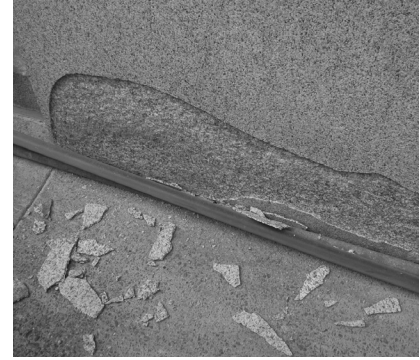
▲ Exfoliation.

Like delamination, **exfoliation** is a type of surface disintegration in which the stone sloughs off in very fine layers. Although the two terms are often used interchangeably, delamination tends to refer to fracture along natural bedding planes, whereas exfoliation is usually due to thermal stress, impeded moisture movement, or other

environmental factors.

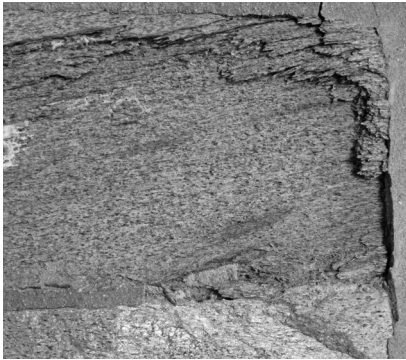
▲ Delamination.

Delamination takes place when the outer surface of the stone splits into thin layers, which then peel off the face. Sedimentary stones are naturally prone to delamination, which occurs along the bedding planes when the rock is set perpendicular to the direction in which it was originally formed.

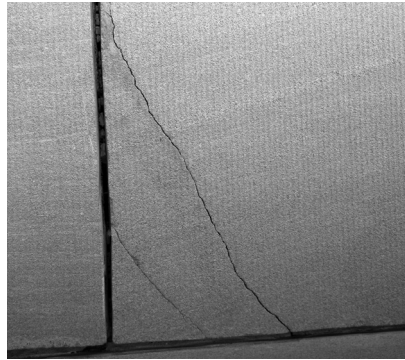
▲ Cracking.

Tracing the source of **cracking** in historic stone masonry can be difficult, as it can originate in a wide variety of sources, ranging from structural settlement to a repointing mortar that is incompatible with the stone. If cracks are narrow and short or confined to within a single stone unit, the issue may be relatively minor; cracks that are wider and longer or those that extend over large areas may be indicative of systemic problems.

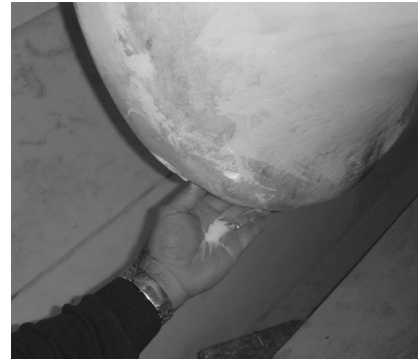
▲ Sugaring.

If, with light rubbing, the surface of the stone falls away in small granules, similar in texture to granulated sugar, the stone may be succumbing to surface disintegration, or **sugaring**. Cohesive minerals in the stone dissolve, and the remaining deposits are easily brushed from the surface. Carbonate stones, especially fine-grained marble, are particularly susceptible to this type of granular separation.

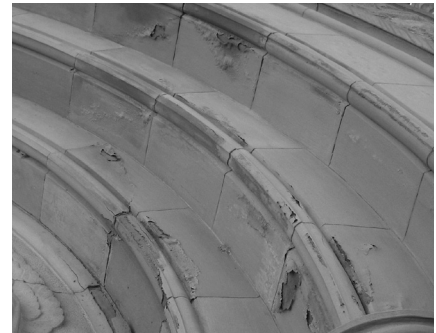
▲ Blistering waterproof coating.

Too often, application of a “protective” waterproof coating, aimed at preventing hypothetical moisture-related deterioration, has the unintended effect of sealing moisture inside the masonry surface and leading, in many cases, to real and irreversible damage. Stone masonry buildings of traditional construction were designed to “breathe;” to be permeable to air and moisture, allowing water to leave the wall assembly through the natural process of evaporation. Introducing impervious coatings and vapor barriers disrupts the balance of moisture across the building envelope, which can result in dire consequences for the stone, at both a macro- and micro-structural level.

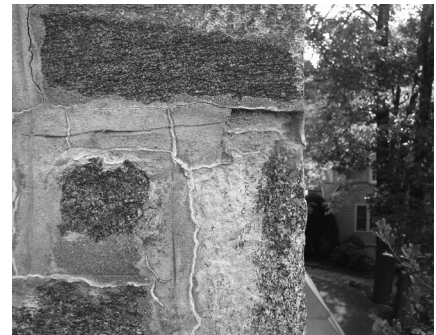
▲ Deteriorated face-pointed mortar.

As a shortcut to address deteriorated mortar joints, a thin layer of mortar is sometimes added without first removing the existing mortar to the appropriate depth. While quicker and cheaper than full repointing, face-pointing is inadvisable, as it does not provide suitable stability and tends to crumble out of the joint.

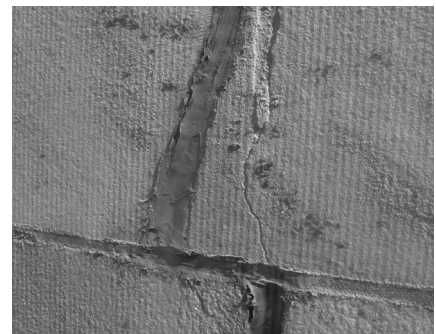
▲ Incorrect use of sealant.

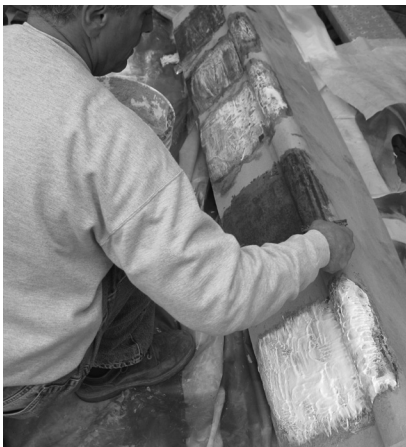
▲ Mockup test of stripping agents to remove prior inappropriate coating.

One case where a water-repellent coating may be appropriate is on a facade that has undergone previous—and often detrimental—waterproof coating application. As the waterproof coating may have permanently altered the properties of the stone, it may be impossible to return to a stable, uncoated state. Application of a breathable coating may protect the porous surface of the existing stone from further damage. Considerations include altered appearance, which may be evaluated through mockup testing, and the maintenance demand of periodic re-application.
