Hoffmann
Architects

Journal

Historic Window Rehabilitation

Erin L. Aichler, Assoc. AIA and Benjamin J. Robinson, Assoc. AIA

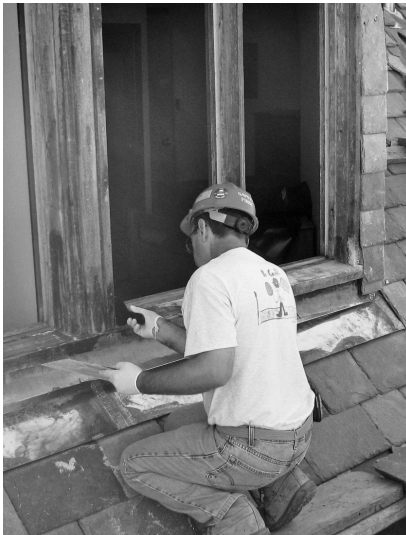
▲ A carpenter restores wood window casing using epoxy repair materials.

For deteriorated windows: Deteriorated wood windows can usually be restored through consolidation, patching, or building up of weathered surfaces. Decayed wood may be dried and treated with fungicide, then coated with a water-resistant material, such as boiled linseed oil, and reshaped with wood putty. Semi-rigid epoxies may also be used to consolidate damaged wood.

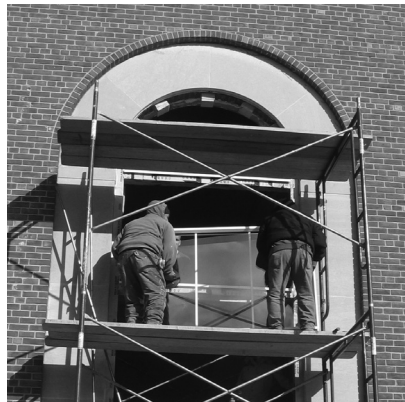
Weathered. No major signs of physical distress are present. Minor exterior corrosion or wood rot, deteriorated joint sealants, and peeling paint may call for maintenance.

Deteriorated. Exhibits isolated deficiencies, such as: cracked glass; broken lead comes, rails, or screens; bulging glazed panels; damaged or missing hardware; poor operation; corrosion; or failed sealant.

Severely Deteriorated. Shows extensive physical distress, which could escalate to Life Safety Risk if untreated. Shares defects in common with deteriorated windows, above, but has multiple signs of distress or failure.

Life Safety Risk. Presents defects that could harm either the operator of the window or a person outside the building, including: broken glass with exposed edges, missing or dried out glazing compound, insecure frames, and missing or broken operable sash hinges. Stabilize or replace immediately to avoid injury.

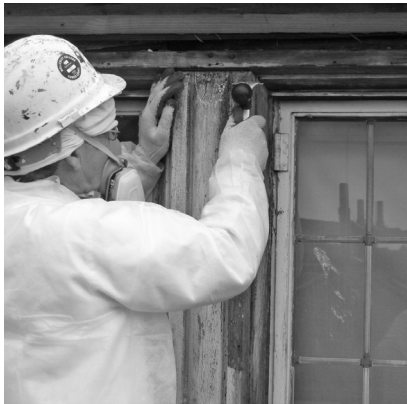
▲ Contractor removing lead-based paint wears personal protective equipment.

Health and safety risks associated with rehabilitation should also be considered. Commercially available fungicides for wood rot, as well as wood preservatives, pose health hazards. Timing restoration work to coincide with low occupancy periods and taking appropriate precautions during application are critical to minimizing exposure risk for building users. Windows installed before 1978 likely incorporate lead paint and/or lead comes, which produce toxic dust
