# Journal

## How Safe Is Your Sidewalk Vault?

Lawrence E. Keenan, AIA, PE and Tai Mahmuti, B. Eng., LEED Green Associate

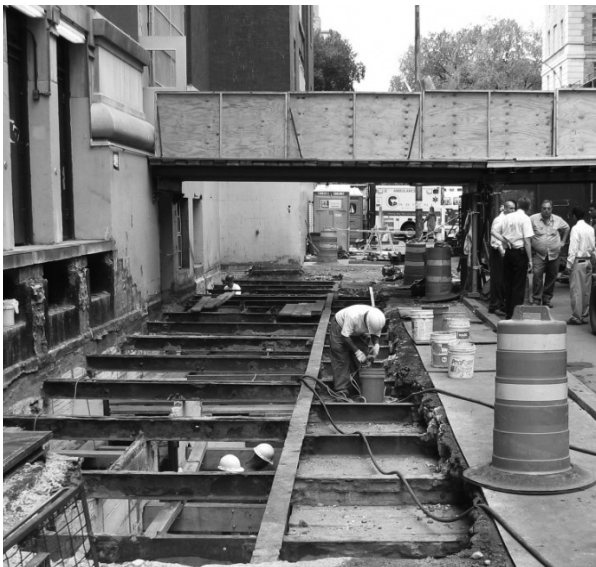
▲ Discovering and remediating sidewalk vault deterioration is crucial to preventing a dangerous collapse.

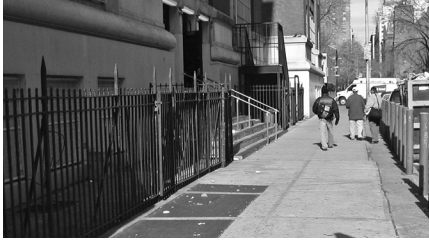
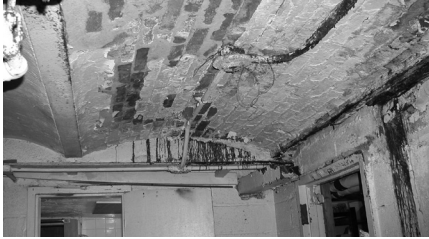
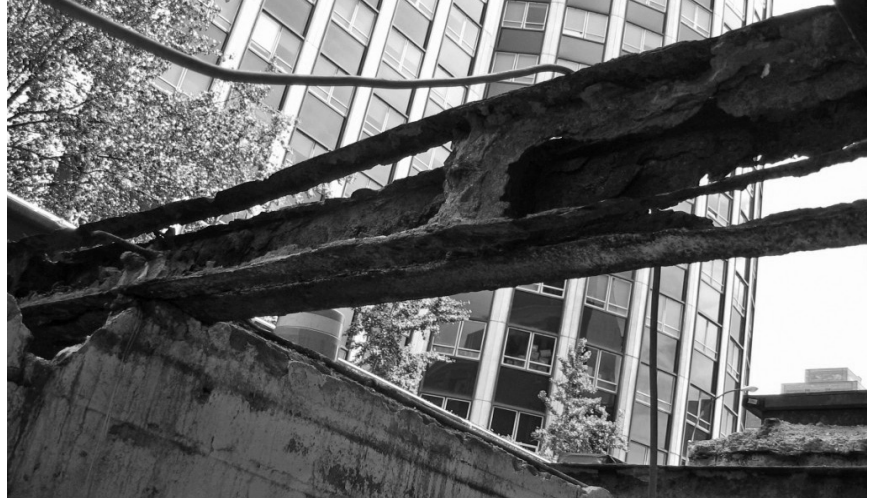
▲ At street level (*top left*), the sidewalk appears to be in good condition. In the vault below (*bottom left*), masonry arches show their age but seem structurally stable. Masonry removal, however, shows how badly deteriorated the embedded steel really can be (*above*).

With steel beams and columns concealed within masonry, concrete, or fireproofing, it can be easy to miss even advanced deterioration of vault structural framing. Until the surface material is removed to reveal embedded structural elements, it may be difficult to distinguish between a stable structure and one that has been compromised. Masonry or fireproofing that appears in good condition may mask steel beams reduced to brittle, tissue-thin scraps by years of corrosion.

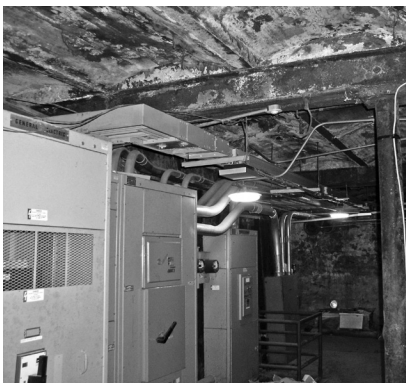
▲ Originally used for coal, sidewalk vaults may house mechanical/electrical equipment.

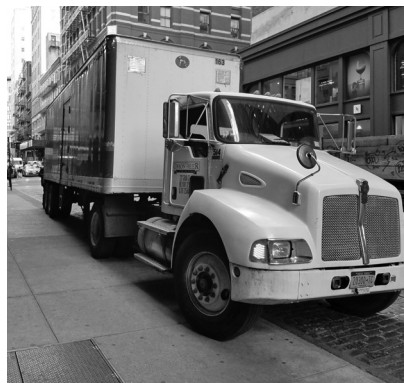
▲ Delivery trucks on sidewalks may add weight beyond what historic vaults can bear.

In historic areas where streets are narrow, such as SoHo in New York City, delivery vehicles commonly park on the sidewalk, placing excessive loading onto vaults, many of which were not designed for vehicle traffic and also are likely to have succumbed to deterioration due to age and neglect. Even intact vaults as originally constructed may not meet today’s load requirements.

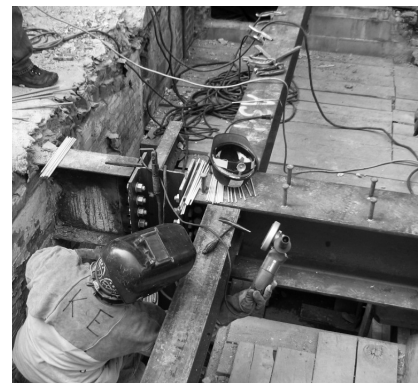
▲ Replacing or reinforcing structural steel may be necessary for today's traffic loads.

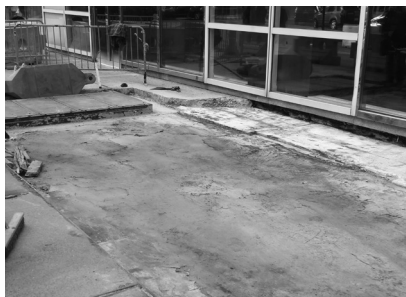
▲ First, the concrete wearing surface is removed to expose the concrete vault.

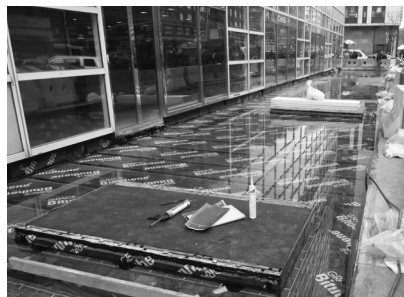
▲ After installation of new waterproofing, flood testing confirms water-tightness.

To prevent further water infiltration, proper waterproofing of the sidewalk is essential. Waterproofing should extend beyond the sidewalk to the face of the building foundation wall to a reasonable depth (depending on existing conditions) on the street side. A typical waterproofing assembly might consist of multi-ply modified bitumen membrane on the new concrete structural slab, with a drainage mat and wearing surface.

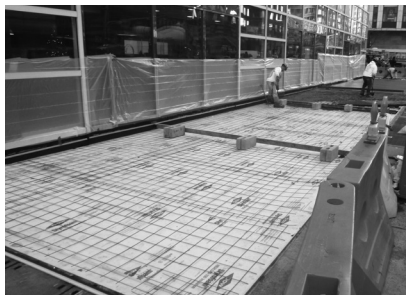
▲ The new concrete sidewalk is poured over the insulation.

emergency vehicles, insulation installed directly below the wearing surface must be designed with an appropriate compressive strength. Depending on the jurisdiction, insulation may not be a code requirement for sidewalk vaults, but it may be beneficial to protect the space below from temperature extremes, condensation, and thermal cycling.

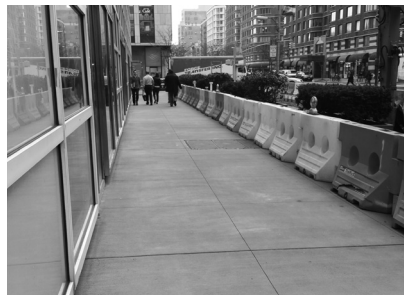
▲ The completed sidewalk system protects against water infiltration into the vault below.

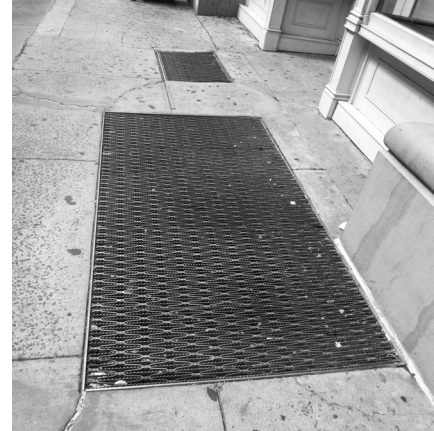
▲ Falling into a faulty grate is a real concern.

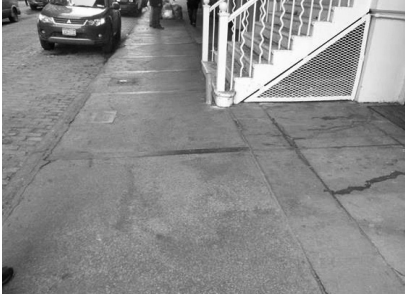
▲ Massive granite paving slabs typify sidewalk construction in historic SoHo, New York.

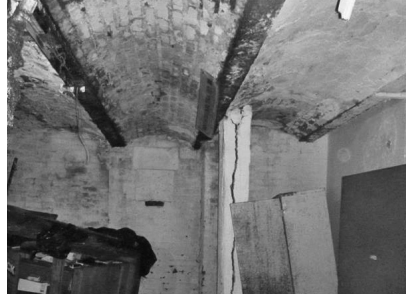
▲ Masonry arches with steel beams comprise the sidewalk vault structure.

Many city sidewalk vaults dating from the turn of the last century were constructed of masonry arches and vaults, often of clay brick. Over time, as structural steel embedded in the masonry began to corrode in the presence of moisture, the oxidized steel expanded, exerting pressure on the surrounding brick and causing it to crack and spall. To treat the damage, masonry must be removed to access and treat corroded steel. The expansive force of the rusting structural steel may have damaged some areas of masonry beyond repair, necessitating replacement. New fireproofing may also be necessary, as per code requirements.

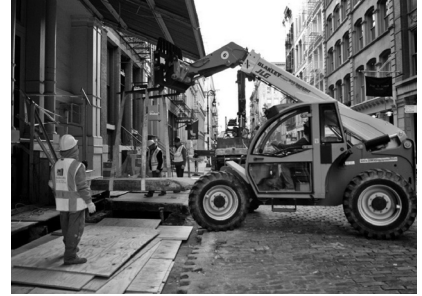
▲ Historic granite slabs are retained for reinstallation after vault rehabilitation.

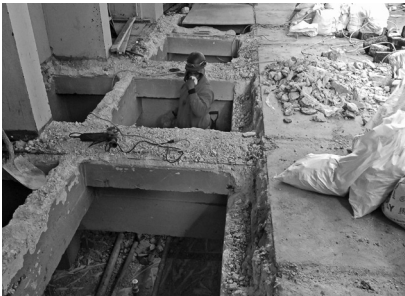
▲ Concrete sidewalk and slab are removed to access the vault below.

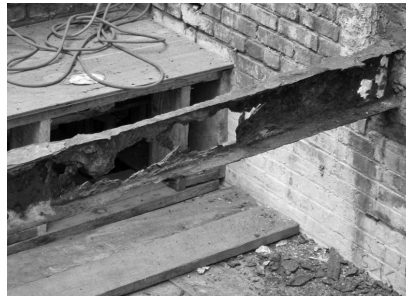
▲ Removal of masonry arches uncovers severely deteriorated structural steel beams.

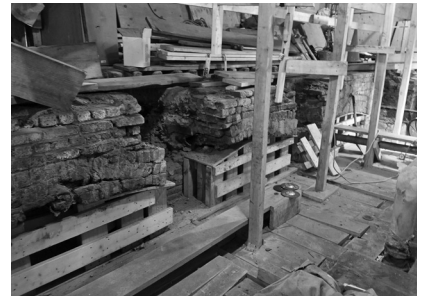
▲ Temporary stabilization of brick masonry permits replacement of deteriorated steel.

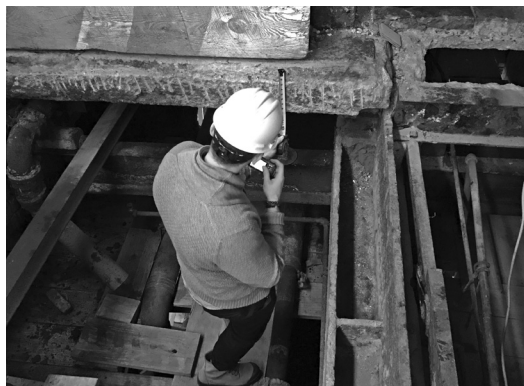
**A** An engineer investigates structural slab conditions at a partially deconstructed sidewalk vault.
