**Hoffmann
Architects**

Journal

Parking Structure Maintenance: Early Detection, Early Cure

Lawrence E. Keenan, PE and Bruce R. Soden

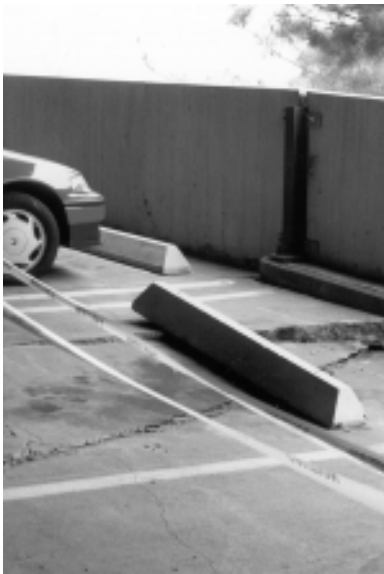
▲ CAUTION! Severe parking structure deterioration leads to drive and/or safety hazards.

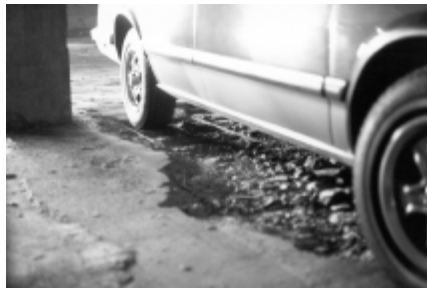
▲ Crumbling parking deck.

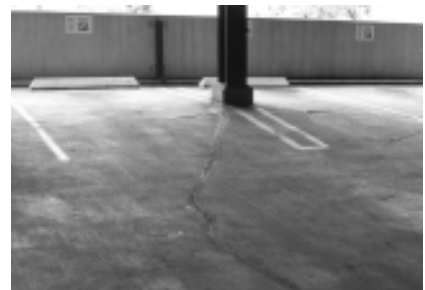
▲ Cracks and settlement of concrete slab.

Cracks, when formed, pose a serious threat to pre-cast elements, as they allow a direct path for salts to the embedded reinforcement. This reinforcement typically consists of wire that is thinner than the reinforcement bars used for cast-in-place decks. As such, a relatively small amount of corrosion can cause a significant loss in strength. To make matters worse, repair of these thin elements is often difficult and costly. Cracks, then, require prompt repair and ardent maintenance.

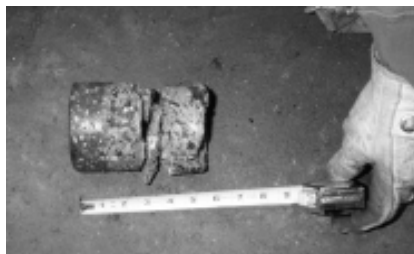
▲ Concrete core has been extracted from a parking deck for analysis.

As every garage contains concrete, concrete testing is an inevitable component of the investigative process. Various concrete tests reveal the material's integrity by disclosing what is often not visible on the surface. The results of these tests yield information to accurately evaluate the condition of the parking structure and determine the scope of repair action necessary.

If, for example, chloride ion testing reveals that chloride levels are high throughout a parking deck, broad action may be recommended to cease and/or prevent further corrosion of the entire deck. Conversely, if testing reveals that chloride intrusion poses a threat to only a single, isolated area, it may be that the rehabilitation effort will focus on that area alone.

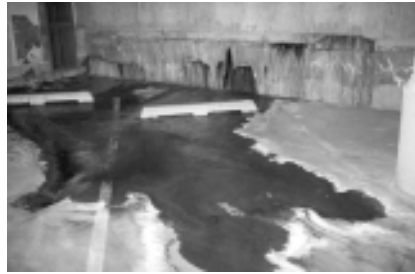
▲ Obvious indicators of water infiltration are ponding and staining.

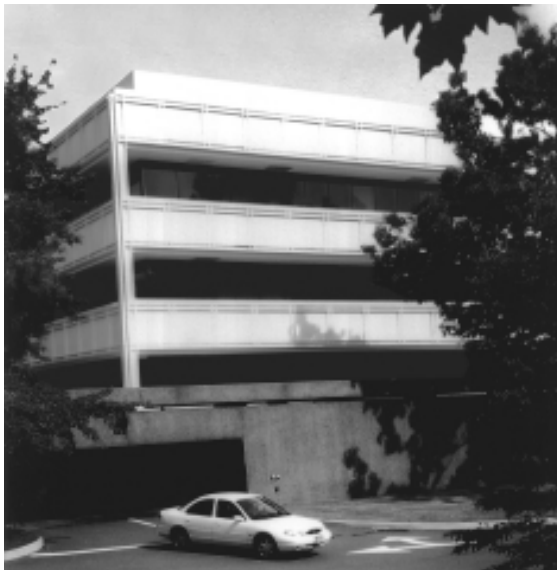
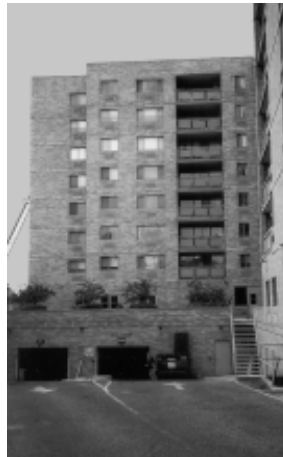
▼ **General Electric Company** Fairfield, Connecticut.
Hoffmann Architects designs parking structure rehabilitation solutions that are minimally disruptive to the normal operation of corporate headquarters facilities.

construction administration and construction management services for a preventive rehabilitation effort of the two-level, 239,000 square foot parking structure at General Electric Corporate Headquarters in Fairfield, CT. Located directly beneath a three-story steel framed office building, the second floor parking deck was deteriorating.

The firm carefully phased the repair work to minimize disruption to the highly trafficked parking structure (usage is consistently greater than 110% capacity). Fast-curing coatings and repair mortars were specified to expedite completion of repairs, and construction

was performed during evenings and weekends. Special precautions were taken during construction to protect against damage to the electrical distribution system that was embedded in the concrete parking decks.

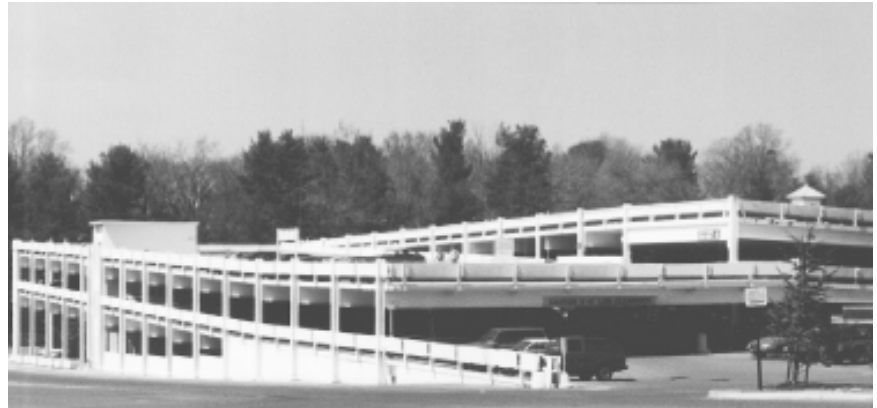
▲ Bishops Corner Parking Facility
West Hartford, Connecticut (Edens & Avant)

of traffic. The garage is divided into two sections: a pre-stressed concrete section and a cast-in-place section, and the total footprint measures approximately 1,040 feet by 240 feet.

Following field testing, field probes, laboratory testing, and structural analysis, Hoffmann Architects developed a program of repairs to correct existing deficiencies and to suspend further deterioration of the garage.

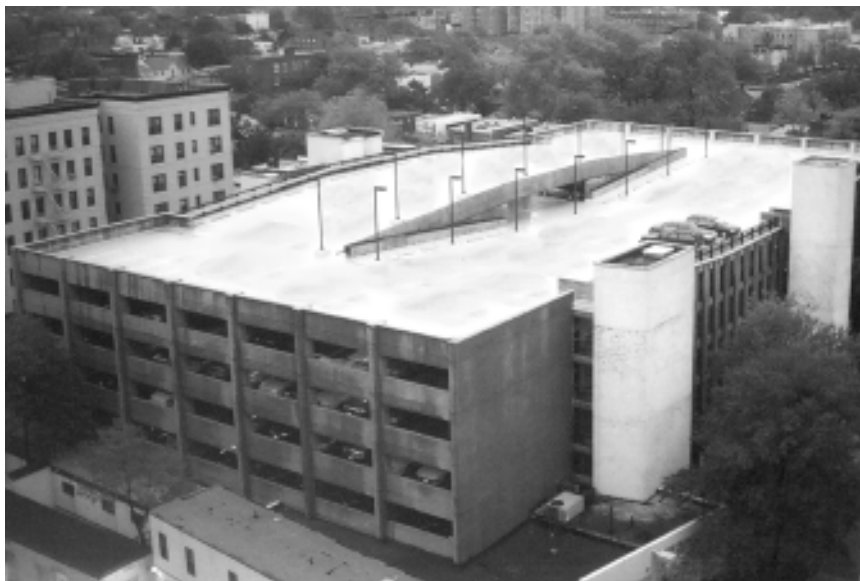
▲ State University of New York Downstate Medical Center
Brooklyn, New York (New York State University Construction Fund)

parking deck is a waffle slab design and the sub-basement level flooring is slab-on-grade construction. Built in 1972 and rehabilitated in 1988, the parking structure showed signs of severe deterioration due to chloride-induced corrosion of reinforcing steel.

Hoffmann Architects conducted a survey of the garage and developed and implemented a rehabilitation program to address damage to the concrete reinforcement caused by the high level of chlorides attributable to road salts deposited by incoming vehicles.

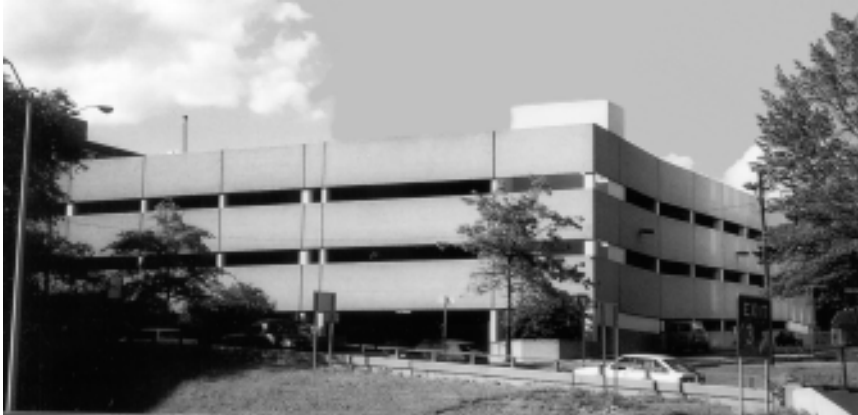
▲ SNET's George Street Garage
New Haven, Connecticut (Southern New England Telephone Company)

Hoffmann Architects conducted an investigation that included chloride ion testing and petrographic testing in order to recommend and administer a successful program of repairs for the deteriorated concrete ramp and deck surfaces.
