Hoffmann
Architects

Journal

Preventing and Treating Distress in Brick Veneer Cavity Walls

Erin L. Kesegi, AIA and Robert A. Marsoli, Jr.

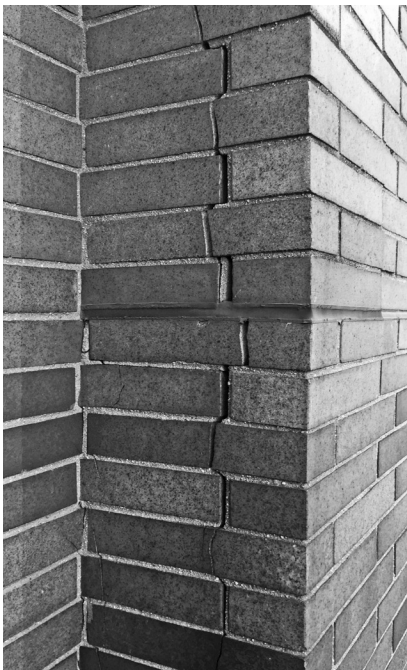
▲ Long, vertical cracks at building corners may indicate underlying structural distress.

When expansion joints are too narrow or spaced too far apart, there is insufficient accommodation for brick expansion, forcing sealant out of the joint and eventually leading to cracks and failure of the surrounding masonry. Failure to include expansion joints at building corners is a common cause of distress; as the masonry expands along the plane of the wall, the brick on each side of the corner comes together, leading to long vertical cracks and/or brick displacement at building corners.

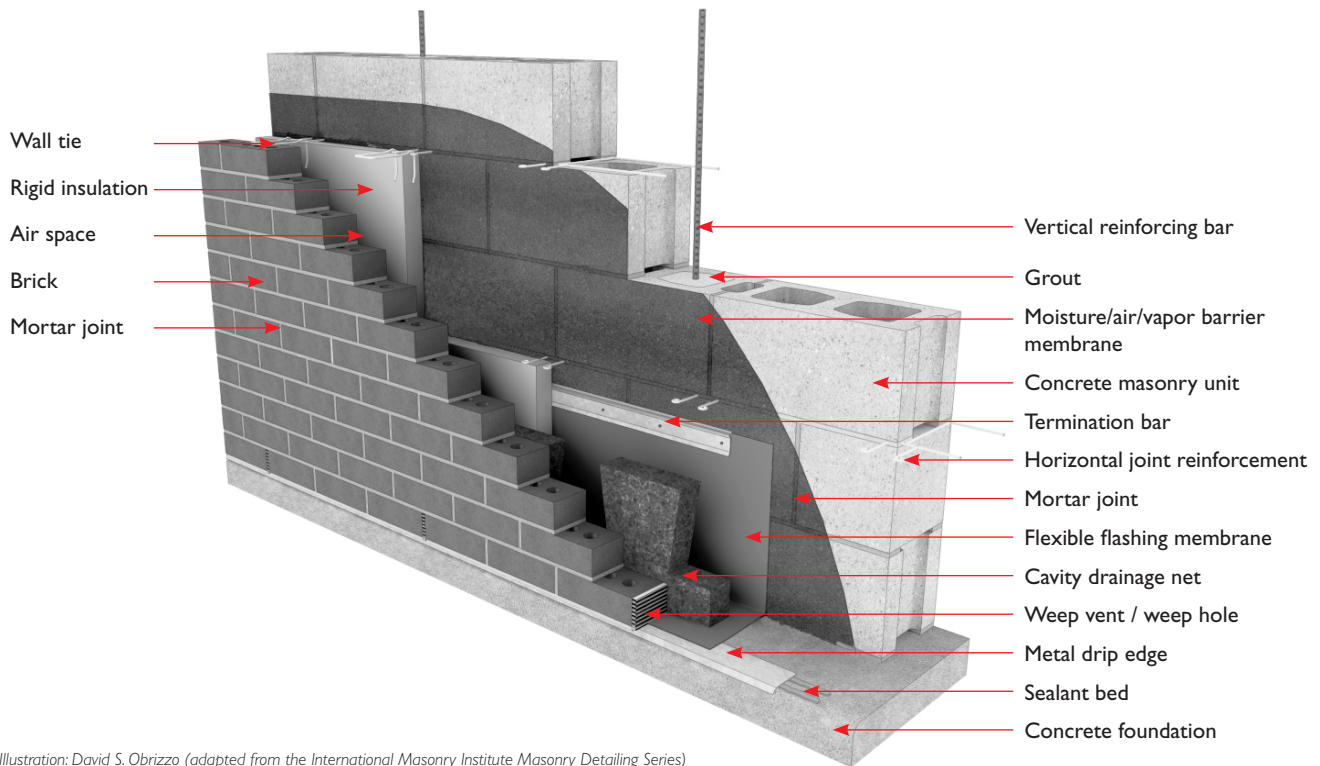
Typical Masonry Cavity Wall

In contrast, modern brick veneer cavity walls anchor a single wythe of face brick across an air space, typically two to four inches wide, to a back-up material. Part of a drainage system that includes flashings, drip edges, and weep holes, the air space creates a pathway for moisture to exit the wall assembly, while a steel, concrete, or masonry back-up provides structural support.

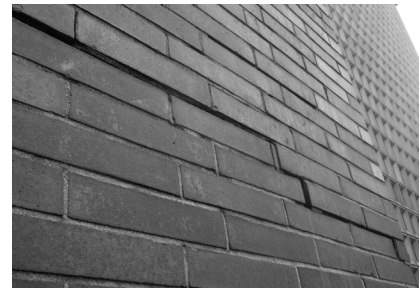
▲ Lateral displacement of brick veneer.

Insufficient or failed anchorage of the veneer to the back-up can lead to bowing and/or lateral displacement of the masonry.

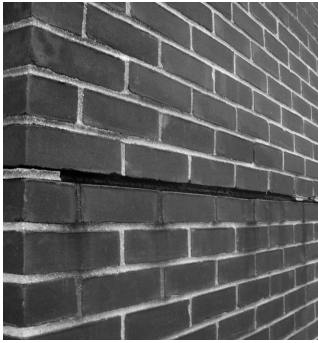
▲ Corrosion of steel shelf angle.

Causes of structural distress in brick masonry cavity walls are often related to the corrosion of embedded steel elements, which can lead to cracks and displacement. As water penetration causes steel lintels, reinforcement, anchors, ties, and accessories to corrode, they expand, exerting tremendous pressure on the surrounding facade, which can sometimes fail dramatically as a result.

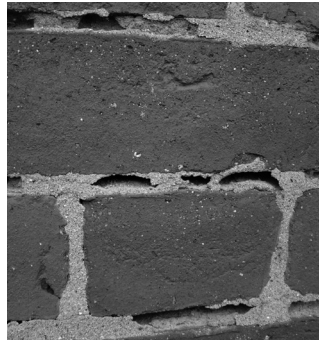
▲ Mortar joint failure.

Mortar Joint Repointing: Repointing is the process of removing damaged or deteriorated mortar to a uniform depth and replacing it with new mortar. When mortar is crumbling, cracked, or softened, repointing may be necessary to protect against water penetration.

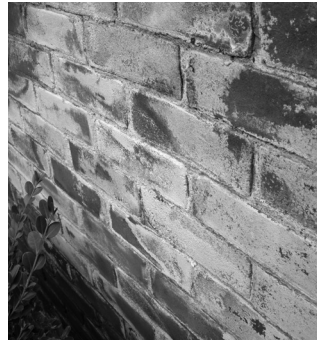
▲ Efflorescence.

Observable as white stains or salty streaks on the surface of masonry walls, efflorescence occurs when moisture within the wall assembly leaches water-soluble salts from the mortar or masonry. The main cause of efflorescence is water infiltration, whether from poor mortar joints, cracked brick, or other sources. Also, sloppy workmanship can clog the wall cavity with excess mortar and prevent water from reaching flashings and exiting the wall. Forced to find another means of escape, trapped moisture travels through the brick, resulting in efflorescence.

Once the problem has been identified and remediated, it may be difficult or even impossible to clean away salt deposits that have bonded to the masonry surface. If moisture has reached the building interior, water damage and mold may also need to be addressed.

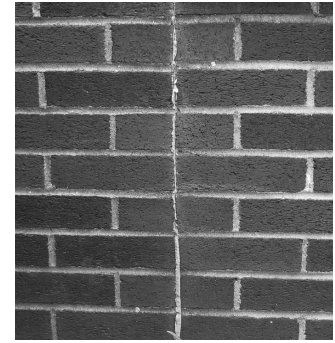
▲ Insufficient expansion joint width.

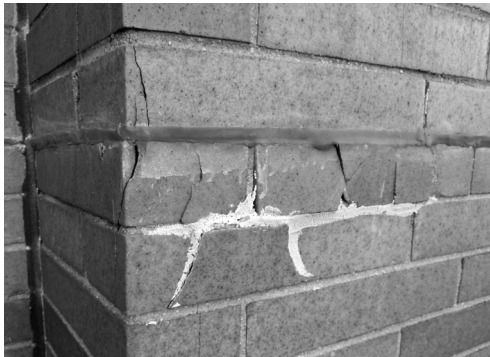
▲ Sealant alone cannot resolve masonry distress.
