**Hoffmann  
Architects**

# Journal

## Preventing and Treating Failure in Glazed Curtain Wall Systems

Russell M. Sanders, AIA and Craig A. Hargrove, AIA LEED AP

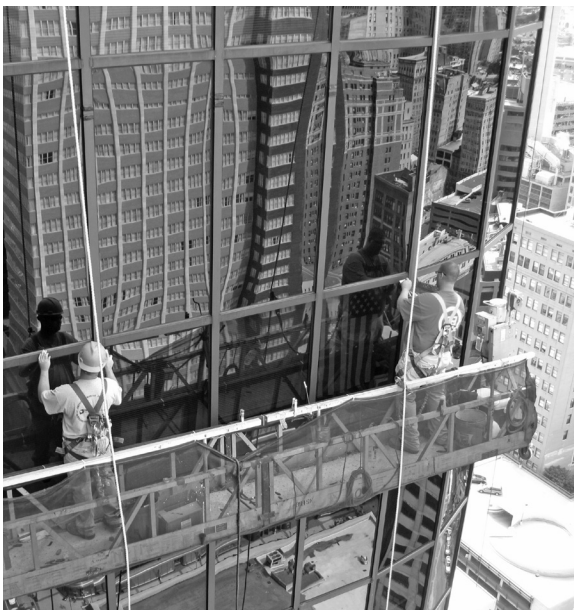
▲ Workers repair failed gaskets at a glass curtain wall high-rise.

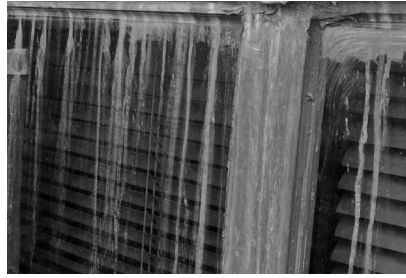
▲ Streaked glazing.

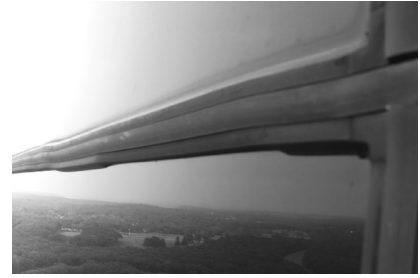
▲ Gaskets disengaged from glazing.

dried gaskets admit air and moisture into the system, leading to condensation, drafts, and leaks. As the gaskets further disintegrate, they may loosen and pull away from the frame. Without the support of flexible gaskets, the glass loses stability and may shatter or blow out. For this reason, it is important to maintain and routinely replace gaskets to keep the curtain wall system operational and safe.

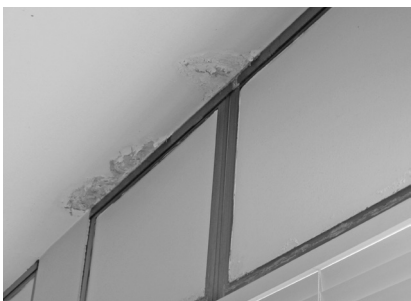
▲ Leaks and drafts.

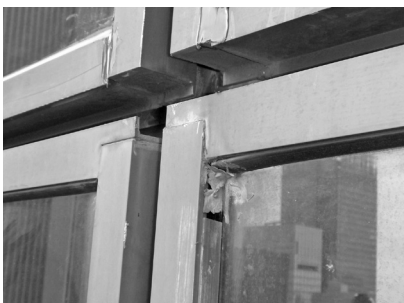
**A** Gaps at frame corners.

**Missing, incorrectly applied, or otherwise deficient sealants** at frame corners and other intersections can lead to serious water infiltration issues. Failure on the part of the contractor to follow manufacturers' guidelines, and on the part of the design professional to provide sufficient oversight, can result in water damage that is both difficult to access and expensive to repair.

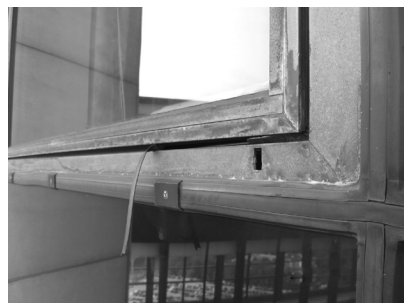
**A** Loose or missing weather stripping.

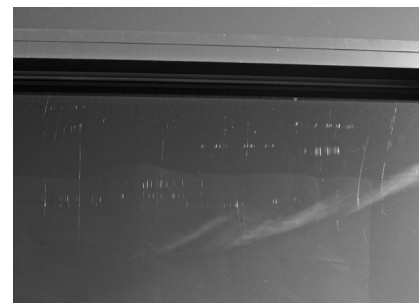
**A** Scratches and hairline cracks.

**Hairline cracks** in glass may indicate excessive thermal loading, particularly if the glass has a coating, such as a low-e film or tint. When the sun strikes the glass, it heats the exposed portion of the pane, causing it to expand. The unexposed edges remain cool, creating tensile stress that can lead to cracking, particularly in glass that has not been heat-strengthened or tempered.

Glazing that displays systematic scratches or other defects after installation may need to be evaluated for structural integrity. In such cases, a representative sample of glass units may be removed and tested under laboratory conditions. ASTM E997 is one test method for determining the probability of breakage for a given design load.

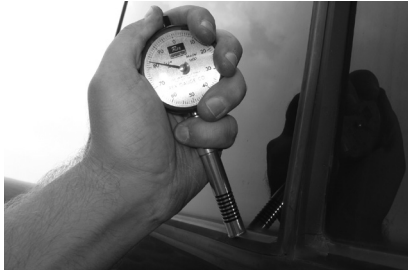
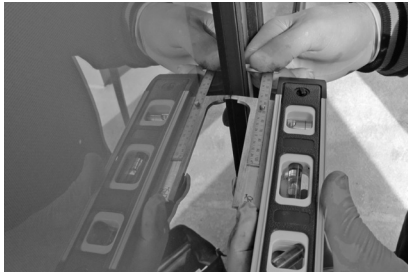
▲ Evaluation may include measurements of gasket hardness (top) and of glazing alignment (bottom).

If leaks, deflection, etched glass, or other issues have become a concern, an architect or engineer should conduct a systematic evaluation of the curtain wall system, beginning with close visual inspection. ASTM International provides test standards for the evaluation of air and water penetration, as well as structural performance of glass in curtain wall applications. Tests for water penetration, such as ASTM E1105, use a calibrated spray rack system with a positive air pressure differential to simulate wind-driven rain. ASTM E783 specifies test procedures for determining field air leakage at specific pressures.
