Preventing Reinforcement Corrosion in Parking Garages

by John Hoffmann, AIA

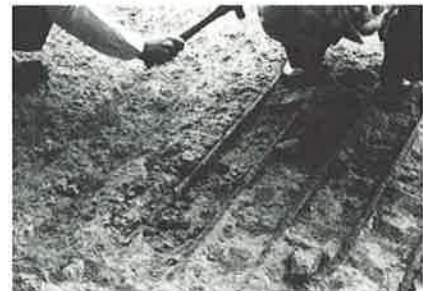
testing adhesion of deteriorated concrete to reinforcing bars

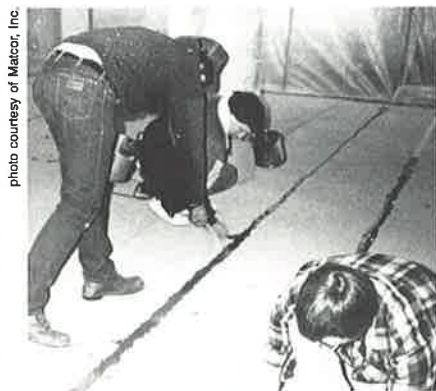
installing anode material in cathodic protection system

One way of protecting the steel is through cathodic protection. In this method, the corrosion is stopped by reversing the processes of electrochemical action that cause the corrosion. By applying a direct current to the rebar in opposition to the current causing the corrosion, the corrosion causing current is overcome. According to ACI 222R - Corrosion of Metals in Concrete, "Although cathodic protection is a viable method of protecting reinforcing steel against corrosion in new construction, most installations to date have been to arrest corrosion in existing structures." Cathodic protection eliminates the electrochemical action that causes the corrosion but has several design requirements to fulfill

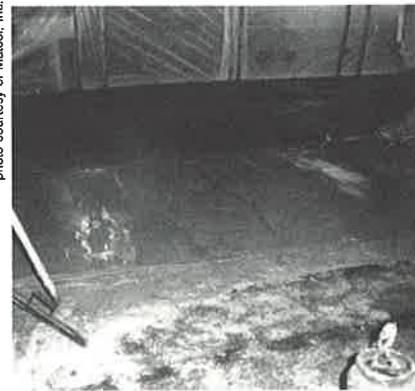
installing wearing surface over anode

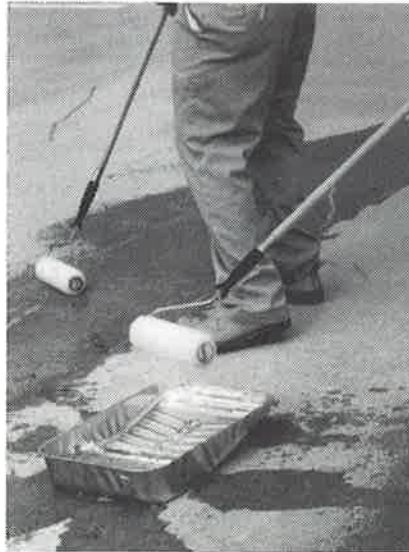
installing sealer - note darkening of concrete

4. Installation of some formulations will interfere with the installation of concrete toppings or grout.
5. Some formulations will darken the appearance of the concrete.

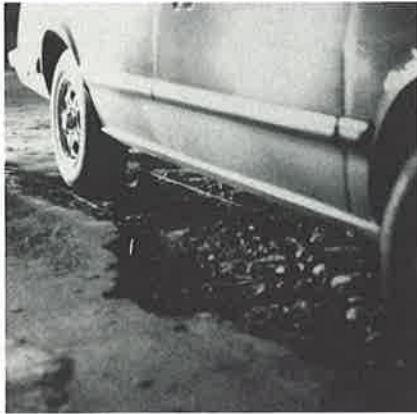
concrete deterioration in parking garage

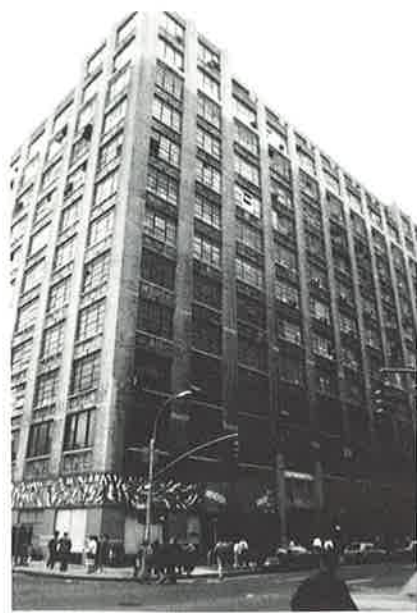
Sylvan Lawrence Company, New York City

For **Sylvan Lawrence Company, Inc.**, a New York City real estate developer, the firm surveyed a newly installed modified bitumen roofing system to report on its condition and the adequacy of the insulation.

The firm is also surveying the condition of the steel sash windows on a building in New York City for **Sylvan Lawrence Company, Inc.** The building, twelve stories high, covers approximately half of an entire city block.

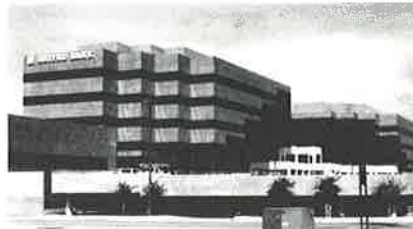
Williams Center, Tuscon, AZ

HRA, Inc., the realty advisory arm of the **Hartford Insurance Group**, commissioned Hoffmann Architects to investigate the causes of leakage at the parking garage of Williams Center, an office building located in Tuscon, Arizona.

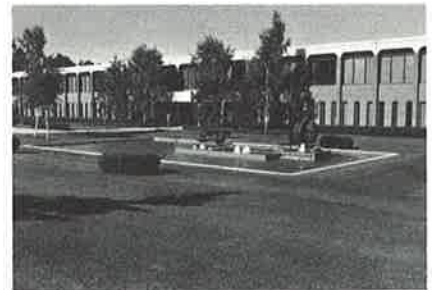
GE Capital Corporation, Stamford, CT

The firm inspected the seven year old EPDM single ply roof and the brick masonry facade at **GE Capital Corporation** in Stamford, Connecticut. The roof survey was done to point out any existing defects while the 67,000 square foot roof was still under warranty.
