Hoffmann  
Architects

## Preventing Winter Damage

Steven J. Susca, PE

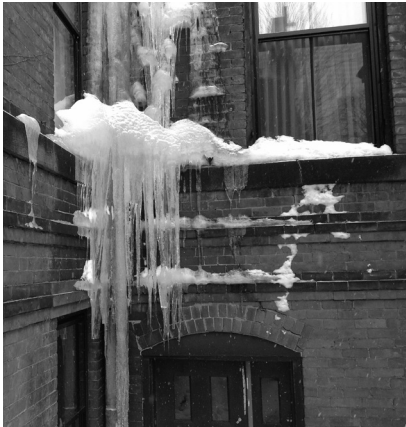
▲ Icicles might seem like charming seasonal decorations, but they mean trouble – both for the building and for those below.

When asked for examples of winter weather problems, the first thing many facility managers and design professionals will bring up is *ice damming*, the frustrating – and potentially dangerous – accumulation of ice and snow at roof eaves. As snow on the roof starts to melt, water flows down to the roof edge, where it collects and re-freezes. Over time, this thawing and freezing creates a build-up of ice at the eave and causes water to back up under the roofing material, eventually spilling over into the building interior.

water at the gutter and drip edge begins to extend downward, forming icicles. With water continuing to flow down from the eaves, these pointed shards of ice can grow to many feet in length, posing a tremendous risk to pedestrians and vehicular traffic below.

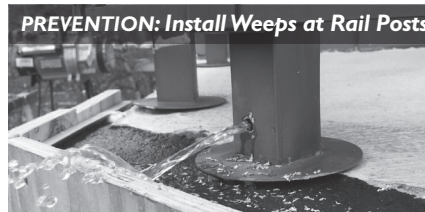
**Cracks at Slab Edge**

aluminum railing posts at concrete balconies are directly embedded into the concrete at the edge of the slab. If not properly finished and sealed, gaps between railing members will allow the railing stanchions to fill up with water. As the water freezes, it expands, which can cause expansion of the aluminum post where it enters the concrete. This, in turn, results in cracks at the edges of the slab.

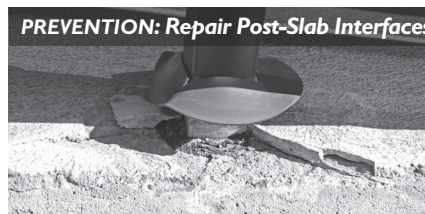
**PREVENTION: Install Weeps at Rail Posts**

#### **Prevention: Install Weeps at the Bottom of Railing Stanchions**

Even if all these recommendations are implemented, water will usually find its way in. For this reason, it must be provided with an escape path from the railing stanchion to prevent it from causing damage. Installation of small weep holes at the bottom of the railing stanchion to allow water to drain will help to ensure the integrity of the balcony railing system.

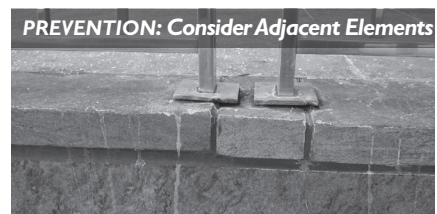
**Freeze-Thaw and Salt Damage**

When water can find a way into the facade, it can cause significant damage, especially as it expands when freezing and contracts as it thaws. To protect sensitive facade elements, it's important to prepare well ahead of cold weather by replacing worn coatings, repointing open mortar joints, replacing failed sealant and gaskets, and replacing damaged materials.

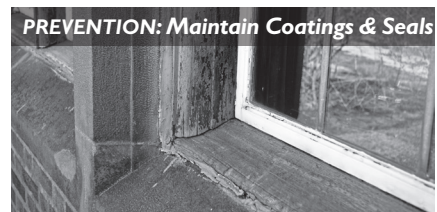
**PREVENTION: Consider Adjacent Elements**

Where different materials intersect, there is potential for damage from differential movement. As each material responds to fluctuating temperatures, one is likely to expand or contract differently from the other, which places strain along the plane where they meet. Even one long span of a single material can undergo movement stress, if that building element is restrained from moving according to its natural tendency. Providing adequate expansion joints to allow for fluctuating material volume as the seasons change is essential, and other measures may be necessary, depending on the materials and configuration.

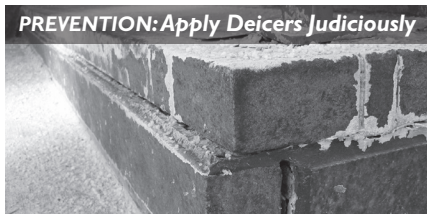
**Corrosion and Deterioration**

Facade elements adjacent to walking and driving surfaces need to be protected from caustic deicing chemicals, which can lead to corrosion, scaling, and disintegration. Opting for less damaging ice management compounds not only protects vulnerable facade materials, it spares exterior stairs, plazas, and garages, too.

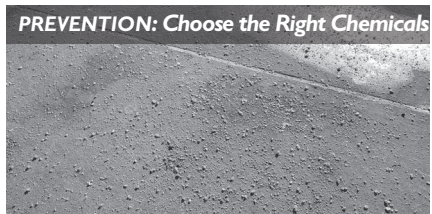
**PREVENTION: Apply Deicers Judiciously**

most common and least expensive deicing chemical, but that does not mean it is the best choice. When its corrosive and destructive properties are considered, it may prove the more expensive option, given the costs of rehabilitating the damage it does.

*Calcium chloride* is a better option, although it is still a corrosive compound. Better still is *calcium magnesium acetate (CMA)*, an ice loosening chemical that does not melt snow, but instead creates a slurry that prevents ice from bonding to the surface. Caveats are that CMA must be applied *before* snowfall, and that mechanical removal of the loosened ice and snow

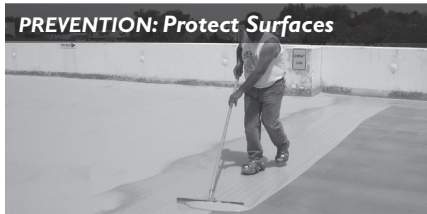
**Damage to Expansion Joints and Parking Decks**

Without benefit of precipitation to clear away accumulated deicing salts, garages are subjected to high concentrations of damaging chemicals. Periodically washing parking decks and clearing drains to remove accumulated salts prevents chemical-laden standing water from causing deterioration.

Surface treatments, including traffic-bearing membranes, penetrating sealers, and migrating corrosion inhibitors, require periodic reapplication to remain effective. Areas of wear can open up the concrete to damage from chloride-containing water. Repair of cracks and spalls and replacement of joint sealant are important maintenance efforts that help protect the garage from water and deicing chemicals.

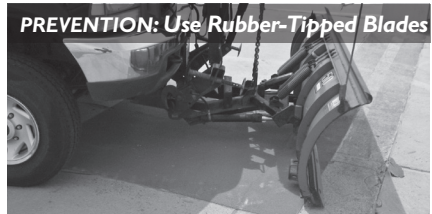
**PREVENTION: Protect Surfaces**

Expansion joints, drains, and other uneven surfaces can take a beating from standard steel snowplow blades. Outfitting the plow with rubber-tipped blades can prevent damage to soft joint materials, edges, transitions, and coatings that are often sites of premature deterioration.
