Hoffmann  
Architects

## Restoration and Replacement of Glazed Curtain Wall Assemblies

Daniel L. Bishop, AIA

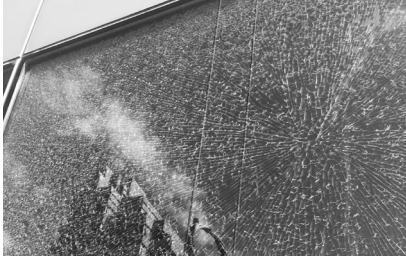
▲ Broken glass.

Damaged glass can be both unsightly and a safety hazard. Cracks in glass may be caused by incidental impact, extreme temperatures, or applied forces caused by thermal movement or displacement of structural elements. Contaminants incorporated into the glass during manufacturing, notably nickel sulfide inclusion, may also lead to what appear to be spontaneous cracks, as the contaminant expands differently than the surrounding glass.

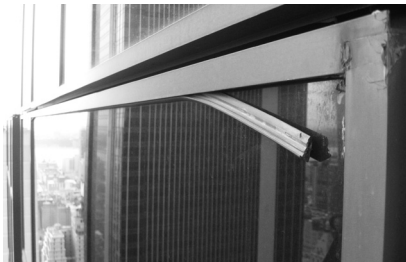
▲ Failed gaskets and seals.

Curtain wall systems are typically designed with integral weep systems to collect and channel incidental water infiltration to the exterior. However, as gaskets are exposed over time to UV radiation and weather, they become brittle and shrink. Deterioration of the gasket creates voids that admit more water than the system was designed

Gaskets installed between the curtain wall frame and glass can be replaced. Gasket replacement can require intensive effort, however, as glazing, framing members, and adjacent elements may require temporary removal to allow access to gaskets. To ensure compatibility with the existing curtain wall frame, identification of gasket size and profile is required.

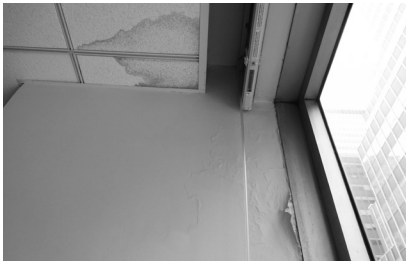
▲ Leaks and drafts.

At the perimeter of the curtain wall, missing, poorly installed, or deteriorated flashings may allow water to penetrate the assembly and leak into the building. Water may be observed directly in line with the site of flashing failure, or moisture may be initially concealed as it travels undetected through interior cavities, only to reveal itself at seemingly unrelated locations.

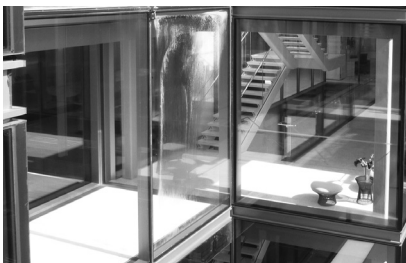
▲ Condensation.

Condensation is especially worrisome for cool climates. When indoor air is heated and outdoor temperatures are cold, insufficiently insulated exterior walls develop an interior surface that is cool enough to condense ambient moisture. Condensation may be directly observed as 'sweat' on visible surfaces, or it may be hidden from occupant view within concealed spaces, such as spandrel locations.

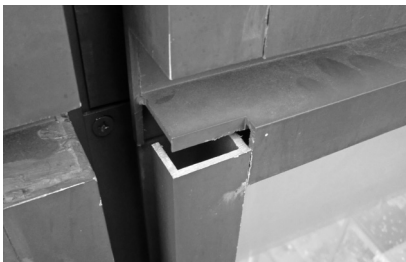
▲ Frame displacement.

Curtain walls consist of framing members that are supported by anchors secured to the building structure. Should these anchors be insufficient, or deteriorate, the curtain wall can become displaced. The resulting misalignment of materials will open seams and apply stress that may deform or break curtain wall components.

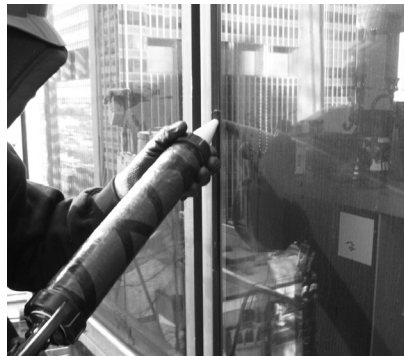
▲ Wet glazing an existing glazed curtain wall.

In lieu of gasket replacement, existing gaskets may be cut back and sealant applied at the glass-to-frame joint. While wet glazing spares the time and expense of removing glazing and framing elements to replace gaskets, the use of sealant requires attentive installation and ongoing maintenance. Understanding of adhesion

and durability properties during the sealant selection process is critical, as incorrectly specified sealants can fail to bond properly or become weathered and brittle. Provision for expansion and movement is also essential.

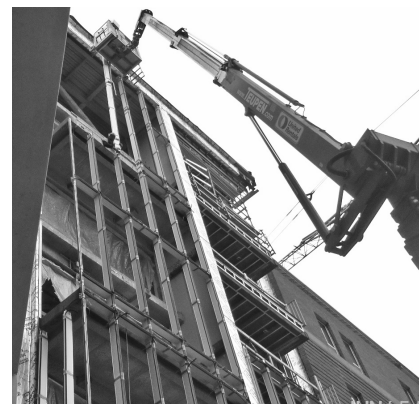
▲ Installation of a new stick-built curtain wall.

In a **stick system**, individual curtain wall components are shipped to the job site for field assembly. Components

can be supplied in stock lengths for field cutting, or in knock-down fashion, where components are custom machined and sized by the manufacturer. With a stick assembly, all connections and seals are installed in the field.

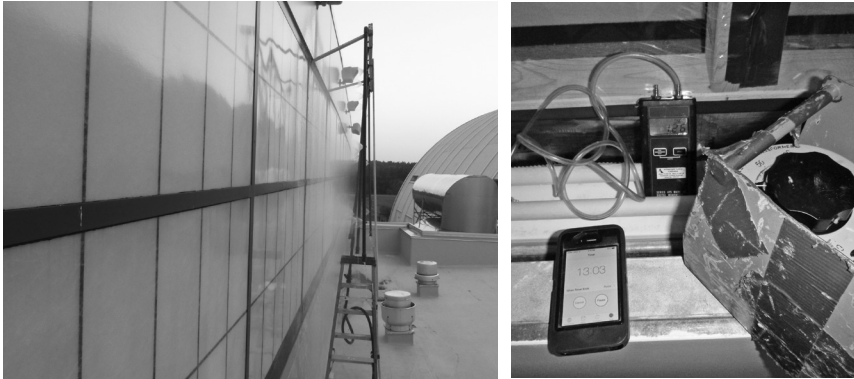
▲ Field water penetration test to investigate leaks at an existing glazed curtain wall assembly.

Whether rehabilitation or replacement is ultimately selected, quality assurance measures, including field testing for air and water infiltration, are an opportunity to evaluate expected performance. ASTM International and the American Architectural Manufacturers Association (AAMA) develop voluntary standards for the testing of materials and products. Field testing of installed assemblies may be mandated by code, required to meet voluntary accreditation standards, or used to confirm installation quality and performance.

- ASTM E783: Standard Test Method for Field Measurement of Air Leakage Through Installed Exterior Windows and Doors
- ASTM E1105: Standard Test Method for Field Determination of Water Penetration of Installed Exterior Windows, Skylights, Doors, and Curtain Walls, by Uniform or Cyclic Static Air Pressure Difference
- AAMA 501.1-17 Standard Test Method for Water Penetration of Windows, Curtain Walls and Doors Using Dynamic Pressure (references test chamber and water spray system per ASTM E1105)
- AAMA 501.2-15 Quality Assurance and Diagnostic Water Leakage Field Check of Installed Storefronts, Curtain Walls and Sloped Glazing Systems (not used for operable components)
- AAMA 503 Field Testing of Newly Installed Storefronts, Curtain Walls, and Sloped Glazing Systems (references ASTM E1105 for water infiltration and ASTM E783 for air infiltration)
