Hoffmann
Architects

Roof Drainage Systems

Richard W. Off, AIA and Steffany Malarik, Assoc. AIA

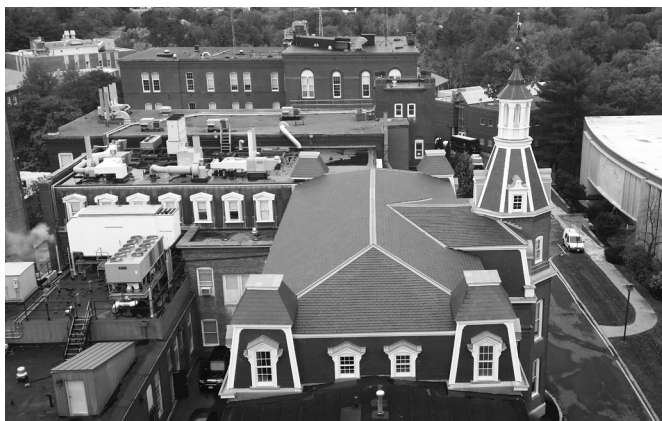
▲ Different roof types demand different drainage strategies.

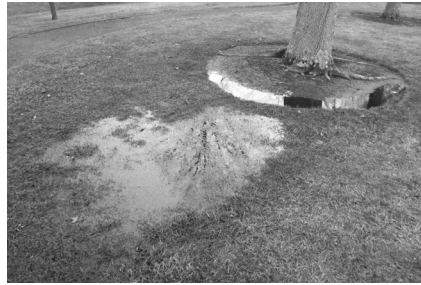
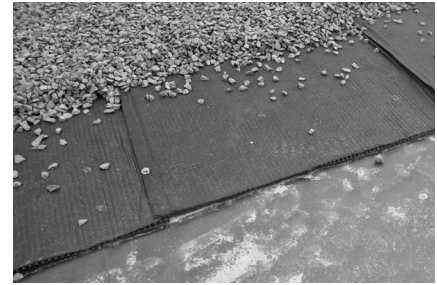
A In this vegetative roof above a parking garage, insufficient drainage caused ponded water (left). The new assembly (right) incorporates waterproofing membrane, drainage mat, and gravel.

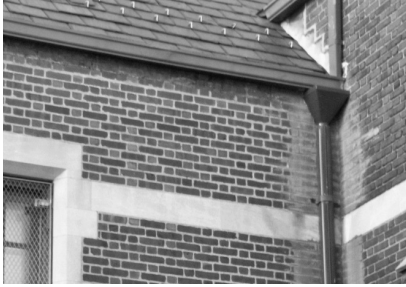
▲ Undersized gutters led to facade deterioration at eaves and downspouts.

Insufficient Drainage Capacity. If gutters and downspouts do not provide an adequate cross-section for rainwater draining from a given roof catchment area and pitch, the water will become backed-up and spill over, potentially leading to moisture infiltration and eventual deterioration at adjacent

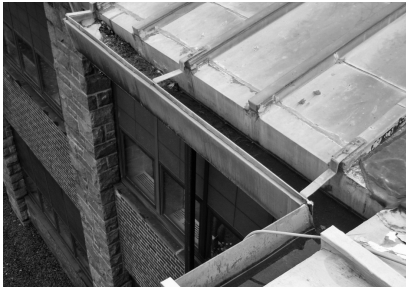
▲ Clogged with debris, these inadequate gutters are filled with standing water.

Standing Water. Arguably the most commonplace issue with steep slope drainage, as with low slope drainage, is standing water from clogged gutters and downspout drains. Clogging can result from excess dirt, debris, and vegetative growth accumulating in the drainage system. Roofs located beneath trees, especially deciduous trees, are most susceptible to clogging from leaves and small branches that fall into gutters and block the drainage path.

These accumulations, combined with the standing water they engender, create spillover in downspouts and generate excess weight in gutters, potentially causing them to sag or break loose from the support brackets and connections. Therefore, clogged gutters not only increase the potential for leaks and moisture infiltration at facades and roofs, but they also pose

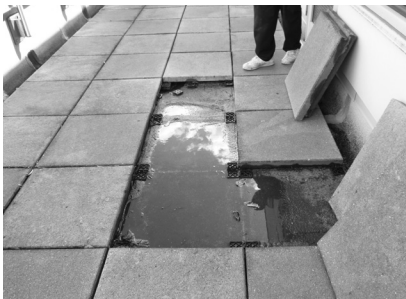
▲ At the surface, these pavers seem fine. But trapped water below may be causing leaks.

Another form of PRMA sets pavers in a sand or mortar setting bed, rather than on pedestals. Below the setting bed are drainage mat, insulation, and a waterproofing membrane adhered directly to the structural deck. In this type of assembly, most of the water does not flow down through the paving surface; rather, it flows along the top of the pavers. Some water will inevitably penetrate the sand or mortar joints, so it is important to include **bi-level roof drains**, which receive water through a grate at the paving surface level, as well as through a perforated screen at the roof membrane level, for water that seeps below the paving surface. This type of assembly is especially susceptible to unwanted plant growth, as water soaks through the joints and is not able to freely flow through the setting bed to the roof

drains. Trapped water can also cause the pavers to spall, crack or develop efflorescence.
