**Hoffmann
Architects**

Journal

Separating Fact from Fiction: Insurance Claims and Building Envelope Failure

Russell M. Sanders, AIA

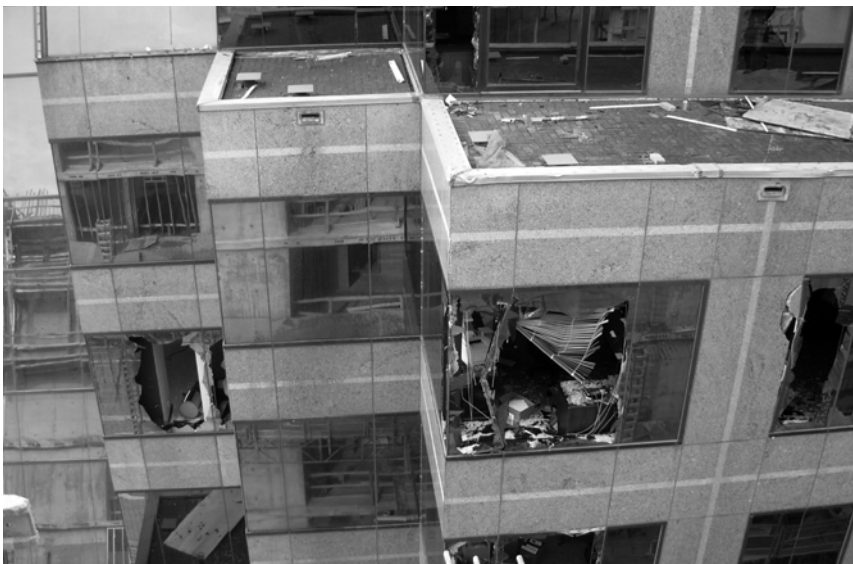
▲ In the wake of a natural disaster, architectural investigation helps reconstruct the chain of events to accurately attribute the cause of damage.

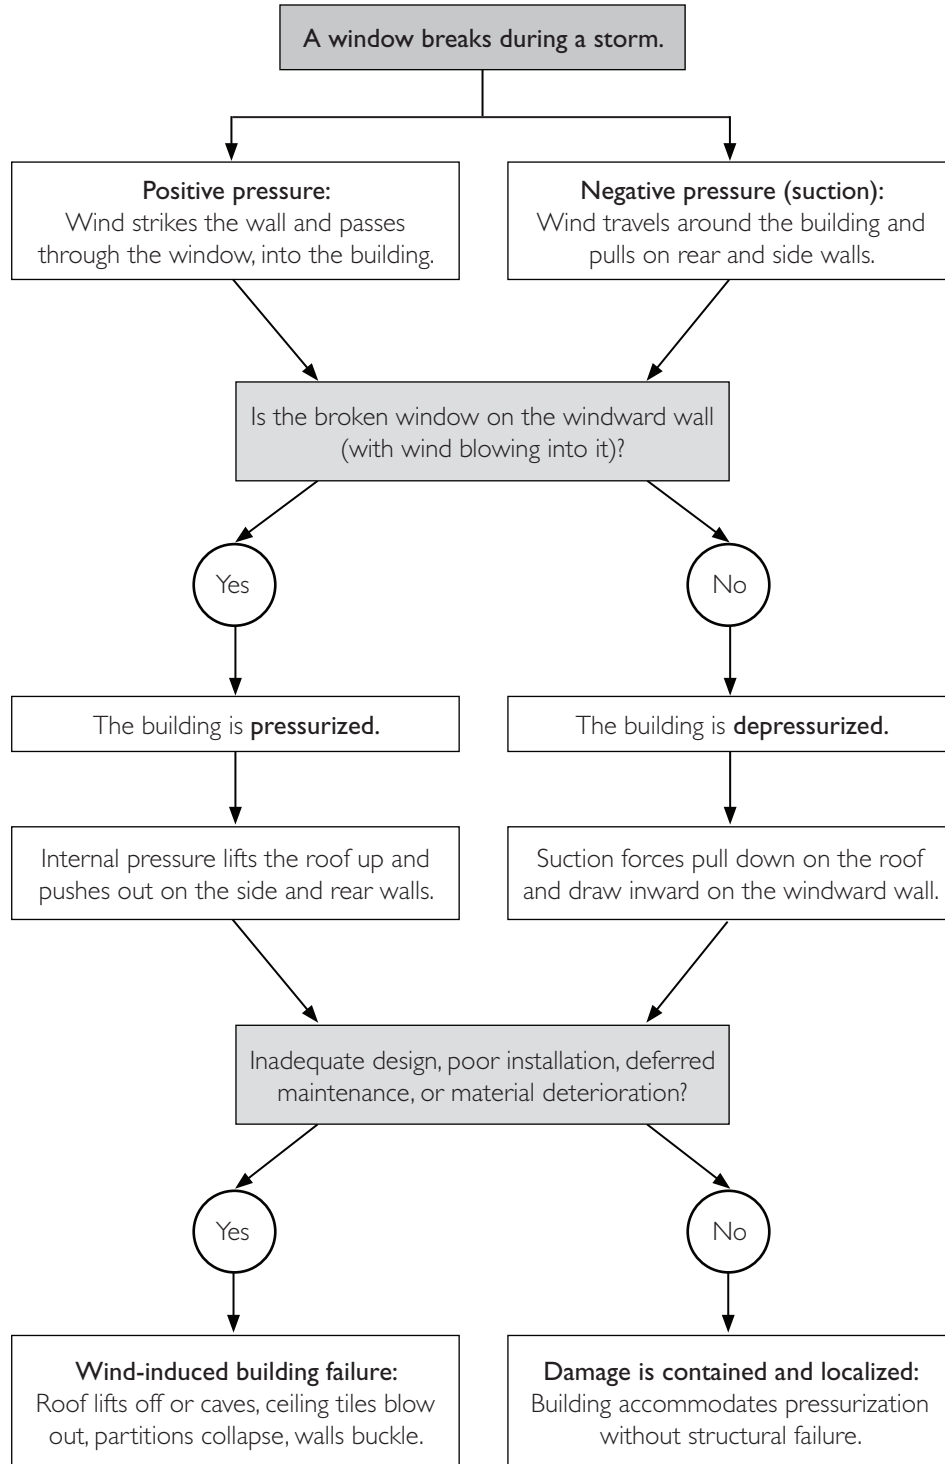
Internal Pressure and Building Envelope Damage

Once a breach occurs in the building envelope, damage can quickly escalate due to the sudden shift in pressure. Because of the rapid build-up of internal pressure, a single wall panel blow-off or broken window can permit a surprising volume of water and debris to enter the building interior:

Because even small building envelope openings, such as weak sealant or doors that are not airtight, can cause a change in pressure within a building, it is impossible to prevent pressurization

completely. However, well-maintained seals, joints, and intersections can help to minimize pressure differentials. The critical difference between a building with adequate wind loading design, sound construction, and good upkeep and one that is ill-prepared for severe weather is in the effect pressurization has on building integrity.

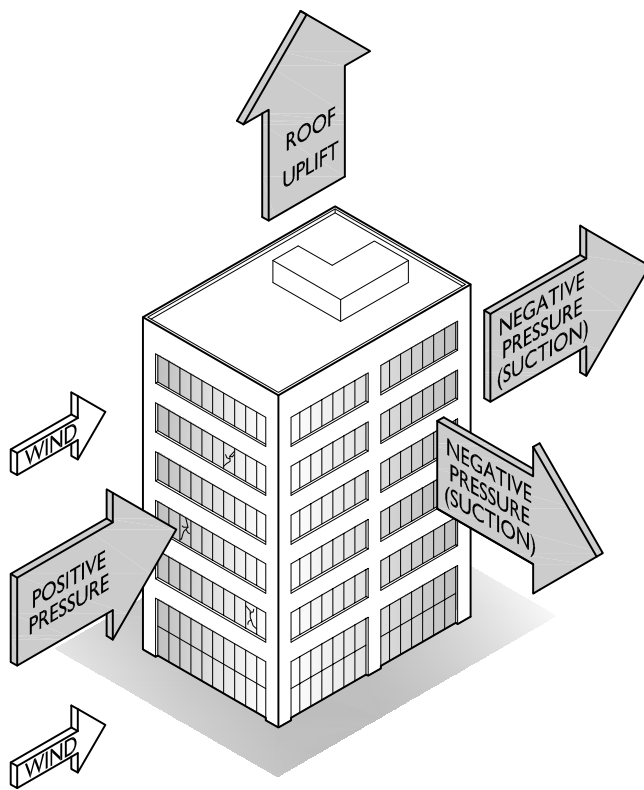
Wind Loads on the Building Envelope

The magnitude of pressure exerted on the building envelope during a storm is dependent upon a number of factors, including:

- Exposure, such as proximity to water or rough terrain;
- Building height, with taller buildings subjected to greater wind pressure;
- Building aerodynamics, a function of building shape and configuration; and
- Wind speed.

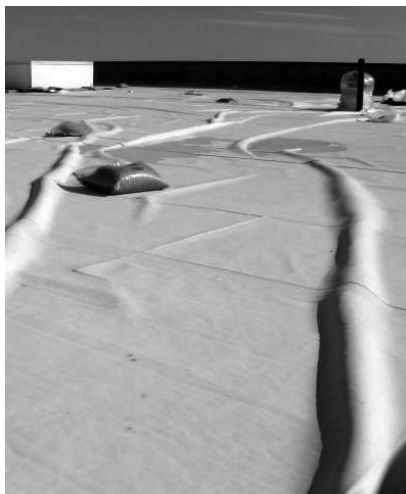
A Sandbags temporarily secure this roof membrane, which detached during a storm.

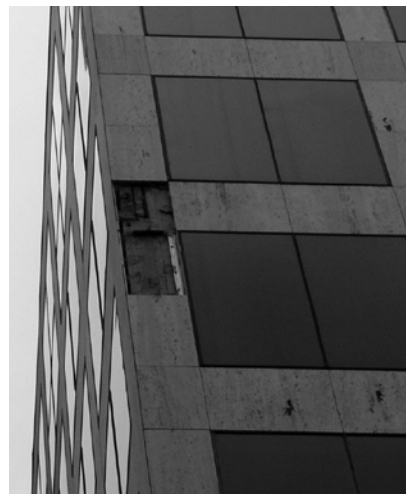
A Insufficient anchorage allowed this stone panel to blow off in a hurricane.

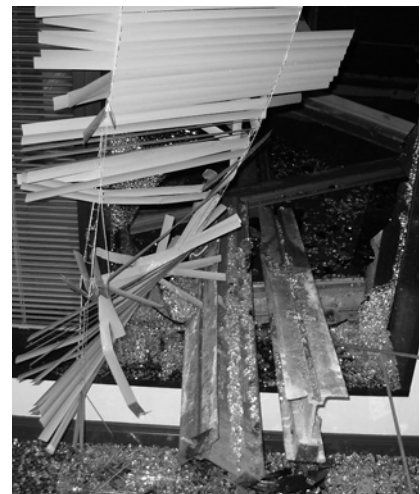
A In high winds, these steel beams became dangerous projectiles.

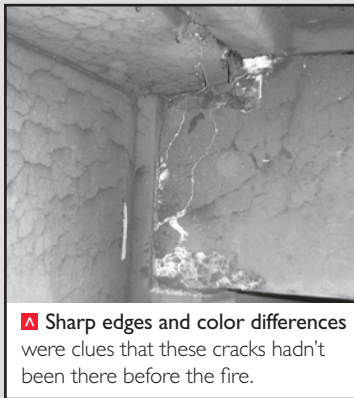
Cracks in the precast concrete structure were sufficient to compromise structural integrity. But were they new or old? Sharp edges, rather than rounded or weathered ones, were evidence that these cracks happened recently. Additionally, the color of the concrete

A Sharp edges and color differences were clues that these cracks hadn't been there before the fire.

inside the cracks differed from the color of the concrete surface, a sign that the cracks had not been open for long. Therefore, the project engineer concluded that the cracks were caused by the fire and could be legitimately included in the insurance claim.

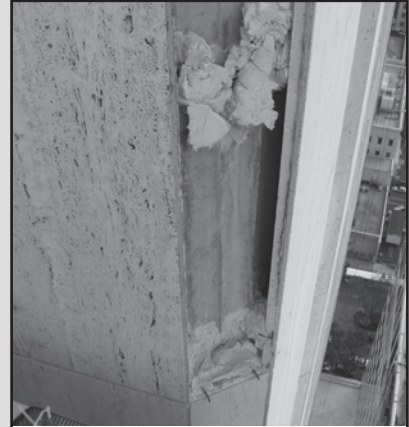
During Hurricane Katrina, a New Orleans high-rise suffered damage to the anchoring system that secures marble panel cladding to the concrete structure. Some panels were blown off entirely, while others sustained cracks, breaks, or dislodgement.

do current codes. Renovations to the building facade had been performed before the hurricane, which included field tests to determine the load capacity of the panel anchors. Despite the repair effort, the post-hurricane evaluation revealed that the majority of anchors did not

A Insufficient load capacity compromised the wind resistance of these panels, which otherwise might have remained intact.

meet current requirements for wind loading with an acceptable factor of safety. Although more stringent codes were adopted in the wake of Katrina, the investigation found that the designed anchorage of the panels not only failed to meet new requirements, it did not comply with the building code in effect at the time of the event.

To make this determination, the project engineer calculated wind loads to be resisted by the marble panels for various heights, building positions, and panel sizes. A sampling of 372 individual marble panels was also evaluated in place. Although the storm was violent enough to have caused pervasive damage, it turns out it wasn't entirely to blame for the extent of the destruction at the high-rise office tower. Had the renovation effort upgraded panel anchors to conform to wind load requirements, the panels would have stood a chance of weathering the storm.

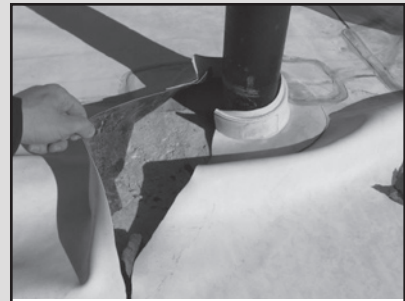
Even outside hurricane zones and tornado belts, weather forces can be strong enough to cause considerable damage to building envelope components. A case in point: at a university campus in the Northeast, sustained winds contributed to catastrophic failure of a building's roof system. During a major rainstorm, the corner of the single-ply ethylene propylene diene monomer / terpolymer (EPDM) membrane sustained a 20-foot tear. As the storm continued, separation proliferated to encompass nearly 100% of the roof area.

Why did the storm lead to such extensive roof failure? Weather history data indicated that wind speeds, while significant, were insufficient to cause a complete blow-off. Examination of the roof system revealed inadequate adhesion of roof assembly components, likely due to poor substrate preparation and inappropriate bonding compound selection. As the weather turned colder, weak adhesion permitted the membrane to pull away from the roof edge, leaving an air pocket. This partial delamination then facilitated further separation when wind gusts struck, with the membrane eventually catching the sharp edge of a fastening plate or termination bar. Bent plates and torn securement strips provided further evidence for this chain of events.

Once the membrane ripped, the path to complete roof failure was as swift as it was inevitable. Under optimum conditions, membrane separation might have been localized to the area around the tear. Here's where good

building practice makes the difference: failure to adequately anchor drains during installation allowed them to lift the membrane in several locations. Other poorly secured components opened additional voids, admitting still more air. As wind forced its way under the membrane, more of the membrane lifted. The result: what could have been an isolated problem became a near-total roof failure. ■

▲ Poor anchorage and weak membrane adhesion were signs that this roof failure could have been avoided.

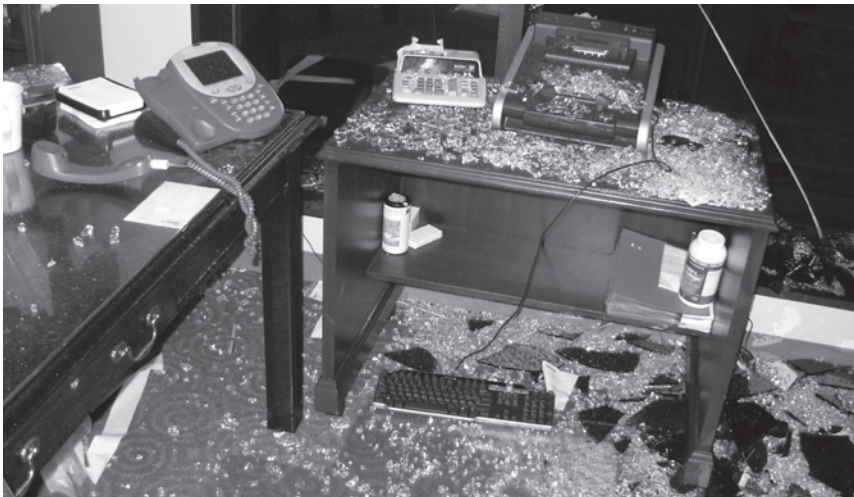
▲ Even a small breach in the building envelope can lead to serious devastation as tremendous wind pressures build inside the structure.
