**Hoffmann
Architects**

Journal

Thin Stone Marble Facade Systems

Juan Kuriyama, AIA and Stephanie L. Dillon, Assoc. AIA

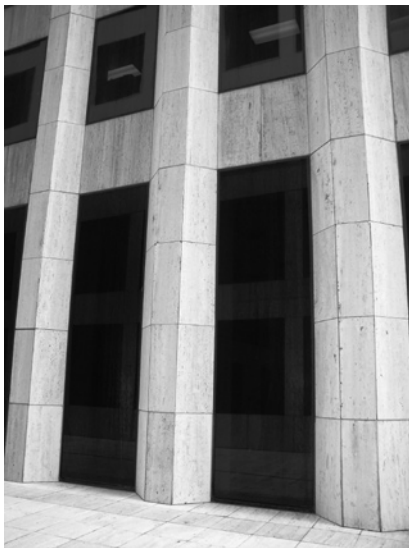
▲ New stone-cutting technology permits thinner marble panels—and brings new design challenges.

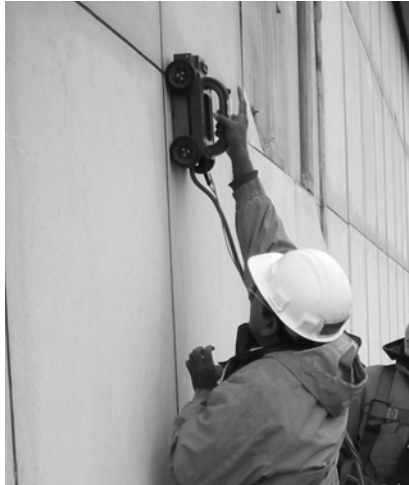
▲ Ground-Penetrating Radar (GPR) identifies anchor locations without removing panels.

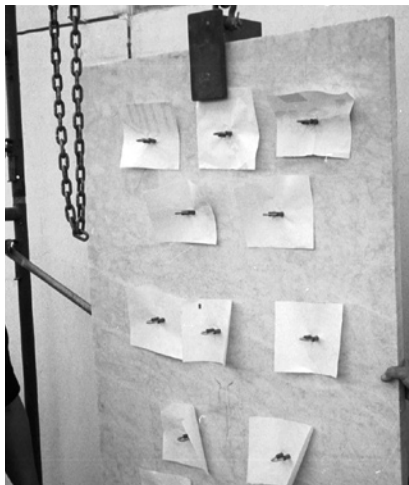
▲ Replacement panel mock-up to assess anchor geometry and installation protocol.

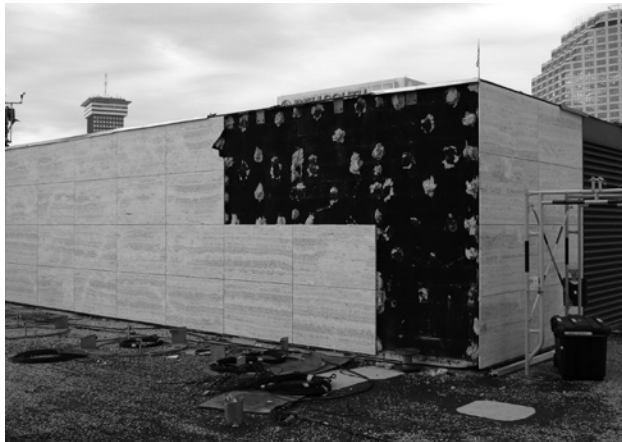
▲ Penthouse marble panel replacement in process.

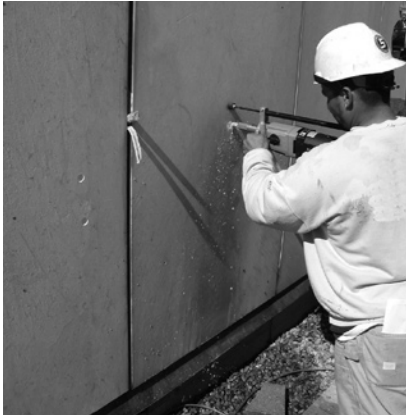
▲ Face-pinning is often used as a safety measure to prevent loose panels from falling.

Where wall cladding distress is observed, often in the form of cracks, displacement, bowing, or leaks, it is important to address conditions promptly. Emergency measures to prevent loose stone from falling, such as face-pinning of marble panels, may be necessary as a safety precaution. As research develops in the field of thin stone technology, new mechanical and chemical treatments are becoming available to address hysteresis and loss of flexural strength, as well as to promote resistance to moisture intrusion and environmental stressors.

Larger, continuous cracks should be evaluated on a case-by-case basis. Usually, face-pinning the stone and patching the crack is sufficient. However, multiple cracks on a single panel could be symptomatic of restraint and hysteresis stresses, which might require replacement of the panel and possibly the anchoring system.
