**Hoffmann
Architects**

Journal

Tips for Success with Exterior Insulation and Finish Systems

Arthur L. Sanders, AIA and Benjamin J. Robinson, Assoc. AIA

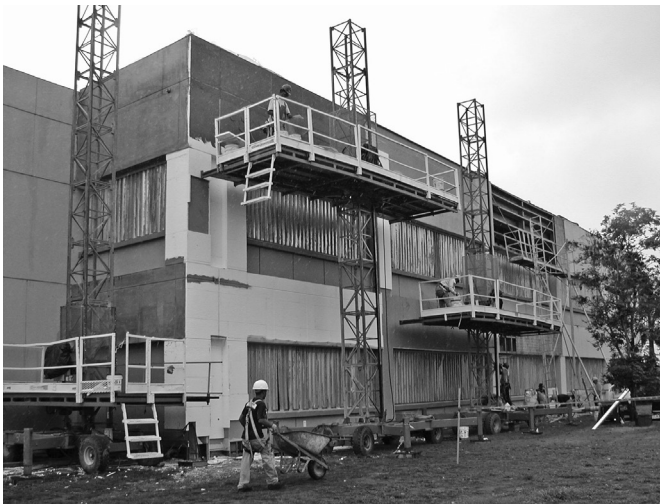
▲ For retrofit projects aiming to improve performance and update appearance, EIFS provides a practical option.

For retrofit projects aiming to improve performance and update the building appearance, EIFS can be a practical option. Lightweight and easy to install, EIFS is often selected for recladding of existing buildings, where it provides a quick, low-cost facade makeover that can also cut energy costs.

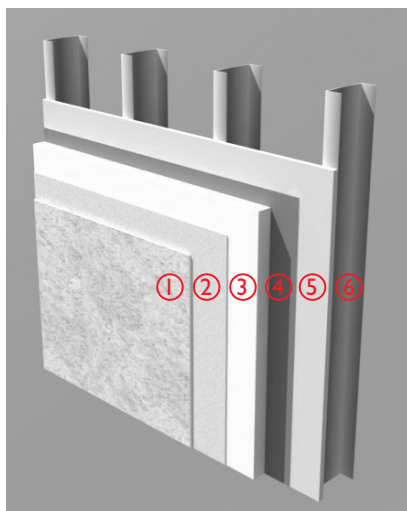
▲ EIFS components: (1) finish, (2) reinforcing mesh, (3) rigid foam, (4) adhesive, (5) substrate, and (6) steel stud.

EIFS is a multi-layer system that consists of six basic components:

- Substrate, usually exterior gypsum board, oriented strand board (OSB), or plywood;
- Membrane or rainscreen (some systems);
- Exterior insulation (adhesively or mechanically fastened);
- Base coat, consisting of proprietary acrylic copolymer dispersions and powder additives;
- Reinforcing glass fiber mesh; and
- Finish coat, or “lamina,” comprised of copolymer dispersions, colorants, and stabilizers.

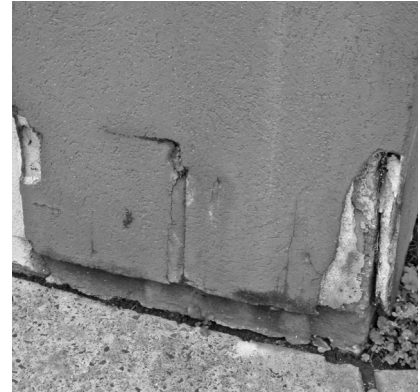
▲ Impact damage that is not repaired promptly provides a pathway for leaks.

EIFS consists of a thin, brittle coating over a soft substrate and is easily damaged by impact. Holes, dents, or scrapes can lead to water infiltration, so it's prudent to provide extra reinforcement at susceptible locations.

Areas needing impact protection should use heavy-duty mesh, usually 12 to 20 ounces, rather than standard 4.5-ounce mesh. For outside corners, the design professional may specify a heavier corner mesh to guard against excess wear and damage. Intricate decorative elements require a lightweight, flexible detail mesh, which conforms to fine contours and ornamental details while still providing some measure of impact protection.

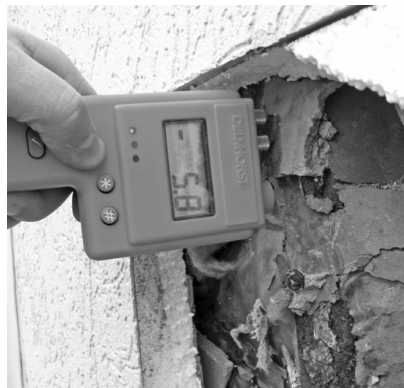
▲ Moisture meters may be used as part of an EIFS failure investigation.

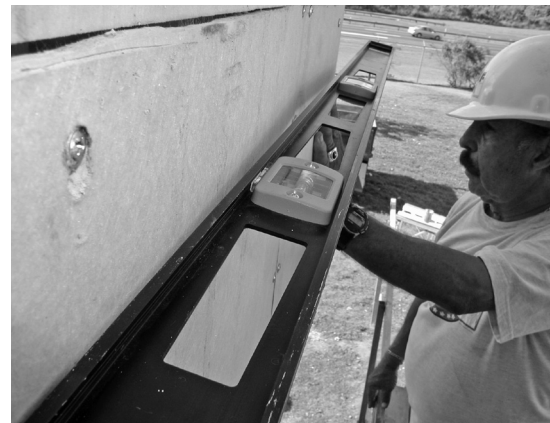
▲ To true the wall surface, the installer should level the insulation board, rather than build up base coat.

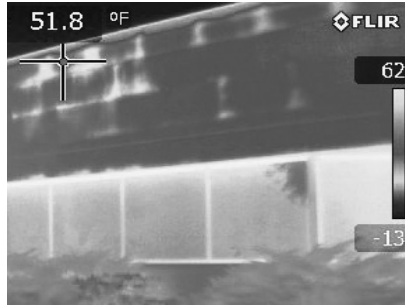
A This infrared thermographic scan reveals trapped moisture at insulation board joints.
