**Hoffmann
Architects**

Waterproofing Challenges

Richard P. Kadlubowski, AIA and Dean W. Yates, AIA

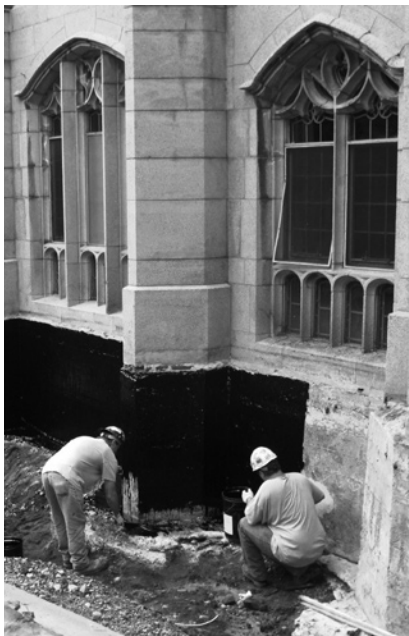
▲ Once below-grade waterproofing is buried, leaks due to faulty application can be difficult to resolve.

Cons. The shortcoming to positive side systems lies in leak detection and remediation. Blind side waterproofing cannot be inspected once the concrete is poured. Even for membranes installed after concrete is cast, it's too late to correct for sloppy installation once the waterproofing is buried. If the system fails, rehabilitation can involve major excavation and reconstruction of paving, landscaping, and wall systems.

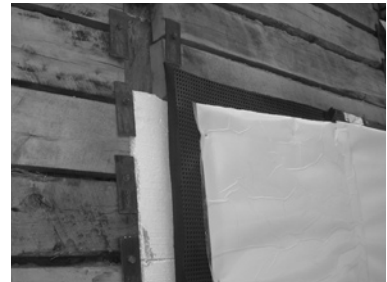
▲ Blind side waterproofing sheet with drainage composite, installed prior to concrete.

For below-grade applications, the earth can be banked back such that a positive side membrane is installed after the foundation is set. In urban areas where every square inch comes at a premium, this may not be an option. Blind side waterproofing incorporates the waterproof membrane on the face of the shoring before the foundation is cast. Concrete is then poured, and the waterproofing fuses to the foundation wall as it cures.

Blind side waterproofing: Installation of waterproofing membranes and drainage before the concrete foundation is poured.

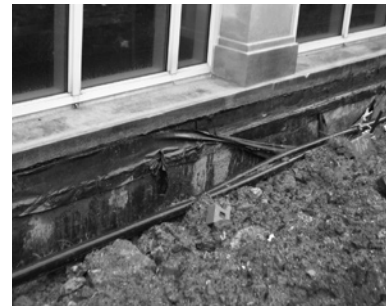
▲ Positive side waterproofing defects, viewed during repair excavation.

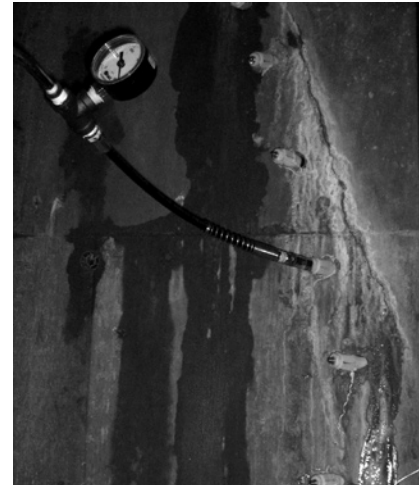
A Negative side waterproofing injection via ports along a foundation wall crack. Gauge monitors pressure of injected resin.

Injections at interior surfaces. Resolving cracks through injection with epoxy, hydrophobic or hydrophilic resins can be an economical way to solve minor waterproofing problems without excavation and reconstruction. The danger, though, is that this approach can be a shot in the dark, as it is nearly impossible to know what conditions are on the other side of the wall without seeing firsthand.

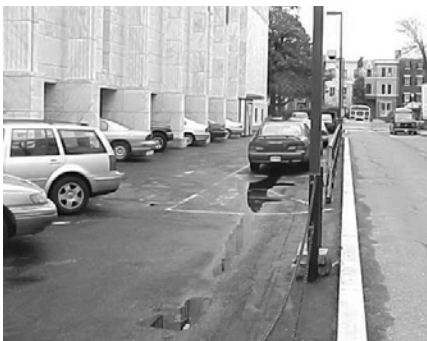
BELOW-GRADE VAULT WATERPROOFING: FOLGER SHAKESPEARE LIBRARY

▲ Below-grade vault is under parking deck.

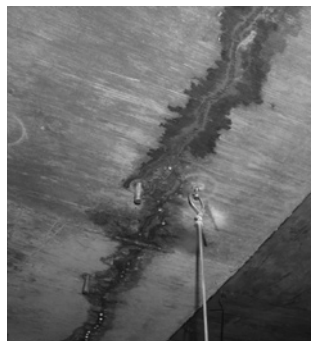
▲ Leaks at underside of deck.

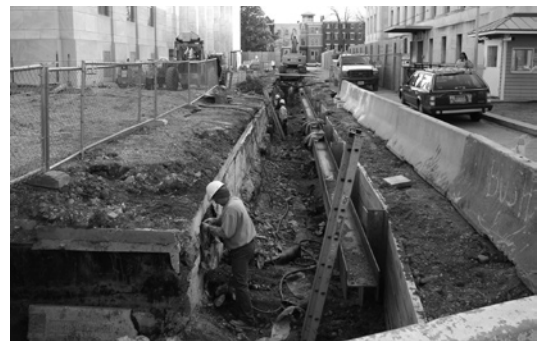
▲ Excavation to expose vault and deficient waterproofing.

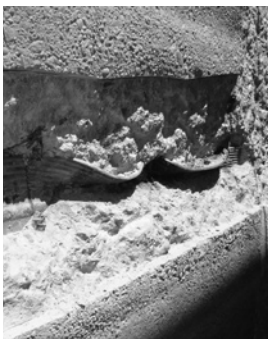
▲ Bent water stop in vault wall.

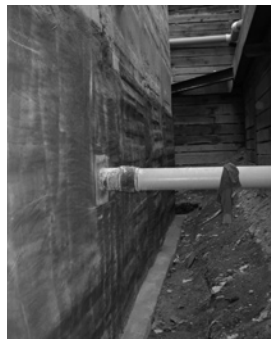
▲ Spray-applied liquid waterproofing.

- *Fluid applied membranes*, similar to those used in roofing applications, roll or brush on as a liquid and cure to form a monolithic, seamless membrane.
- *Sheet systems* are also similar to those used on roofs, including single-ply thermoplastics and rubberized asphalts.
- *Hybrid systems* combine a fluid-applied membrane with embedded fabric reinforcing to create a

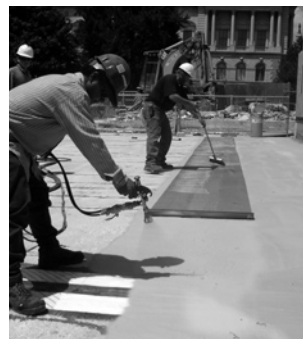
▲ Application of deck waterproofing with reinforcing fabric.

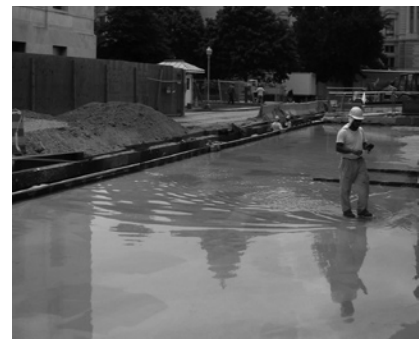
▲ Flood test of waterproofing on rehabilitated deck.

Non-destructive testing. Flood tests saturate an area, such as the backfill at a foundation wall, to generate conditions conducive to moisture penetration. Waterproofing failures can then be noted and addressed. Additives,

such as dyes or scents, incorporated into the flood test water can help identify leaks that are otherwise difficult to detect.

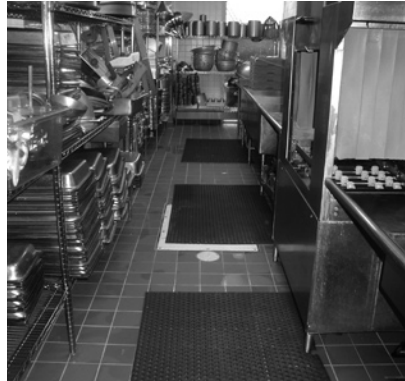
▲ Dishwashers and other kitchen equipment introduce a high-volume water source with a high potential for leaks.

Where numerous penetrations, complex plumbing systems, liquid storage units, and heavy traffic combine, waterproofing distress is hard to avoid. Pumps, dishwashers, and tanks add a high-volume water source to a space—and a high potential for leaks. From the brewing room at an entertainment complex to the lobby of an urban hotel, water infiltration at essential operational facilities is as logistically difficult to resolve as it is challenging to diagnose. Such functional spaces cannot be closed down for weeks at a time while waterproofing remediation proceeds. Thoughtful phasing is needed to take advantage of usage downtimes and to permit continuous operation during critical periods.

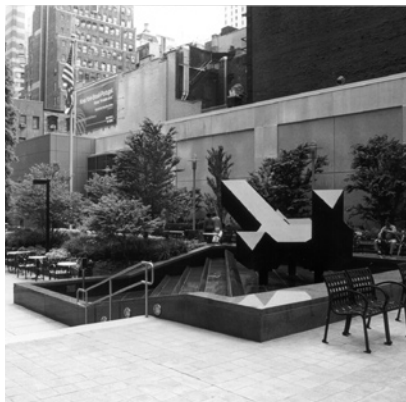
▲ Fountains demand extra attention to waterproofing detail, especially when over occupied space.

If a fountain sits above occupied space, even a small leak may be immediately noticeable as damage to interior fittings or finishes. For water features on grade, however, the only sign of trouble may be an uptick in the volume of make-up water added to keep the water level consistent. Pools and fountains are closed systems, so water loss should be minimal. If you're

adding far more water than would be necessary due to evaporation, you may have a leak.

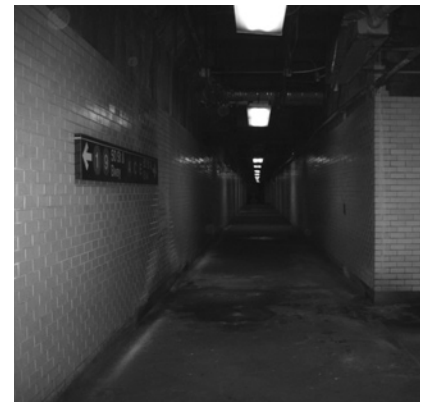
▲ Pedestrian tunnels offer convenient access, but their location under busy areas makes waterproofing particularly challenging.

Where high basements or tunnels penetrate foundation walls, water entry is a common problem. If the floor of a tunnel is a slab-on-grade, where the concrete rests directly on the ground, and the foundation wall extends below this slab at the intersection, water will follow its natural

tendency and run downhill, into the deeper below-grade space. Transitions such as these demand extra attention to detailing and construction sequencing to prevent failures.

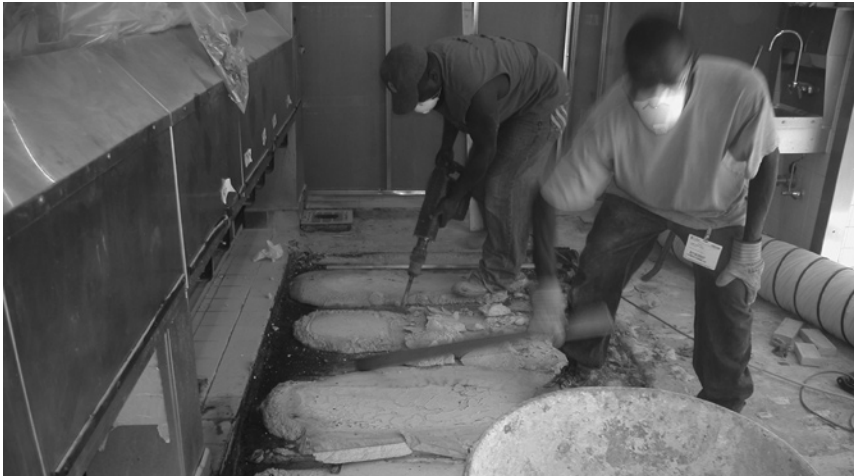
▲ Suspending kitchen operation for waterproofing rehabilitation is hardly desirable. But if leaks are ignored, water damage to structural systems and finishes will only make things worse.
