# Journal

## What's Wrong with My Precast Concrete Parking Garage?

Steven J. Susca, PE and Robert A. Marsoli, Jr.

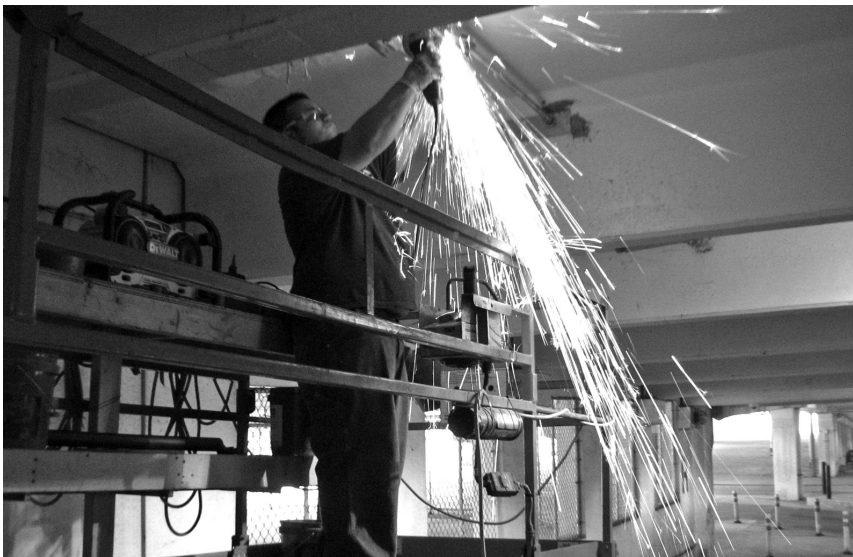
▲ Trimming a chord connection rod as part of a precast concrete garage rehabilitation.
