# Journal

## What Went Wrong?

### Diagnosing Building Envelope Distress

John J. Hoffmann, FAIA and Deborah J. Costantini, AIA

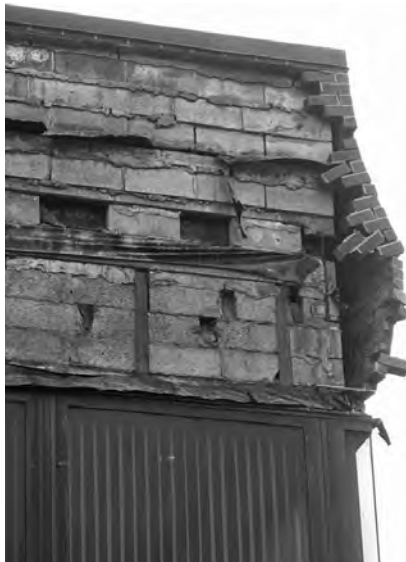
▲ Unless the problem is correctly diagnosed and repaired, it will continue to worsen, sometimes to the point of major failure.
