REVIEW OF FATIGUE FAILURE STUDIES FOR WELDED PRECAST DOUBLE-TEE CONNECTIONS: NEW DATA VALIDATES SAFETY CONCERNS

Lawrence E. Keenan, AIA PE, Hoffmann Architects + Engineers, New Haven,
Connecticut

ABSTRACT

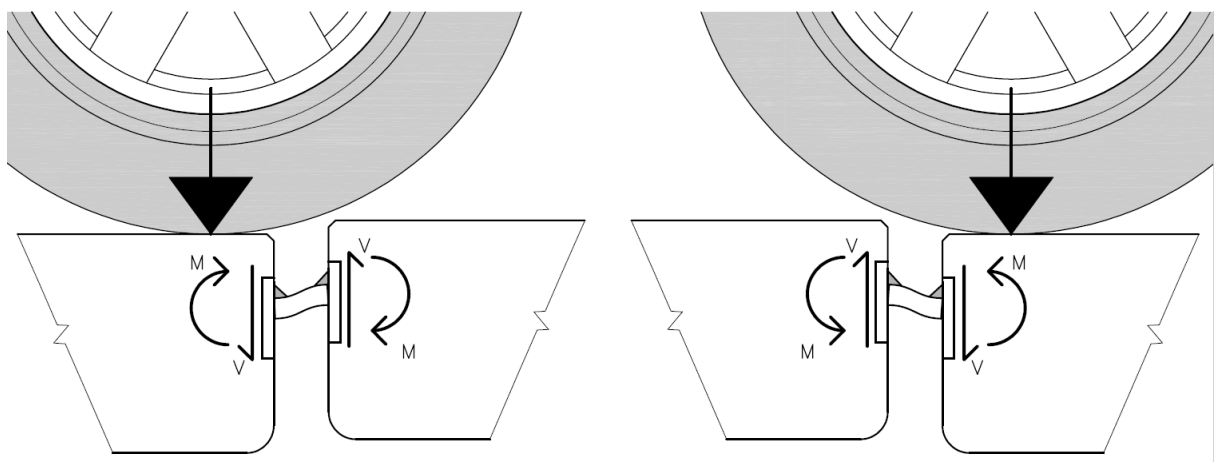
The force transmitted across each connection is resisted by the field-installed erection bar which is welded to connection anchors embedded within each flange. As these anchors are separated by the width of the erection bar, moment is created. This moment is applied to each weld about an axis parallel to the joint, creating a concentration of tensile stress at the root of the weld, followed immediately by compression stress as the wheel traverses the joint (Figure 1). With enough cycles, this stress reversal can lead to *high-cycle fatigue failure* of the weld.

Figure 1 Exaggerated depiction of beam deflection at flange joint connection.

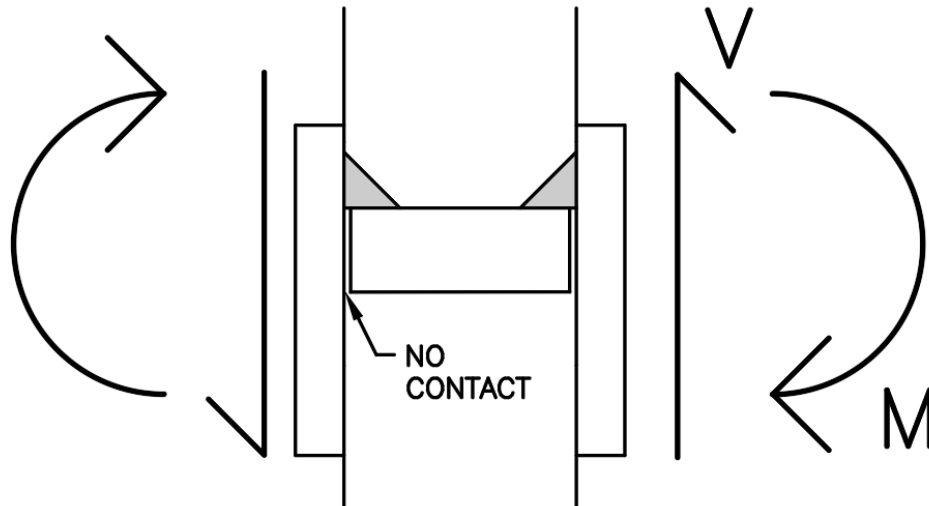
To demonstrate the fatigue design process, the Keenan Paper analyzed a typical garage connection under anticipated loading. The connection model assumed a 1" wide field erection bar welded to embedments with a ¼" fillet weld, 3" long. The embedments were assumed fixed such that the shear and moment remained constant along the length of the weld (Figure 4).

Figure 4 Connection model assumes fixed embedments within the concrete flanges such that stress along the length of the welds is constant.

This design exercise revealed the stress range in the weld due to bending to be approximately 11 ksi. For comparison purposes, this is far greater than the *Fatigue Threshold* (F_{TH}) of 8 ksi that would apply to a Stress Category F fillet weld loaded in an acceptable manner.²⁷ As the fatigue threshold for the connection model would be less than that of a Category F detail, the connection was deemed unsuitable.

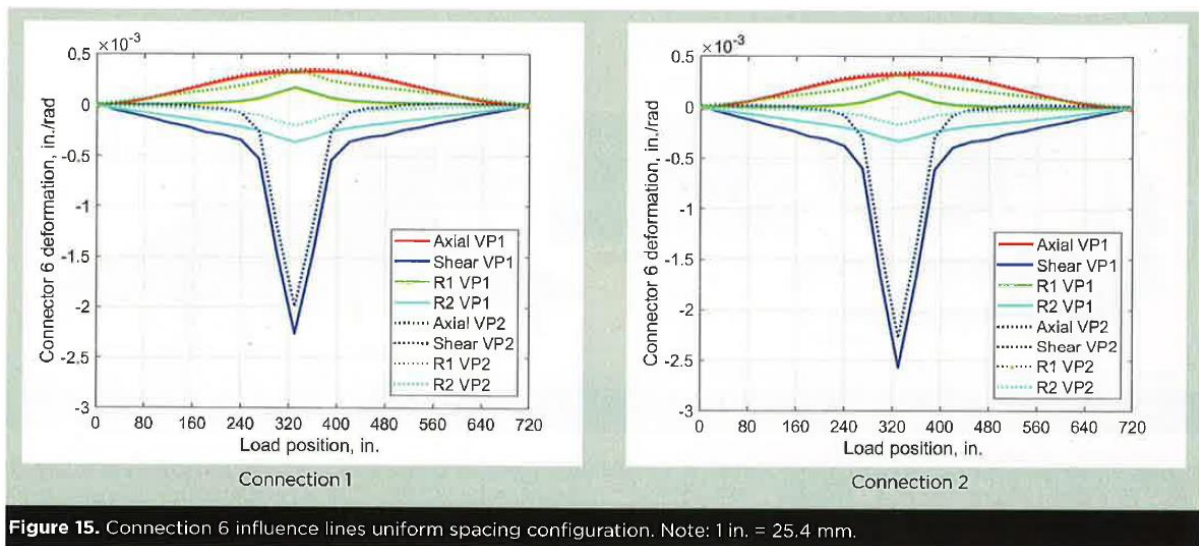
More important than vehicle weight is its placement. Load testing performed by the Task Group revealed connections located near midspan are subjected to the highest strains from, and thus are most sensitive to, applied load.⁴⁹ Further, influence lines calculated and graphed by the Task Group (Figure 6) reveal the magnitude of shear load transferred across a single connection is highly sensitive to placement of the load, with applied shear across a connection diminishing greatly within relatively little distance from the applied load.

Figure 6 “Flange-to-flange double-tee connections subjected to vehicular loading part 2: Fatigue life assessment” Figure 15⁵⁰; influence lines for connection near mid span on double-tee beam.

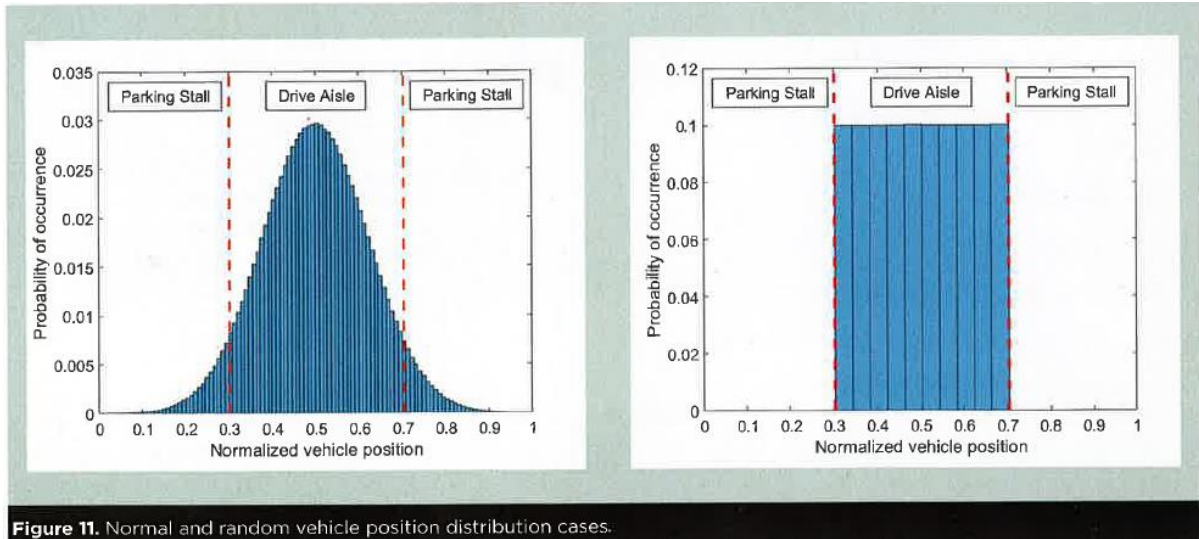
To calculate the fatigue loading, the Task Group assumed vehicles would traverse the deck in accordance with “two common scenarios”: a normal distribution or a uniform distribution (Figure 7). For the normal distribution, a standard deviation of 86 in. was used, encompassing 90 percent of the vehicles within the 24 ft. drive aisle. For the uniform distribution, the center of vehicles was assumed to occur evenly at all locations within the 24 ft. drive aisle.⁵¹

Figure 7 “Flange-to-flange double-tee connections subjected to vehicular loading part 2: Fatigue life assessment” Figure 11⁵².

Close review of these loading conditions reveals peculiarities. In the normal distribution, 10 percent of the vehicles are assumed to drive through the parking stalls. While it is debatable that these areas would be traversed routinely if empty, the fact that a single parked car would render such an occurrence impossible is incontrovertible. Further, in most garages, the parking stalls are also the location of immovable K-frames and shear walls. Therefore, assuming one out of 10 cars traverses these areas is not a conservative or realistic assumption; the true number would be negligible. Should a normal distribution be assumed, the outer limits should be defined by the edges of the drive lane, such that 100 percent of vehicles are within the drive aisle. This would necessarily indicate a concentration of traffic at the center of the aisle.

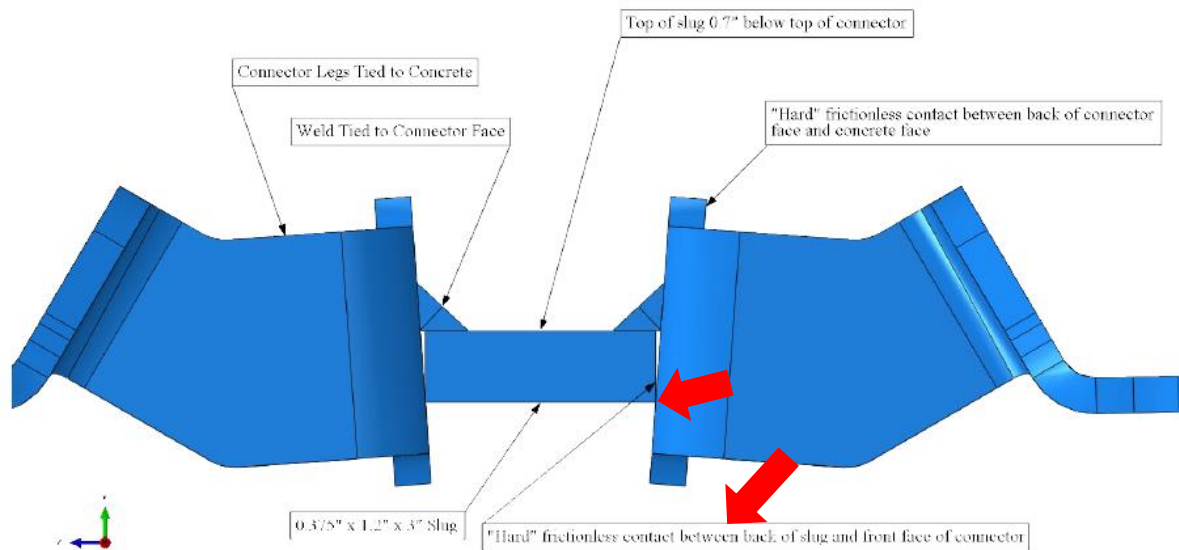
The connection model used by the Task Group is shown in Figure 8. This model assumes common manufactured connection embedments joined with a 3/8" erection bar and 1/4" fillet welds, 2 1/2" long. Importantly, the model assumes "hard" frictionless contact" between the bottom of the erection bar and the face of the embedded connector. The Task Group Study neglects to explain how this hard contact is to be consistently achieved or verified in the field. Further, the study does not discuss whether this condition has been witnessed or is achievable in practice. As the Keenan Paper explores the possibility of such hard contact extensively and concludes that it is not attainable, overlooking these concerns is a grave omission by the Task Group.

Figure 8 "Double Tee Flange Connections – Analytical Evaluation" Figure 39⁵⁵; Note "hard" frictionless contact" where bottom of erection bar meets connector face (arrows).

If hard contact is assumed, as shown in Figure 8, the stress in the weld is greatly reduced. At the side where the hard contact is in compression, a couple is created between the weld and the point of contact, greatly reducing stress in the weld and transforming it primarily from moment about the weld axis to tension between the erection bar and faceplate. The reduction in stress this creates is estimated by the Task Group to be as much as 75 percent⁵⁶. Further, the nature of the stress is changed, as much of the moment about the weld axis is transformed into a

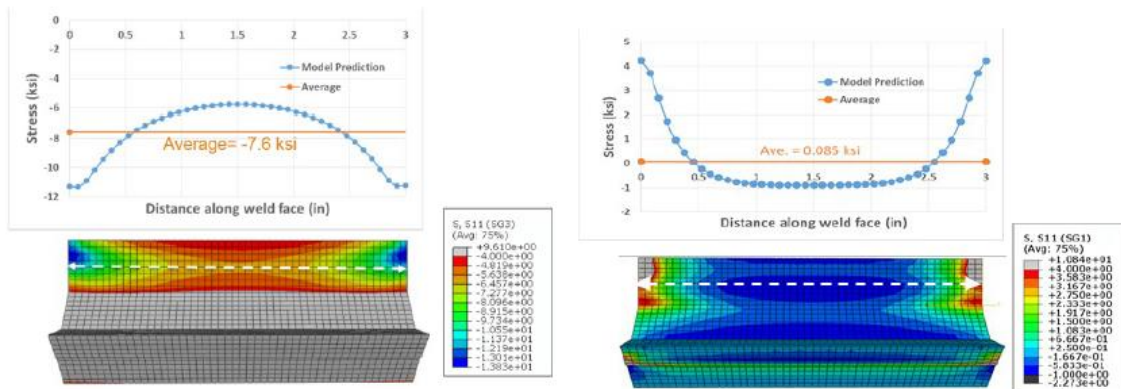
This condition is graphically represented in a figure provided by the task group (Figure 9). The figure and associated graphs illustrate the stresses in the welds under reverse loading conditions. The stress is provided both as actual calculated values along the weld, with stress elevated at the ends of the weld, and as an average value. If there were no hard contact of the erections bar, such that the moment was entirely resisted through bending stress in the welds, the graphs would indicate average stress levels to be roughly equal but opposite for the reverse loading conditions. However, the graph indicates a dramatic shift in stress levels during reverse loading, with an average of -7.6 ksi and 0.085 ksi for these opposing conditions.

Figure 9 “Double Tee Flange Connections – Analytical Evaluation” Figure 30.⁵⁷

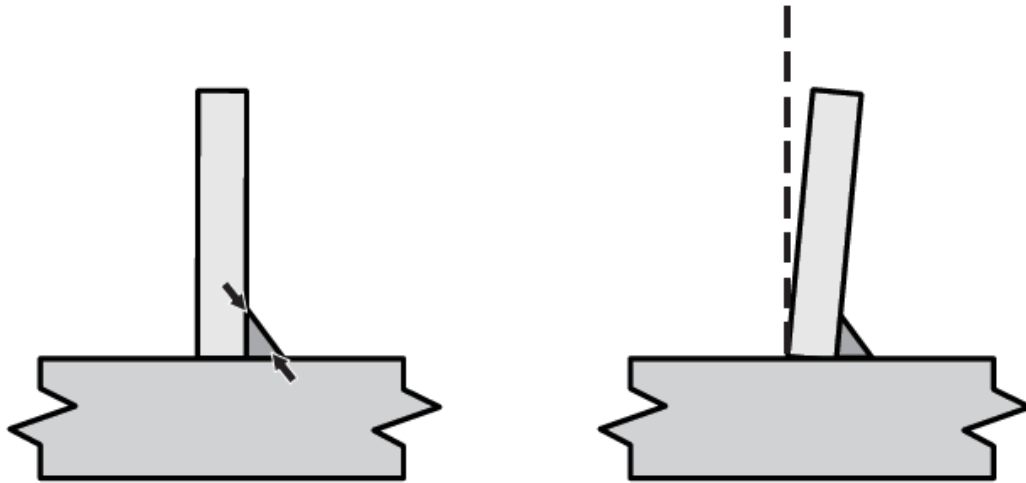
More importantly, the act of welding itself necessarily causes such a gap to occur. As the weld metal cools, transverse shrinkage of the weld pulls the members to the weld. This well-documented phenomenon, termed *angular distortion* (Figure 11),⁶¹ creates a root opening on the side of the erection bar first welded and lifts the other side of the erection bar off the opposing embedment. The distortion effect is greatly exaggerated by the relatively thin ribbon of steel from which the embedments are fabricated. Such deformation is further exacerbated by the 50 percent higher coefficient of thermal expansion of stainless steel over mild steel, making it highly susceptible to warping when welded. This angular distortion commonly creates a visible separation between the erection bar and the embedment into which at least a business card can be inserted (Photo 4).

Figure 11 Angular Distortion (Figure 6-3, AISC Design Guide 21)⁶²

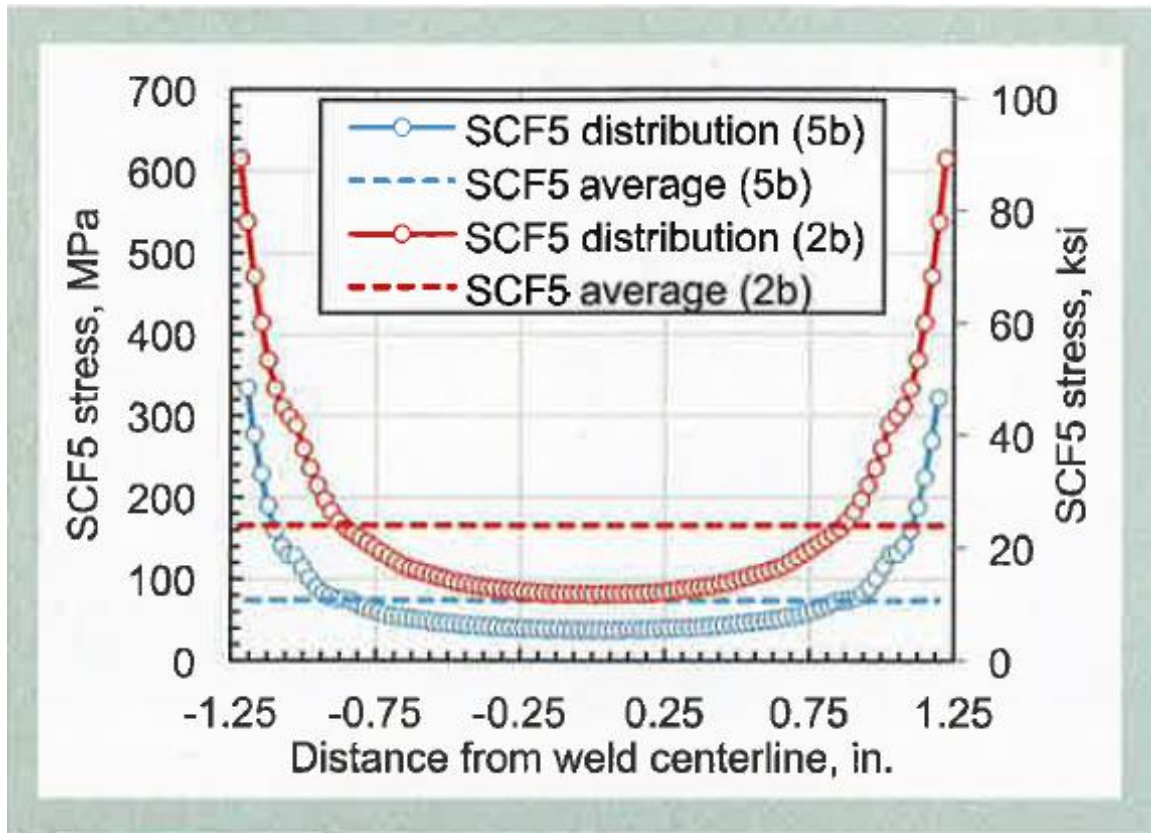
The typical stress along the length of the weld, as calculated by the Task Group, is depicted in Figure 13, which shows both calculated stress along the length of the weld and the average stress.⁶⁸ It is apparent from this graph that the anchorage of the common flexible connection to the concrete beyond either end of the welds causes stress to be concentrated at the weld ends. This was confirmed by the Task Group, which concluded that the "...stress varies along the length of the weld due to the flexibility of the faceplate."⁶⁹

Figure 13 “Flange-to-flange double-tee connections subjected to vehicular loading part 2: Fatigue life assessment” Figure 6⁷⁰.

Nonetheless, the increase in stress at the ends of the weld was not considered by the PCI Task Group for design purposes, despite their determination through fatigue testing that “...*the fatigue failure surfaces started at the ends of the weld and propagated toward the middle. The failure surface was also greater at the ends and smaller at the middle of the weld due to the elevated stress generated from the flexibility of the faceplate.*”⁷¹ The final calculations for fatigue, which resulted in a predicted 50+ year design life, did not use the *maximum* stress calculated but rather were performed using the much lower *average* calculated root stress along the weld.⁷²

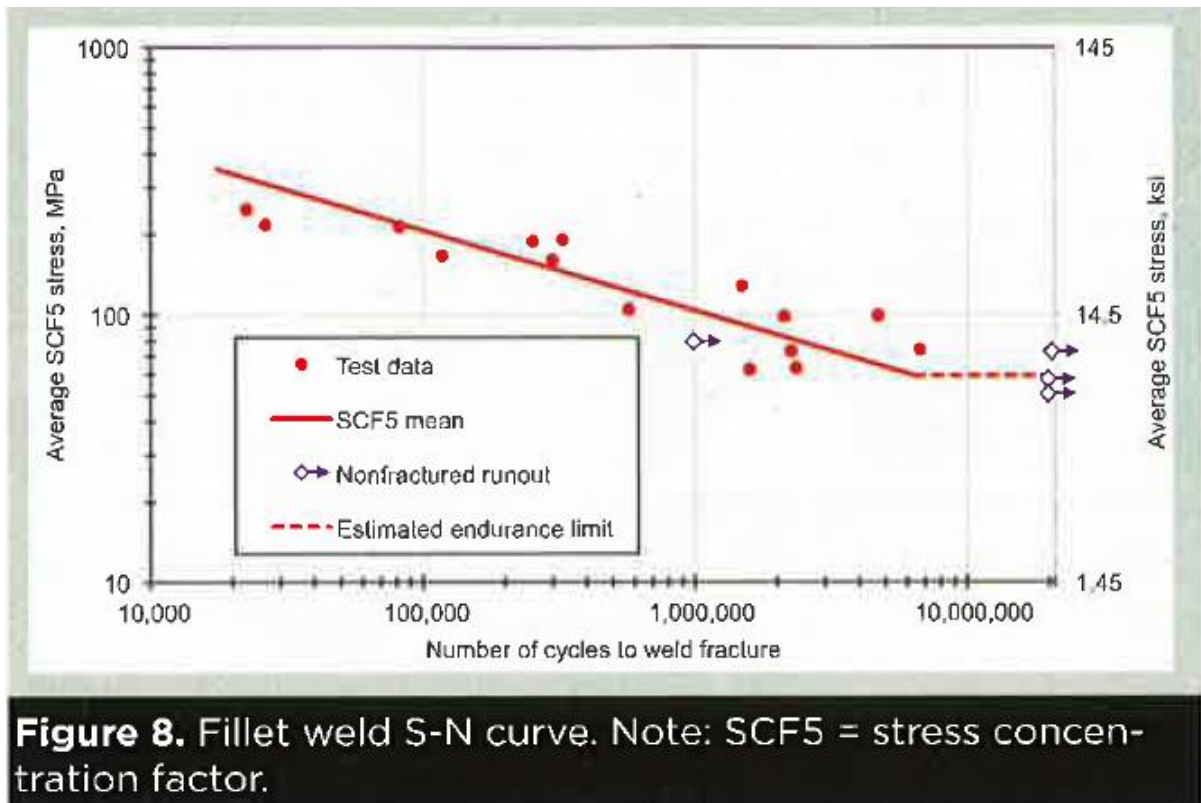
Figure 14 “Flange-to-flange double-tee connections subjected to vehicular loading part 2: Fatigue life assessment” Figure 8⁷⁴.

Upon cursory examination, it would appear that the endurance limit (fatigue threshold) for these specimens, loaded in a manner that stresses the root of the weld in tension, was determined to be 8.6 ksi,⁷⁵ which exceeds that of an AISC/AWS Category F fillet weld utilized as commonly intended (8 ksi). However, close review of these results reveals that the Task Groups S-N curve is expressed in *mean/average* stress range at failure, while the industry standards are expressed in *allowable* stress range for design purposes. An inquiry to the Chairman of the AWS Welding Code provided insight as to how a factor of safety was incorporated into the AISC/AWS S-N Curve: “The data contained in the chart started as experimental results with experimental variations. The mean was reduced two sigma, so 97.7% of the experimental data lies above the design curve.”⁷⁶ No such allowance for safety has been

In utilizing an S-N curve based upon the average stress range at failure, the Task Group did not establish a 50+ year design life, but rather predicted the life expectancy by which half of the welds would fail. With two welds per connection, failure of only one weld is required for failure of the connection as a whole. Further, failure of a single connection would cause failure of additional connections along the same line through stress redistribution. A garage designed under such parameters would completely fail well before the stated 50+ year life expectancy.
