Journal of architectural
technology published by
Hoffmann Architects, Inc.,
specialists in the rehabilitation
of building exteriors.

Caring for Glazed Architectural Terra Cotta

Arthur L. Sanders, AIA and Kara L. Shypula, Assoc. AIA

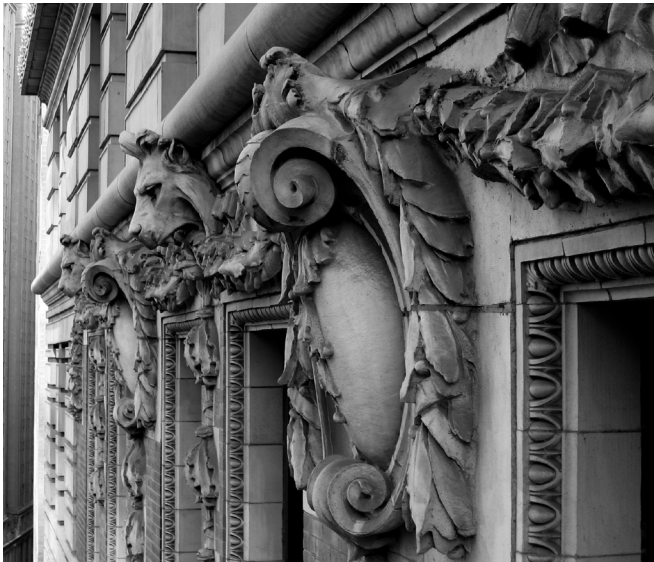
▲ Often finished in imitation of stone, terra cotta can be difficult to recognize and may be mistaken for cast stone, concrete, stone, or brick.

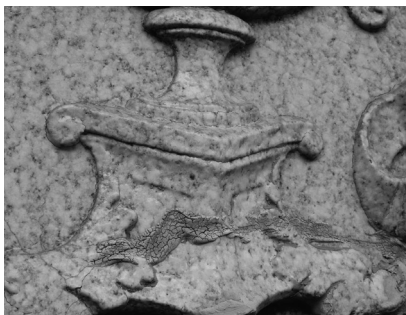
▲ Failed prior repair effort.

Many repairs fail prematurely because they do not address the root cause of distress or failure. Often, repair

materials are not durable and are incompatible with the existing terra cotta, creating a poor visual match and a short-term fix, at best. Where repairs fail, they tend to make deterioration worse.

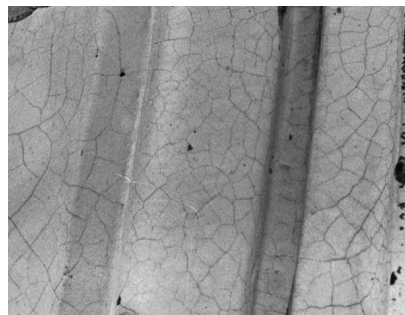
▲ Crazed glazing.

Cyclic wetting/drying and freezing/thawing can lead to glaze deterioration, cracks and spalls in the body of the terra cotta, and fracturing and displacement of the units. *Crazing*, the formation of small random cracks in the glaze, occurs when the terra cotta unit absorbs moisture from the air and expands over many years. When new terra cotta is removed from the kiln, firing has shrunk it to its smallest size; over time, the porous clay grows, and the glaze goes into tension. Once the strength of the glaze has been exceeded, it cracks and shatters, increasing the water absorption of the terra cotta unit and exacerbating water infiltration in a self-perpetuating cycle.

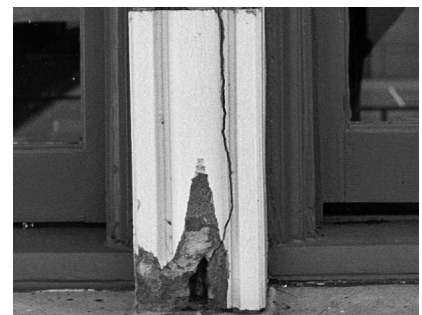
▲ Crack and spall caused by corroded steel.

As water penetrates, it comes in contact with embedded steel anchors and reinforcement. In historic applications, steel was often untreated, making it particularly susceptible to corrosion. As it corrodes, the steel expands, exerting pressure on the surrounding terra cotta and causing cracking and displacement. Embedded steel corrosion may be caused by unmaintained roof drainage systems, which admit water into the cladding assembly.

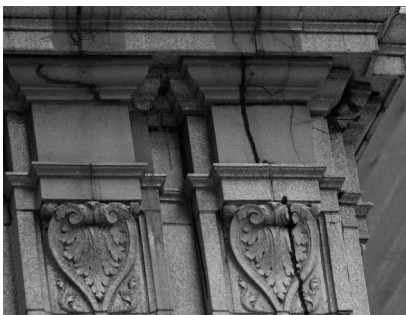
▲ Cracking at building corners.

Most high-rise buildings from the early 1900s had little or no provisions for movement, so unaccommodated thermal expansion and contraction, along with building-frame shortening under load, placed sufficient strain on building materials to cause displacement and cracking. Without proper expansion joints, buildings create their own, in the form of long cracks that admit significant water infiltration and invite further problems.

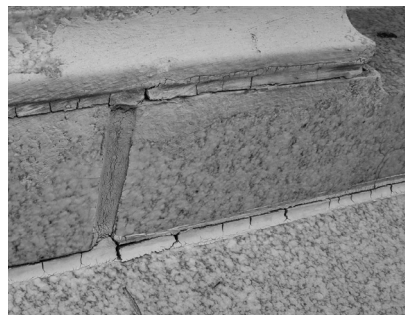
▲ Joint deterioration.

Maintaining mortar joints is very important to the lifespan of the terra cotta. Periodic repointing prevents water entry and inhibits deterioration. It's important to use a mortar with a compressive strength that is lower than that of the adjacent terra cotta, since a hard mortar may prevent the outward migration of water and may cause point loading. Never repoint with sealant, as it impedes moisture movement. Use sealant selectively, such as at joints in horizontal surfaces of copings and sills.

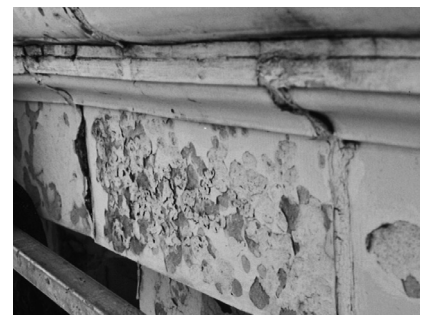
▲ Blistering coating.

For spalled glazing, coat or seal blistered areas to prevent water infiltration, using color-matched products. At lower stories where visual integrity is critical, the unit may need to be

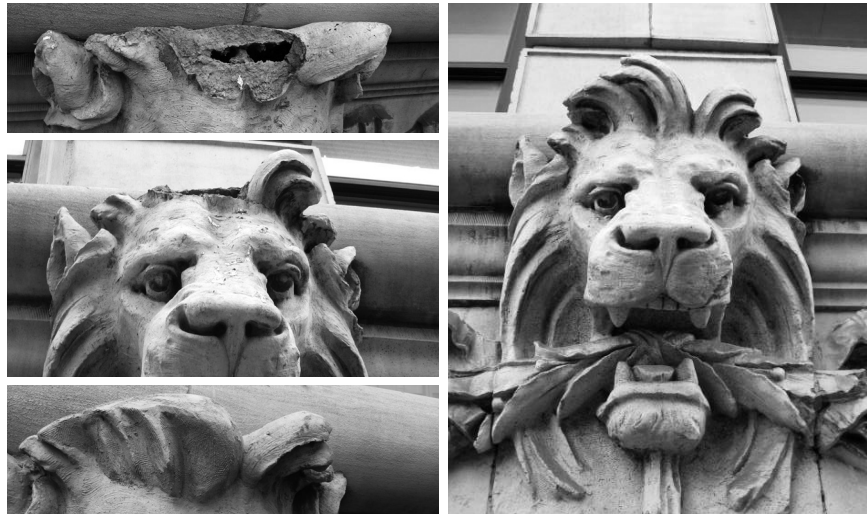
▲ Restoration of spalled terra cotta decorative element.

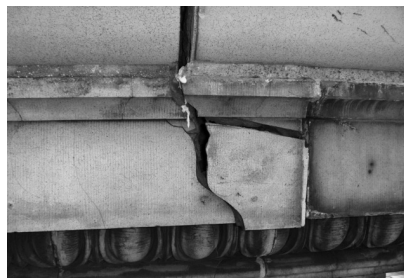
▲ Untreated deterioration can result in hazardous conditions.

Where deterioration is so severe that pieces may fall from the building, temporary stabilization or replacement may be necessary to protect public

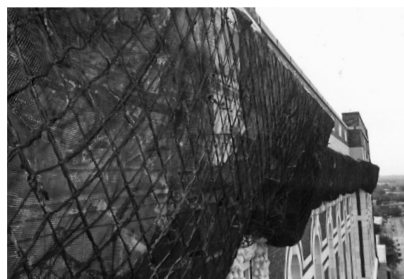
▲ Until permanent repairs are made, netting may be used to secure unstable terra cotta.
