Remedial Sealant Application

by Karen L. Warseck

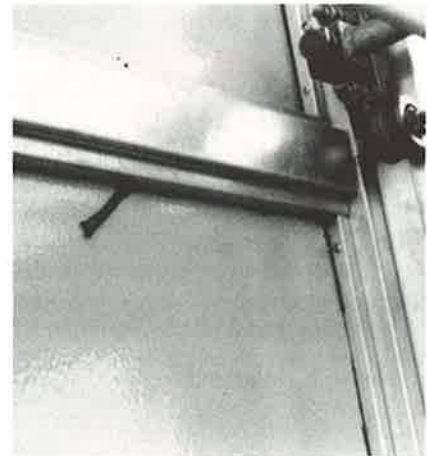
failed sealant in aluminum curtain wall

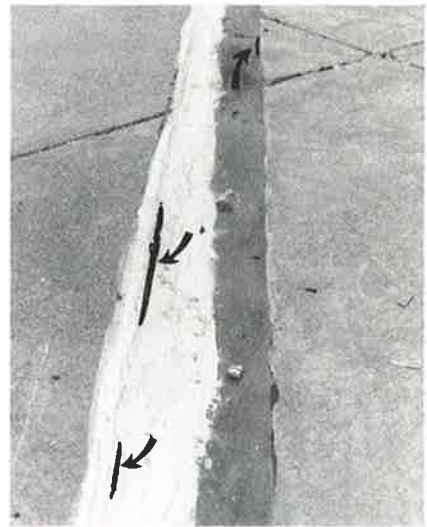
adhesive failure

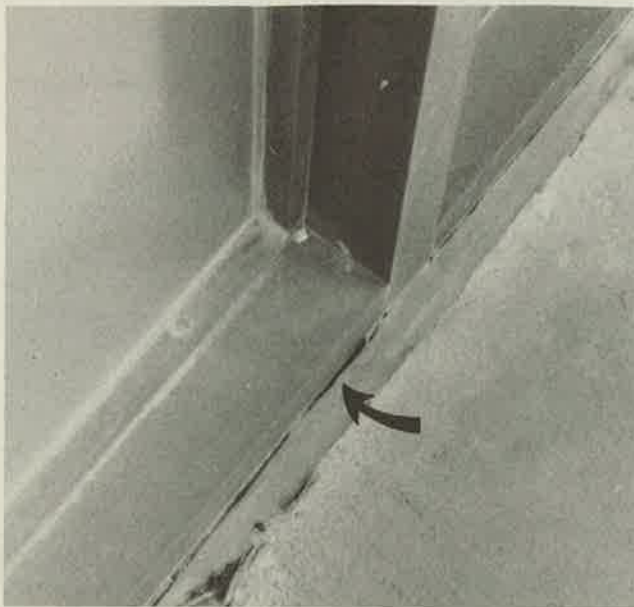
Adhesive Failure – Loss of bond between sealant and substrate where sealant itself remains intact.

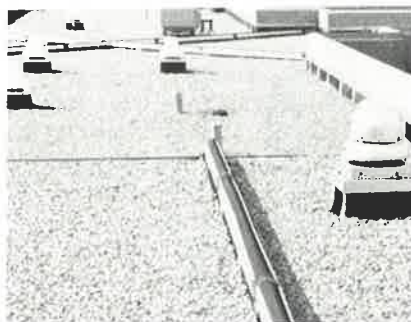
ballasted roof

With the interlocking, lightweight concrete pavers, however, no movement appeared during the tests at the maximum wind speed of 125 mph. That lack of movement is expected to be a major consideration in ballasted roofing system design in areas where high winds are common.
