One of the most prevalent materials found on historic buildings, glazed architectural terra cotta was popularized in the late nineteenth century as a versatile, lightweight, economical, and adaptable alternative to stone. Through the 1930s, the sculptural properties of terra cotta gave rise to diverse architectural styles, including the Chicago School, High Rise, and Beaux Arts styles.

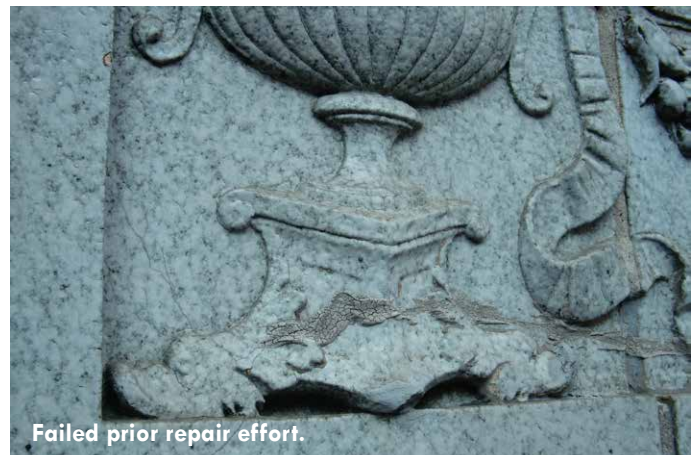
Failed prior repair effort.

Many repairs fail prematurely because they do not address the root cause of distress or failure. Often, repair materials are not durable and are incompatible with the existing terra cotta, creating a poor visual match and a short-term fix, at best. Where repairs fail, they tend to make deterioration worse.

Poor detailing, including failure to properly anchor the patch to the backup, leads to failure of not only the repair area, but also the surrounding terra cotta. For example, replacement brick and cement stucco are neither watertight nor flexible enough to accommodate movement, so they tend to pull free or crack and spall. Surface-applied sealants are likewise not watertight, and bituminous patches are ineffective and aesthetically unsuited to terra cotta repair. In an effort to keep out water, non-breathable coatings are sometimes applied; these have the effect of trapping water inside the terra cotta, particularly if the source of water entry has not been addressed.

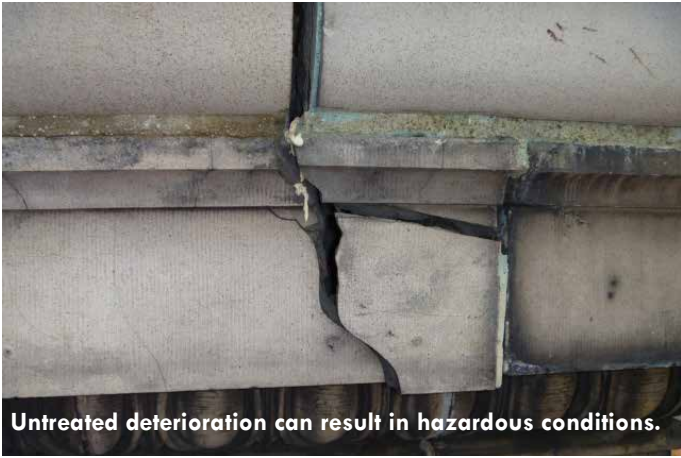
Untreated deterioration can result in hazardous conditions.

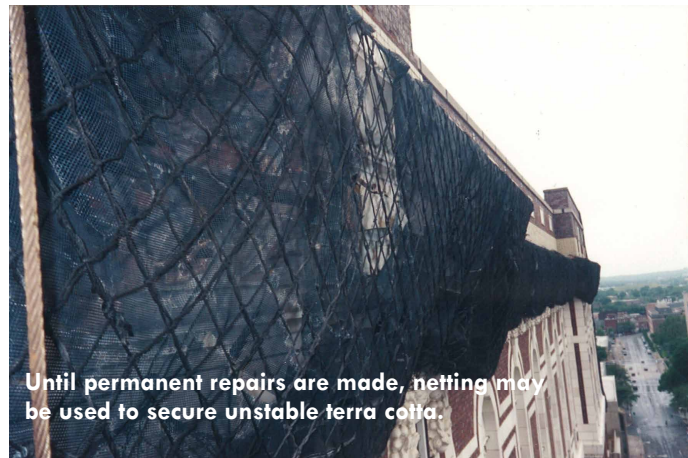
Until permanent repairs are made, netting may be used to secure unstable terra cotta.

Where deterioration is so severe that pieces may fall from the building, temporary stabilization or replacement may be necessary to protect public safety. Particularly in urban areas or locations with high seismic activity, code compliance—and civic responsibility—dictate the immediate securing of identified hazards. Until a permanent solution can be implemented, nylon netting and metal strapping are commonly used to secure unstable pieces.
