**Hoffmann  
Architects**

# Journal

## Care and Preservation of Slate Roofs

Deborah J. Costantini, AIA and Benjamin J. Robinson, Assoc. AIA

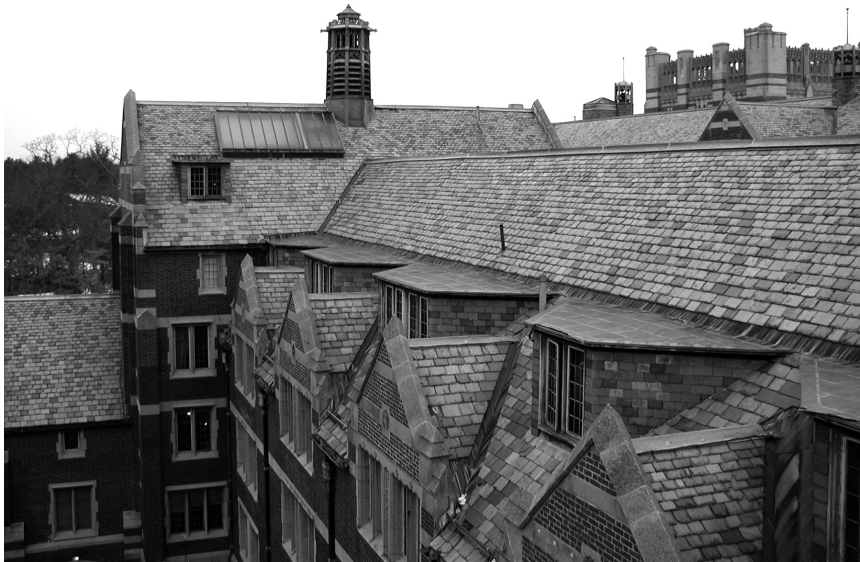
**A** With regular maintenance and appropriate, periodic repairs, a well-designed slate roof can last upwards of a century.

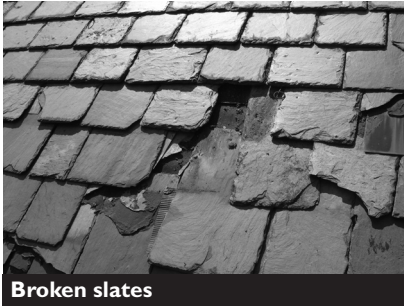
**Broken slates**

- **Slate.** Document cracked, broken, misaligned, delaminated, or missing slates. "Sounding" a slate by tapping it with knuckles or a slating hammer can help determine its integrity; a dull thud can indicate poor condition, whereas a full, deep sound generally means the slate is intact.
- **Flashing.** A slate roof is only as good as the weakest flashing detail.

**Replace deteriorated or missing slates.** To remove a broken or damaged slate, a slate ripper can be used to extract the existing nails. The slate then slides out, and a new one can be inserted using either the nail-and-bib or slate hook techniques described above.

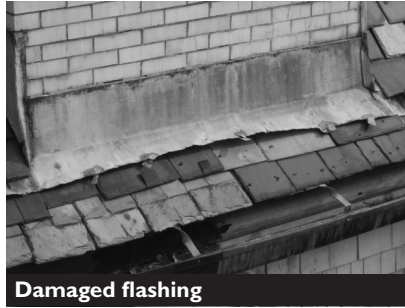
**Damaged flashing**

Slates may last centuries, but flashing must be maintained and replaced periodically. Look for loose and missing fasteners, and flashing that exhibits deformation, wearing, corrosion, or pin holes. Open seams and missing flashing members are also common sources of water entry. Areas to investigate include: ridge, hip, valley, roof-to-wall, drip edge, and step flashing.

**Repair/replace flashings.** Open seams and missing or inappropriate securement can be repaired, while deteriorated flashings will need to be replaced. Copper flashings can be replaced in kind, with a minimum of 16-ounce copper; although a heavier, 24-ounce weight is preferred for erosion-prone areas like valleys and gutters. Lead-coated copper is also commonly used for historic restoration, because of its durability in repair applications.

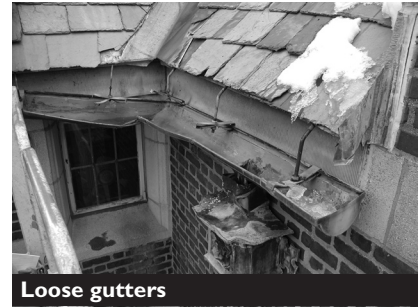
**Loose gutters**

- **Drainage system.** Deterioration of copper gutters and drainage attachments manifests similarly to flashing damage. Check for the signs of distress listed above at gutters, conductor heads, leaders, attachments, and related flashings.

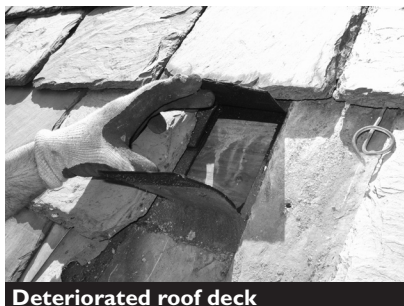
**Deteriorated roof deck**

- **Substrate/roof deck.** Inspect the rafters and sheathing for moisture staining. Test probes, involving removal of selected slates to expose the substrate, can be used to determine if wood rot is present when attic space is inaccessible.

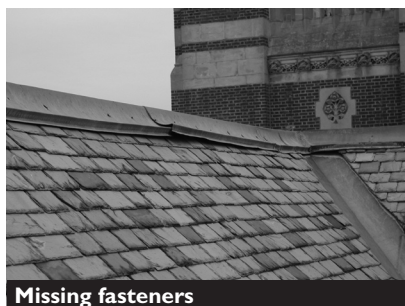
**Missing fasteners**

- **Fasteners.** Confirm the condition and material of nails and other fasteners. Copper or steel nails are generally found on most slate roofs, but replacement slates or flashings may have been secured with inappropriate fasteners, which may deteriorate prematurely.

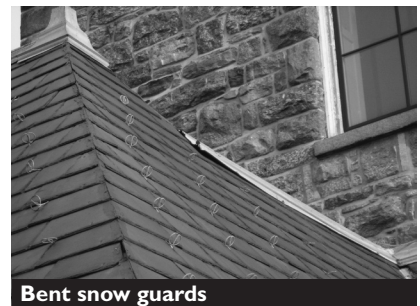
**Bent snow guards**

- **Accessories.** Check the stability, proper functionality, and correct installation of snow guards, lightning protection systems, and other safety devices.

**Replace damaged safety accessories.** Snow guards that are bent or broken should be replaced promptly, as large drifts of snow are potentially dangerous, both in themselves and in their tendency to loosen and dislodge slates, which can then fall from the roof.

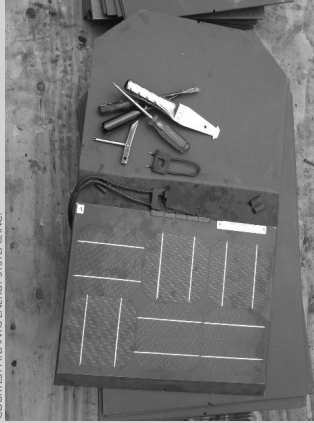
One way to integrate a PV system with a slate roof is with a product called “Sunslates.” Sunslates are dimensionally the same as a slate shingle and are installed the exact same way by a roofer. They clip together in series to create a low voltage electrical circuit, and an electrician connects the system to the building’s electrical panel.

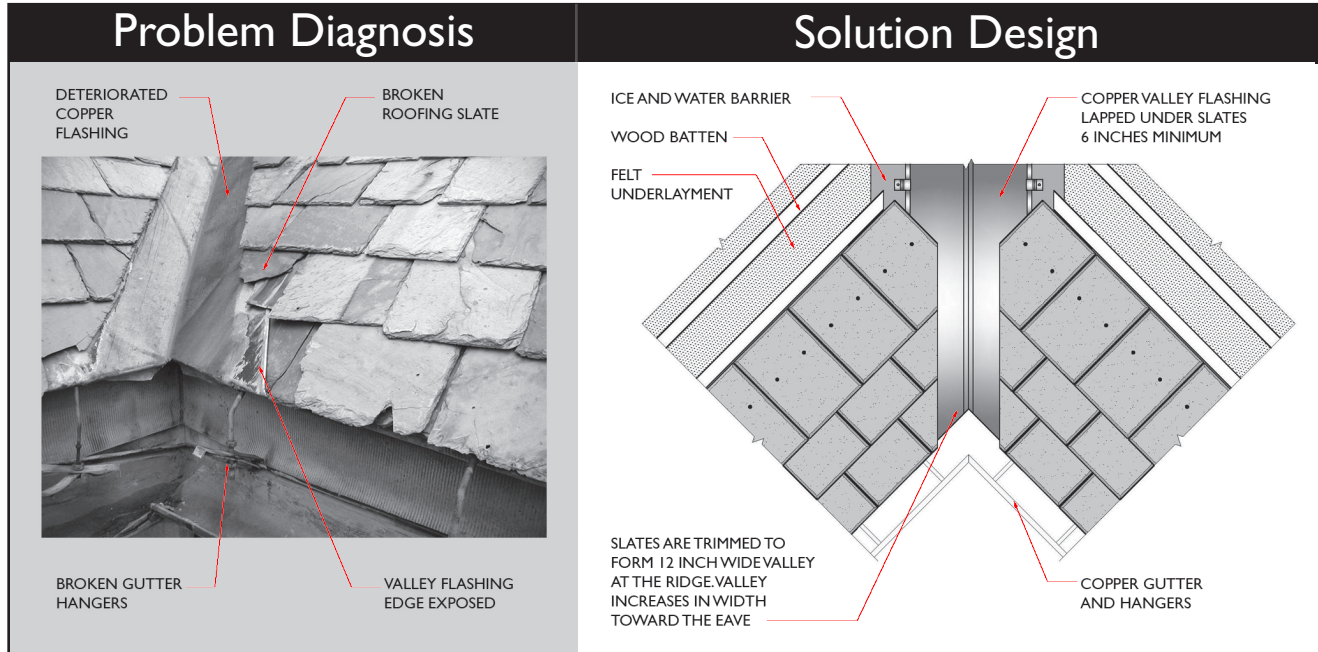
**Standard grade** roofs, which are the most common, use uniform slates of consistent length and width, with even cleavage at the edges. *Headlaps*, the overlap of each slate with the courses above it, and *sidelaps*, the lateral spacing of slates in relation to the courses above and below, are regular.

**Random width** or **textured** roofs use slates of various thicknesses, widths, and tail lengths to create a less uniform appearance. Cleavages may be uneven at the bottom, and slates may range in color and texture.

**Graduated** roofs employ thicker, larger slates at the eaves, and gradually diminish in slate size along the slope, with the smallest, thinnest slates at the ridge.

*Hips* and *ridges*, the upper unions of two adjacent roof slopes, could be covered with specially cut slates in a variety of arrangements, or might be ornamented with flashing formed of sheet metal or terra cotta. *Valleys*, at the internal angle of two roof slopes, shed the bulk of water runoff and so must be particularly well protected. As such, they may employ metal flashing, with slates overlapping at the sides (*open valley*), or they may have slates overlying a metal lining (*closed valley*).

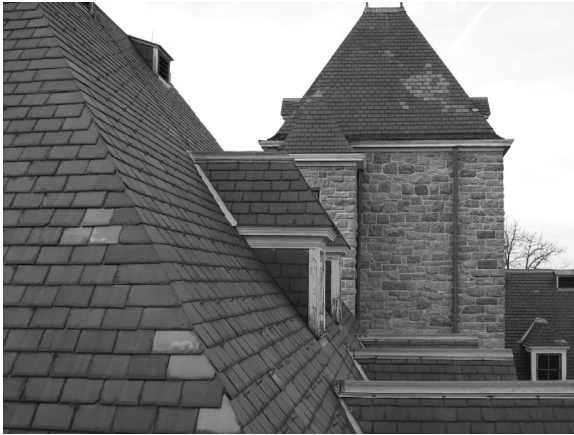
**A** Failure to match the color, profile, and texture of existing slates when selecting replacements can lead to an unattractive patchwork appearance.

To avoid a patchwork of obvious replacement slates, matching by color, size, and texture is an essential part of any slate replacement effort. When available, attic stock can be used, or extra materials can be ordered during a replacement project to maintain stock for future repairs. A knowledgeable roofing design professional should be able to identify the slate type on your roof and its origin, and should be able to locate matching slate, either salvaged or newly quarried.
