# Journal

## Copper Roofing: The Original Green Roof

Juan Kuriyama, AIA and William Hayes, Assoc. AIA

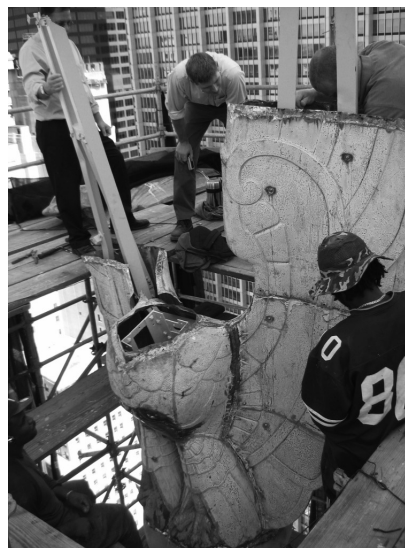
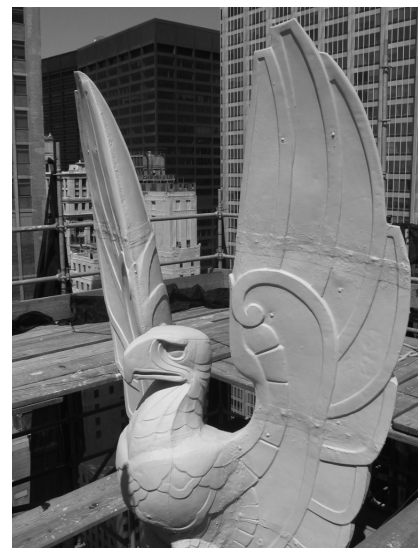
▲ Beyond roofing, copper is also used for ornamentation. Restoration of this copper eagle atop a 1929 high-rise involved off-site and on-site repair, cleaning, and reconstruction.

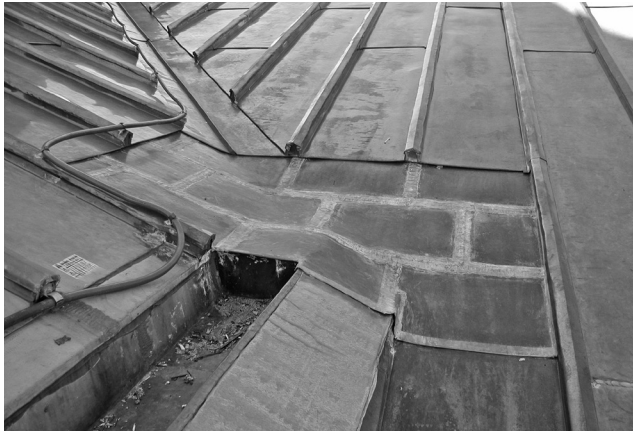
▲ Unusual conditions, such as this combination of soldered flat-seam roofing with steep-slope batten-seam, demand customized designs.

Unique to copper roofs, flat seam construction is generally reserved for low-slope roofs or curved surfaces, such as domes or vaults. Cold-rolled copper sheets are folded over at adjacent sides, with copper cleats installed in the seams. Typically, the longitudinal seams are continuous, whereas transverse seams are staggered. For slopes of 3"-in-12" or less, the flat-locked seams are soldered to improve water-tightness.

With its characteristic box-shaped seams, batten seam construction is commonly used on domes, barrel vaults, and cupolas to create a dramatic roof line. Like standing seam roofs, batten seam construction positions copper pans parallel to the roof slope.

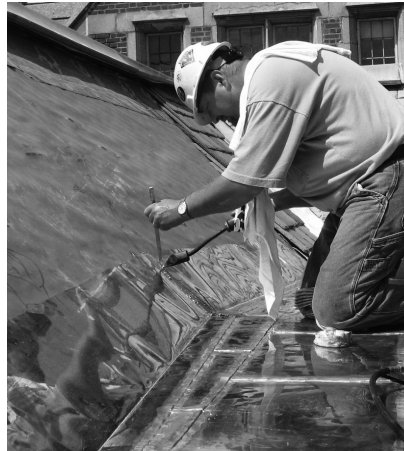
▲ Application of lead-tin solder to a flat-seam copper roof.

With proper design and detailing, sealants are generally unnecessary on copper roofs. The lifespan of copper is significantly longer than that of most sealants. If sealant is used on a copper roof, it must be routinely inspected, maintained, and replaced, adding substantially to maintenance demands. Where appropriate, such as on low-slope flat-seam roofs, solder should be used rather than sealant. For rehabilitation applications, it is preferable to open the seam, remove the existing solder, and re-form and solder the joint.

Solder is not the solution to all copper repair problems, however. Because the coefficient of expansion for lead-tin solder is different from that of copper, solder used to fill stress cracks will eventually break away. If cracking and metal fatigue are widespread, it may be time to consider roof replacement.
