**Hoffmann
Architects**

Journal

Curtain Walls: Not Just Another Pretty Façade

Russell M. Sanders, AIA

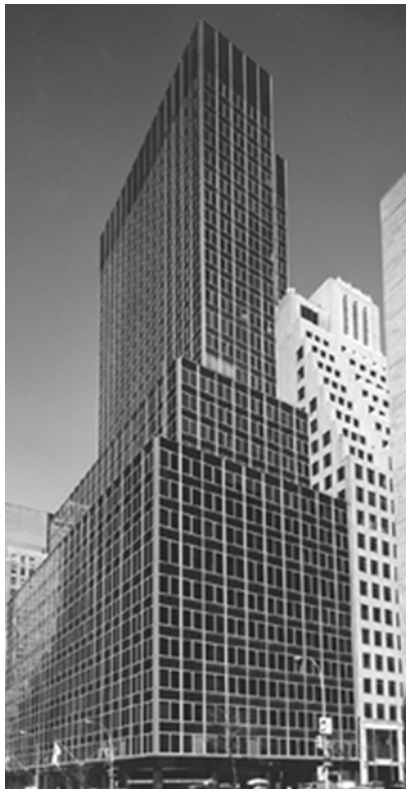
A Curtain walls may be rehabilitated for aesthetic reasons or to improve energy efficiency, in addition to the need to resolve deterioration associated with weathering, age and materials or installation failures.

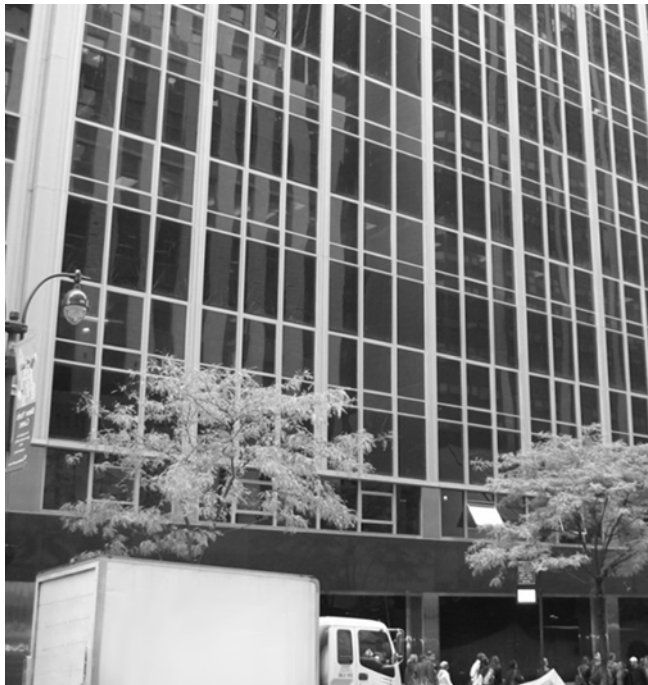
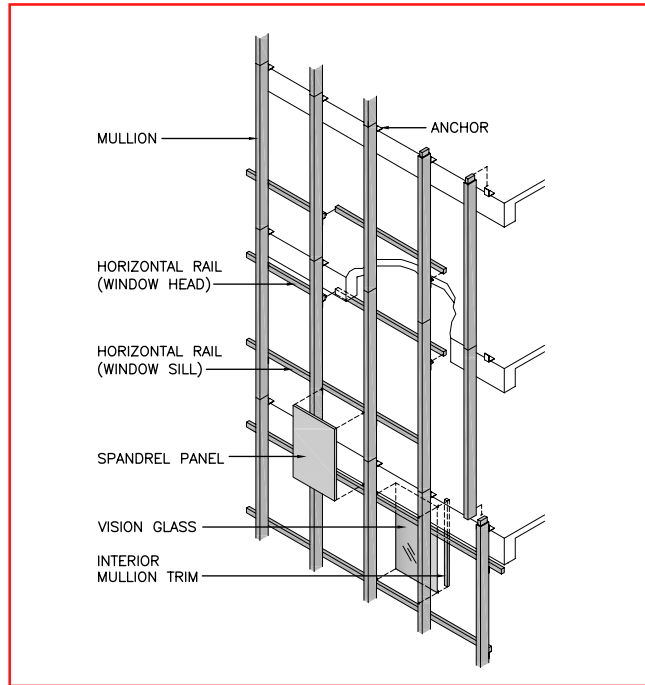
▲ Figure 1a.

▲ Figure 1b. Illustration demonstrates the characteristics in a typical stick curtain wall system, shown in Figure 1a to the left.

The oldest type of curtain wall is the stick system. (Figures 1a and 1b below) It features a cladding and exterior wall structure from floor to floor. The stick system is assembled in the field using various components, including anchors, mullions, rails, vision glass, spandrel glass, insulation and metal back pans. In addition, there are various hardware components, including connectors, setting blocks, corner blocks, pressure plates, caps, gaskets and sealants. Not only is the stick system airtight and resistant to water penetration, it's cheap, and quick

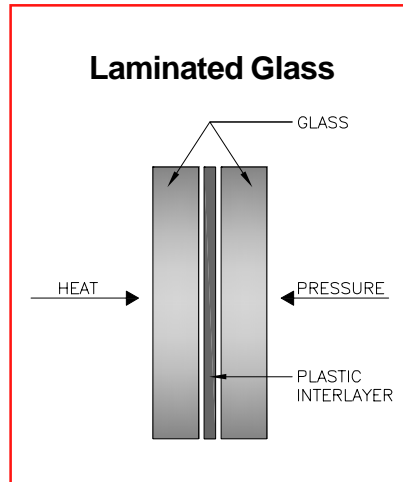
Figure 2

Laminated glass is made of two or more layers of any type of glass with a plastic interlayer, usually polyvinyl butyral (PVB). In the manufacturing process, a vinyl, polycarbonate or cured resin interlayer is bonded applying heat and pressure to the glass layers (Figure 2). This interlayer holds the pieces together when the glass is broken, keeping the glass from shattering. Like tempered and chemically strengthened glass, it can meet safety glazing requirements. This glass can be assembled in combination with any other type of glass. For example, combining laminated and tempered glass in a single pane produces a very strong, secure product. This combination provides an unsurpassed level of security from breakage, and is typically specified for overhead applications and areas vulnerable to impact damage, such as storm debris, bullets or a bomb blast. Laminated glass also deadens sound impact, as in airports or near highways, but is very costly due to the additional steps required in manufacturing.

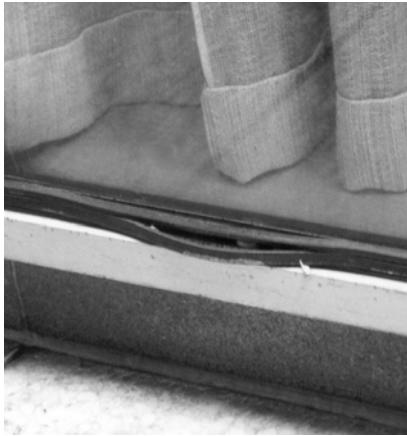
A Figure 3. Failed gasket at the base of the glazed curtain wall will permit water and air penetration.

A curtain wall is a combination of many elements with two common interfaces between the parts: gaskets and seals. Gaskets and seals provide watertight, flexible connections between the panels and framework. Generally, curtain wall framework and panel materials rarely deteriorate; failure of those components is a result of damage. But gaskets and seals are made of compounded elastic materials that can dry, shrink and crack and lose adhesion (Figure 3).

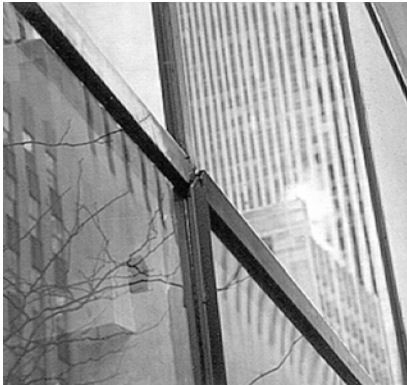
A Figure 4. The metal support system behind the mullion cover has rusted, causing it to extrude.

Dripping water at window heads or wet flooring are the most obvious indications of moisture problems. If the existing curtain wall is a thermal pane system, condensation can form between the panes of glass. Insulated panels that no longer provide insulating qualities can mean that moisture is entering the system. Deformation of the framework can occur if water that has intruded the system collects and expands during freeze-thaw cycling (Figure 4).

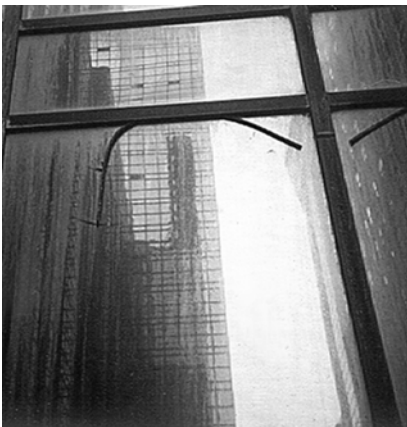
A Figure 5. Loose gaskets permit water infiltration; winds can loosen and eventually blow out the glass panel. Staining is the result of contaminants that have washed into the glass panel and may lead to permanent etching.

A compromised thermal seal in the curtain wall can have several effects. The most obvious is water infiltration into an interior space. Fogged or etched thermal windowpanes can be one result of a less-than-tight seal (Figure 5). Air leaks may not be quite as obvious, but can show up as drafts, hot and cold spots at panel edges or increased heating and cooling costs.

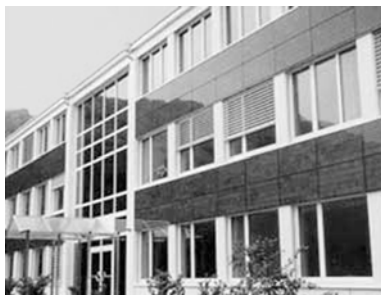
▲ Figure 6

▼ Below, Figure 6 shows a factory built with spandrel glass incorporating photovoltaic cells.

Solar cells, or *photovoltaics*, convert sunlight directly into electricity (Figure 6). Solar cells are made of semi-conducting materials similar to those used in computer chips. When these materials absorb sunlight, the solar energy knocks electrons loose from their atoms, allowing the electrons to flow through the material to produce electricity.

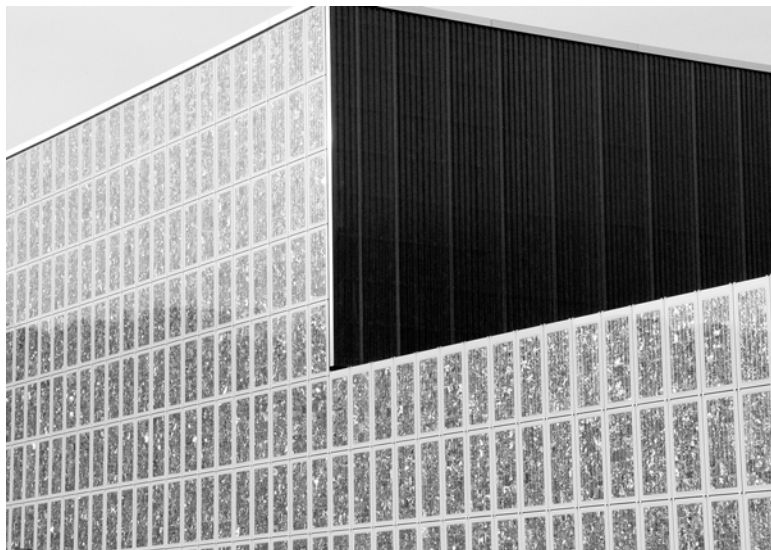
▲ Figure 7

► At right, Figure 7 shows a sports stadium with solar cells incorporated into the curtain wall.

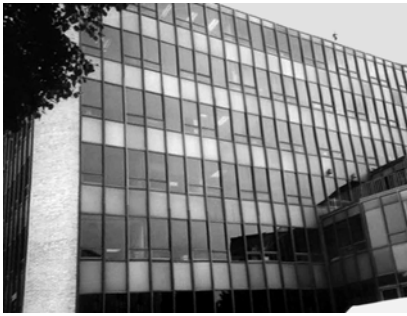
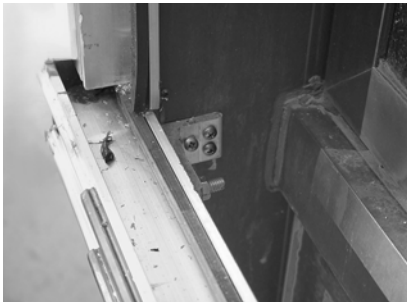
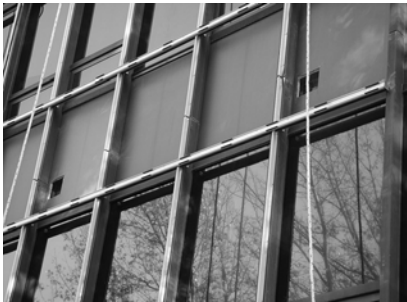
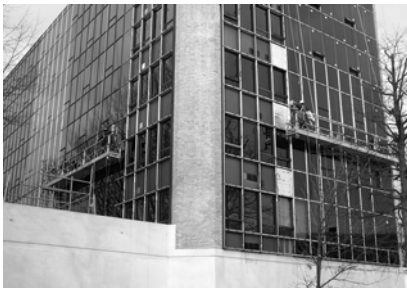
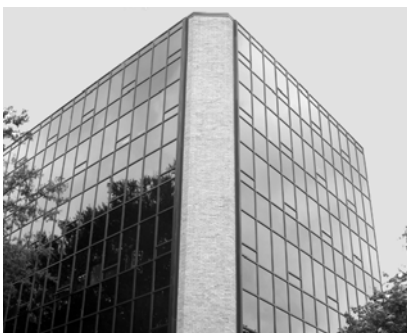
◀ From top to bottom, figures illustrate how a curtain wall is re-clad. Figure 8 shows the curtain wall prior to replacement. Figure 9 shows the horizontal rail attached to the structural mullion. Figure 10 shows new veneer rails attached to existing curtain wall mullions. Figure 11 shows the installation of new vision, spandrel and insulation panels. Figure 12 shows the completely re-clad curtain wall.
