**Hoffmann
Architects**

Journal

Sealant Joint Solutions

Arthur L. Sanders, AIA and Lawrence E. Keenan, AIA, PE

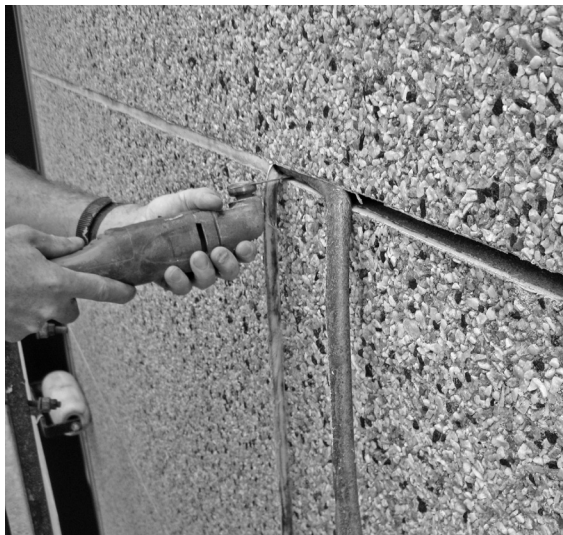
▲ Facade sealant replacement begins with complete removal of existing sealant and backer rod.

Where feasible, sealant replacement projects should begin by resolving original design flaws in joint dimensions and spacing. Joint preparation should involve removal of existing sealant, dirt, and debris through the use of grinding, compressed air, or wire brushing, as appropriate. Non-porous substrates may be cleaned with solvents, using the two-rag method: one rag for solvent application, followed immediately by a second clean, lint-free rag to dry the surface.

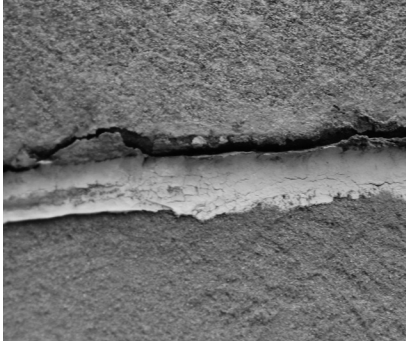
▲ Adhesive failure: Sealant pulls away from the substrate.

Joints that are too narrow or too widely spaced may force sealant to stretch beyond its capacity, which can cause the sealant to pull away from the substrate (*adhesive failure*) or to tear within itself (*cohesive failure*). Expansion of the substrate may compress the sealant beyond its tolerance, causing it to extrude out of the joint. A joint that is excessively wide may not be able to accept sealant at all, as

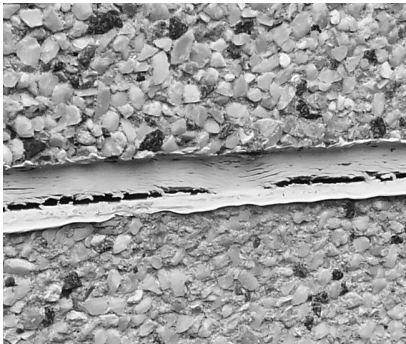
▲ Cohesive failure: Sealant tears within itself.

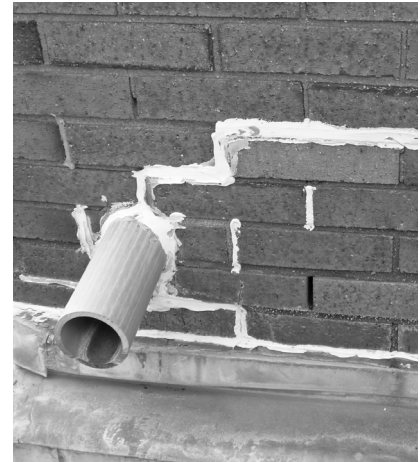
▲ Sealant misused to repair mortar joints.

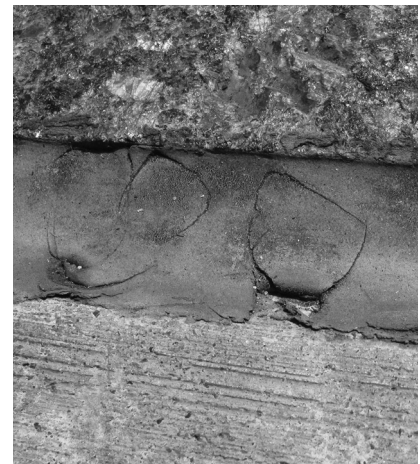
▲ Damage to plaza sealant caused by high heels.

Fountains, parking garages, plazas, schools, and other sites subject to vandalism, water, and weather conditions demand sealant with superior abrasion resistance. High-heeled shoes, the bane of the precast concrete parking garage owner, are notorious for puncturing sealant at joints. Special additives and hardeners are manufactured specifically to resist damage from high heels. Pick-proof sealants can withstand vandalism, but these harder sealants tend not to accommodate much movement.

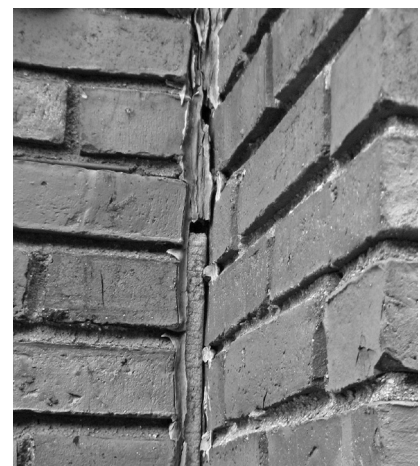
▲ Failure to maintain sealant joints can lead to severe deterioration and water entry.

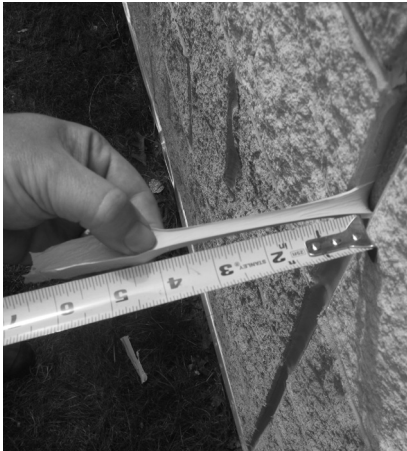
▲ Peel tests are used to evaluate sealant elongation and adhesion.

Peel tests for adhesion involve applying sealant to a test area, allowing it to cure, and evaluating the elongation prior to fracture or loss of adhesion.

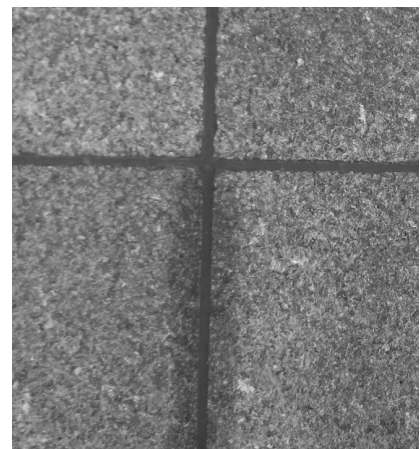
▲ Compare the non-staining sealant at the top of this image with the sealant at the bottom, which has discolored the substrate.

Staining. The components of some sealants may leach into porous substrates, particularly natural stone, leaving a visible stain. To evaluate compatibility with the substrate, even sealant rated as non-staining should be tested in an unobtrusive area before use.

Substrate compatibility is another major consideration when selecting a sealant. Some sealants can leach chemicals that may discolor or degrade porous substrates, such as brick masonry and stone. Under stress, a sealant that is stronger than its substrate can cause cracks and spalls, as force is dissipated within the weaker material. This phenomenon is common with Exterior Insulation and Finish Systems (EIFS).

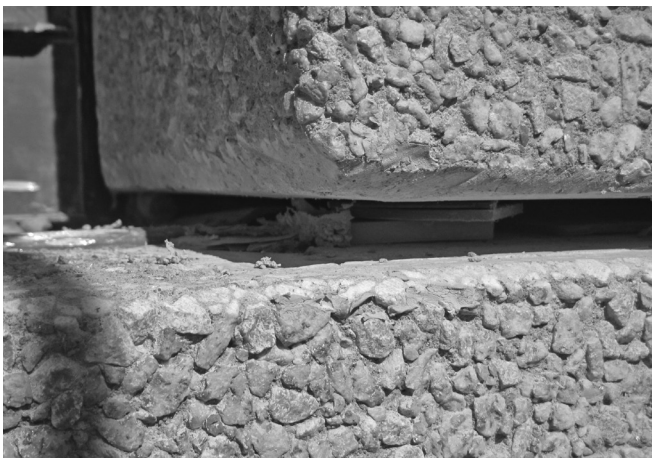
A Insufficient joint preparation can compromise sealant adhesion. Debris and residue must be cleaned prior to new sealant installation.

The number-one concern in the sealant application process is surface preparation. Given how often sealant failures related to poor surface preparation occur, and how costly such failures can be to rehabilitate, it would be reasonable to assume that a top consideration for sealant installers would be the diligent and thorough cleaning and, if required, priming of joint surfaces. Not necessarily so. Especially for workers who have “always done it this way,” manufacturers’ recommendations for preparing the substrate may have little bearing on what is actually done in the field. At a minimum, surfaces must be clean and dry. Too often, though, even this simple stipulation is ignored. Dirty rags, incorrect or contaminated solvent, lint, and residue from existing sealant are
