**Hoffmann  
Architects**

# Journal

## Storefront Rehabilitation and Design

Juan A. Kuriyama, AIA and Tai Mahmuti, B. Eng., LEED Green Associate

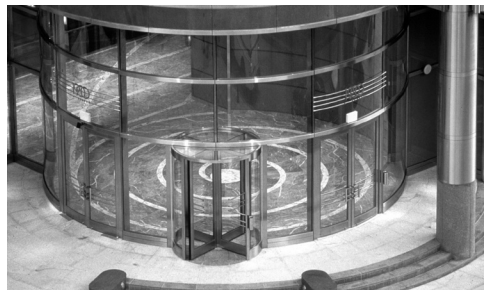
**A** Investigation of the poorly functioning revolving door at this office complex revealed extensive corrosion.

**Revolving doors.** For buildings with significant traffic, such as commercial buildings, hotels, shopping malls, or hospitals, revolving doors can mitigate strong positive and negative pressures. Where HVAC and outdoor conditions would cause excessive wear

and tear on a typical door, revolving doors permit high-volume usage without compromising indoor climate. Automatic revolving doors provide ADA-compliant operation while managing heavy traffic.

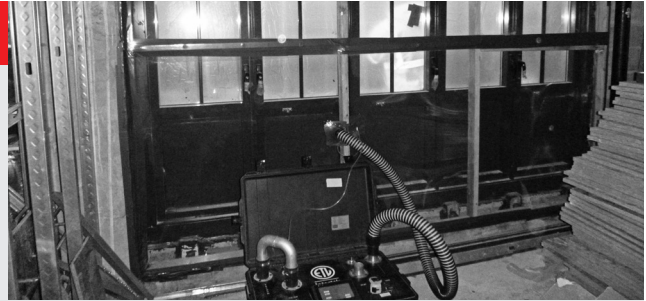
Field tests confirm the storefront meets performance standards.

Depending on the complexity of the design, the architect or engineer may recommend testing of the entire storefront system, including all components and glazing. The testing laboratory provides a basic structural skeleton, on which the contractor/installer builds the test specimen under the direction of the manufacturer. Since minor modifications are often necessary to pass the performance tests, it is important to have participation of the installer as well as all manufacturers, especially for custom assemblies involving parts from different companies.

In-situ field testing is often recommended to confirm the installed assembly performs as expected. ■

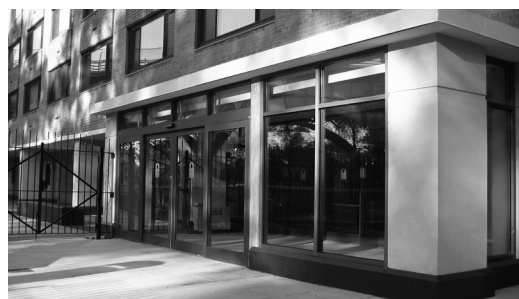
Replacement of this aging storefront (*below*) demanded modifications to the new assembly (*left*) for operation in strong wind.

selected over a balanced door due to its lower cost. If the building is situated in a high-wind zone, the door will be subjected to strong forces when open, taxing the hardware and leading to constant maintenance repairs or replacement. In this location, a balanced door, while more expensive at the outset, might prove less costly in the long term, as its resistance to wind pressure could mean longer lifespan and fewer repairs.

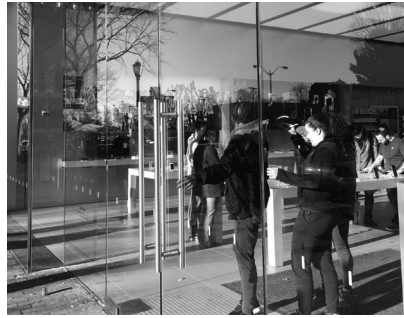
Without weatherstripping, these doors look sleek, but air infiltration may be an issue.

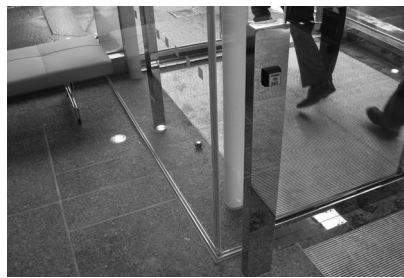
Vestibules prevent drafts and heat loss.

For lower-intensity settings where weather exposure and drafts are considerations, such as restaurants, commercial institutions, and shops, **vestibules** can moderate temperature differentials and wind conditions. Some energy conservation codes require vestibules for certain types of new construction. To limit heat transfer at entry points, existing buildings may be retrofitted with vestibules.
