Hoffmann
Architects

Journal

Treating Reinforcement Corrosion in Parking Structures

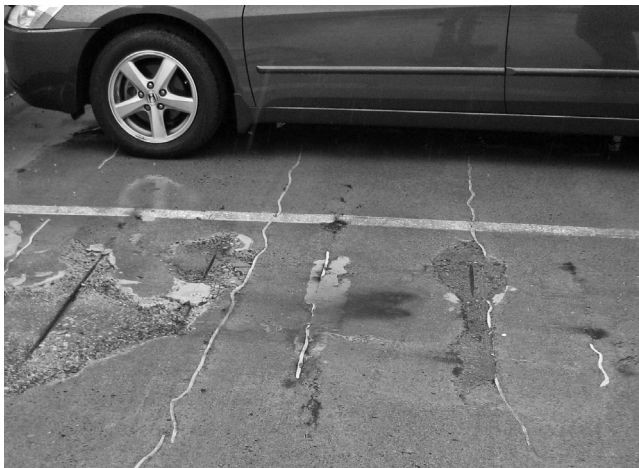
A Corrosion of embedded steel reinforcement is a leading cause of premature deterioration in parking garages.

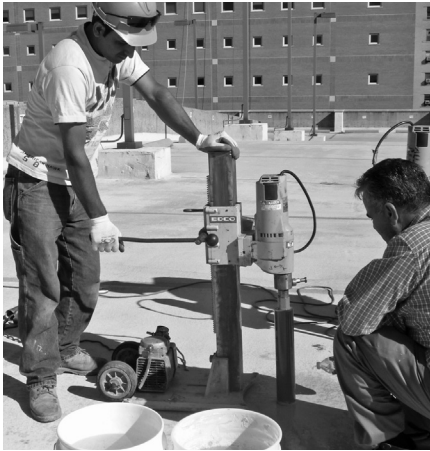
▲ Core samples of concrete may be tested for chloride content, strength, and composition to guide the design professional in evaluating the structure's resistance to corrosion.

Rebar in concrete that has undergone carbonation and de-passivation has lost the protective layer around the reinforcing steel and is therefore susceptible to accelerated corrosion from even low concentrations of chlorides. Laboratory tests can measure the extent of chloride contamination as part of an investigation and repair project.

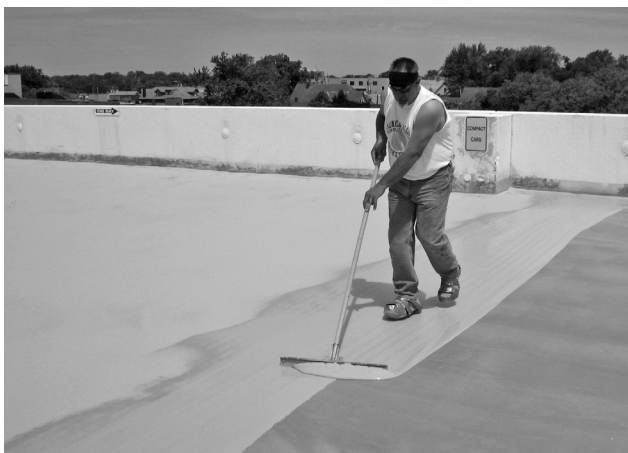
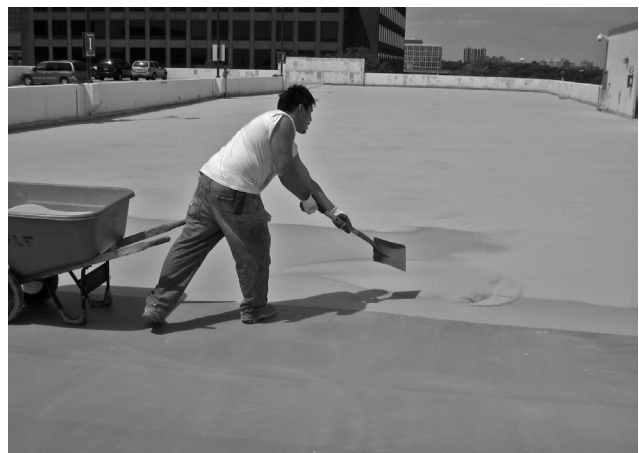
▲ Installation of a traffic-bearing membrane involves multiple steps, including application of a liquid-applied coating (*left*) and integration of a textured wearing surface (*right*). The resultant membrane protects against corrosion, but requires maintenance and periodic reapplication.

Traffic-bearing membranes are elastomeric coatings that form a barrier, locking out moisture and chlorides to protect the underlying concrete and

reinforcement. Composed primarily of epoxy, methylmethacrylate, or urethane, traffic-bearing membranes are flexible and can bridge cracks, but they are also very expensive and require periodic recoating, as their pliability makes them susceptible to abrasion damage. Lengthy downtime for application, which can take several days, may also be a consideration.

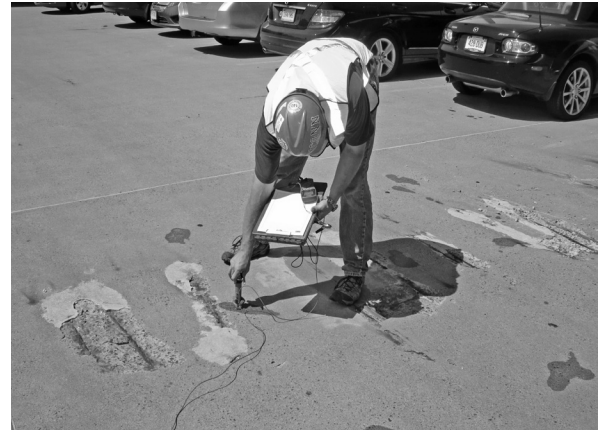
▲ Half-cell potential readings can be used to identify areas of reinforcing steel that are at greatest risk of corrosion.

Half-cell potential testing determines the electrochemical behavior of embedded steel by measuring its electrical potential, or the difference in charge from one area to the next. The greater the electrical potential is, the greater the risk that corrosion is occurring. Conducted on-site, the test involves removal of concrete cover over reinforcing bar, then connection of exposed steel to an electrode through a voltmeter. Half-cell potential readings can be used to generate an electrical potential map, indicating areas with the greatest and least risk of corrosion.
