**Hoffmann
Architects**

Journal

Windows:

An Integral Part of the Building Envelope

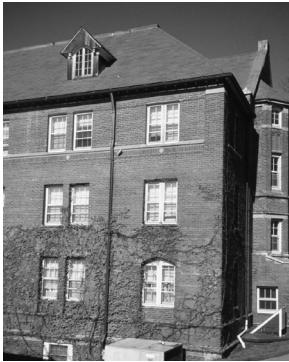
Double-hung

Single or double hung. Two sashes that slide vertically in adjacent planes. "Single hung" refers to one operable sash, "double hung" to two. Taller openings may have triple hung windows. Although familiar to many homeowners, this window type is also widely used on high rises, due to its ease of operation and good wind resistance.

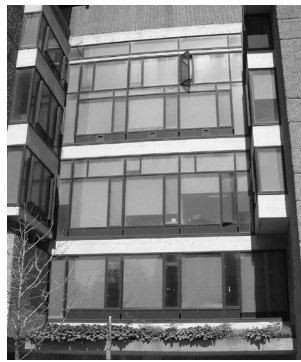
Casement

Casement. One or more sashes that swing outboard or inboard from the vertical frames. Although common on residential applications, consideration must be taken with high-rise commercial use, because the sash and hardware have lower wind pressure tolerance.

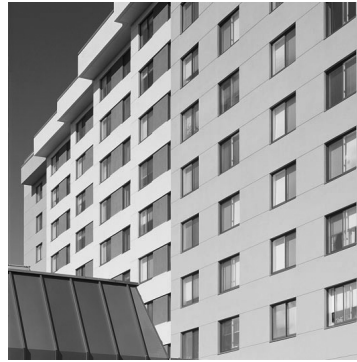
Sliding

Sliding. Operate like their single- or double-hung cousins, but slide horizontally, rather than vertically. Maintenance of track hardware to remove dust or accumulated particles is critical for proper operation.

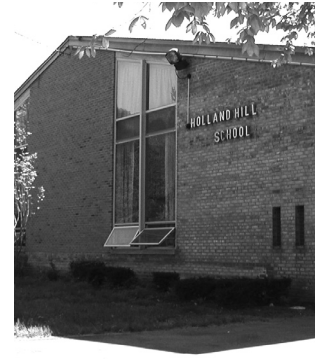
Awning

Awning. One or more sashes that swing outboard from the upper frame. Their name derives from the weather protection offered by the window in the open position, when it creates a canopy-like projection above the opening.

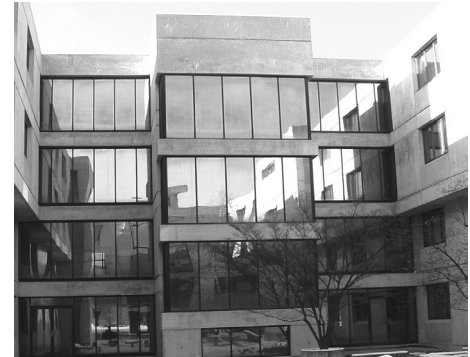
**Fixed**

Fixed. Do not need operable hardware, and so achieve the maximum glass area for a given opening. Also known, more familiarly, as “picture windows.”

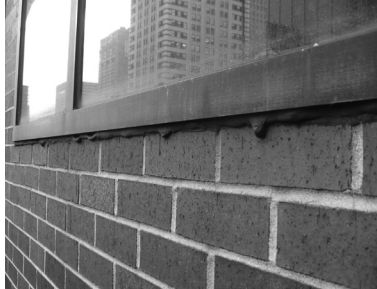
Sealant failure at window exterior.

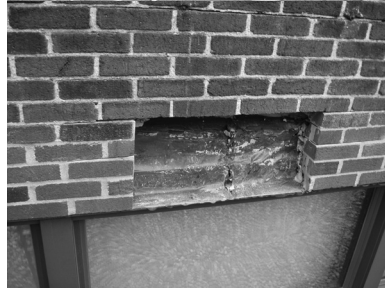
Damaged flashing at window head.

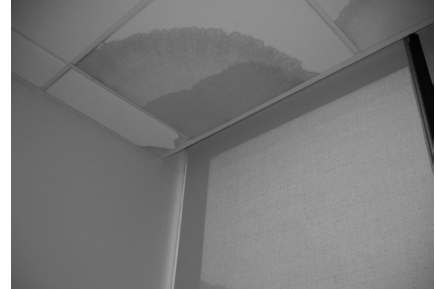
Water intrusion and interior damage.

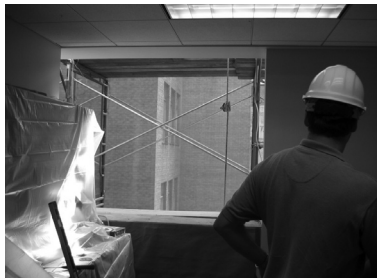
Window removed; wall opening ready for replacement window installation.

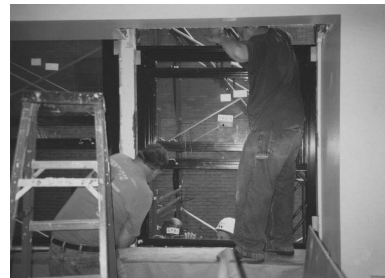
Installation of replacement windows.

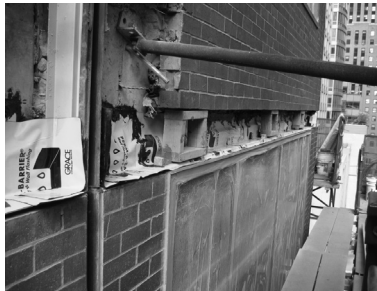
Installation of new flashing at window head.

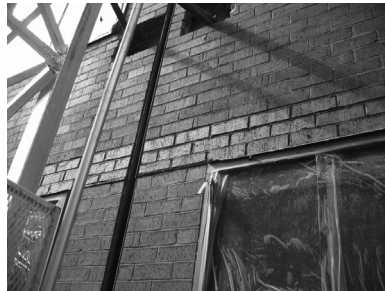
Reconstruction of brick exterior wall after flashing replacement.

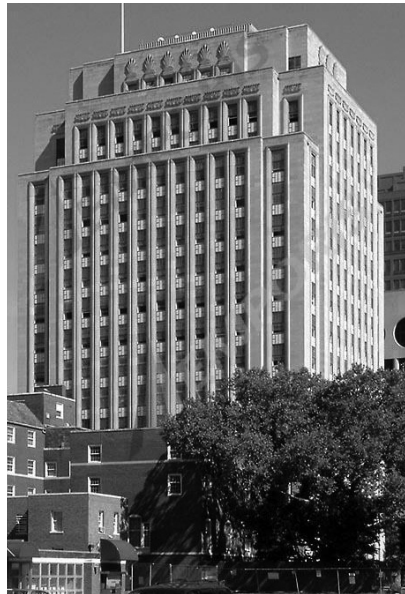
▲ Former Southern New England Telephone Headquarters in New Haven, Connecticut. *Historic Window Refurbishment:* *Restored steel windows to preserve historic materials and provide cost savings.*

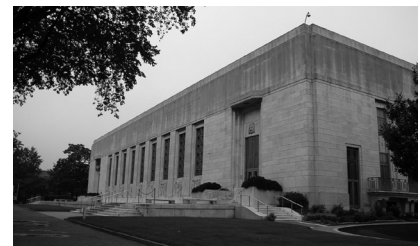
▲ Folger Shakespeare Library in Washington, District of Columbia. *Historic Window Assessment:* *Evaluated eleven window types for efficiency, waterproofing, and finish integrity.*
