STOREFRONT REHABILITATION AND DESIGN

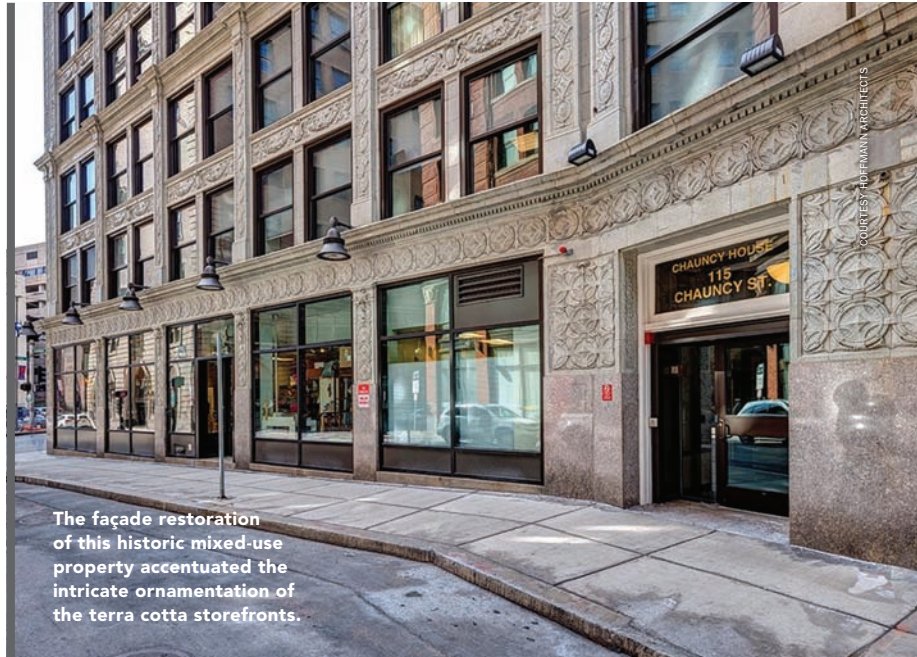
The façade restoration of this historic mixed-use property accentuated the intricate ornamentation of the terra cotta storefronts.

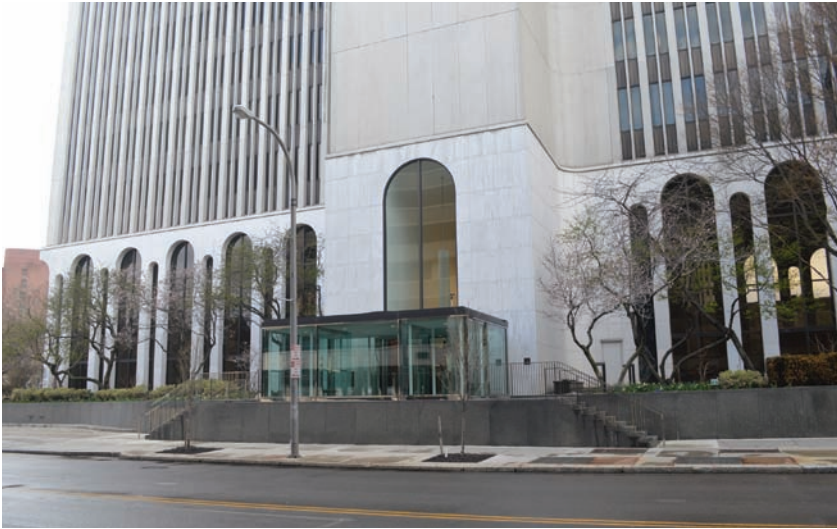
The award-winning storefront entrance redesign at this Modern-era landmark maintained the aesthetic of the original while improving thermal regulation and pedestrian traffic flow.
